July 2017 **Technical Service**

RECALL CAMPAIGN 14V-428: REPLACE PASSENGER'S FRONT AIR BAG MODULE:

E46 (3 Series)		
L40 (3 Selles)

Model Year from 2000 to 2006

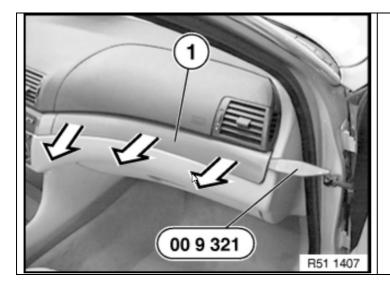
- Insert special tool 00 9 321 at the side and with the second special tool 00 9 321 next to the retaining pin.
- Unclip the decorative strip (1).

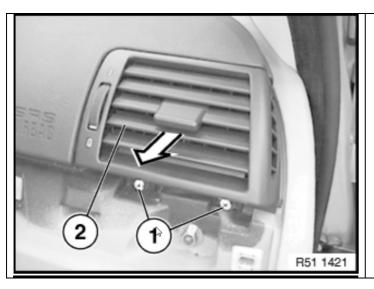
- Loosen the screws (1).
- Withdraw the fresh air grill (2) in the direction of the arrow.

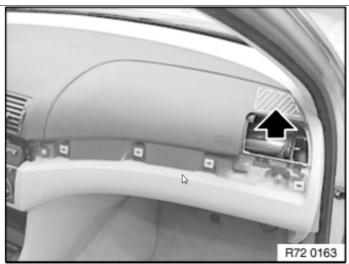
Position of the retaining clip of the front passenger's airbag cover

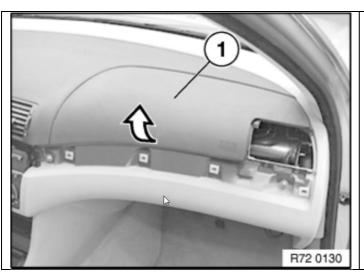
Lever out the front passenger's airbag cover (1).

The retaining clip remains in the dashboard when removing the cover.

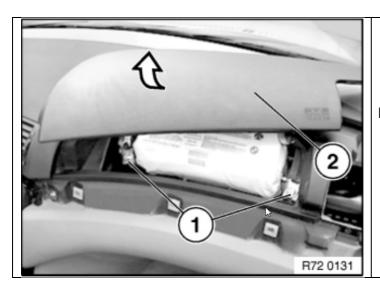
Undo the screws (1) and place the front passenger's airbag cover (2) on top.

Tightening torque for the retaining straps for the cover, passenger's airbag module on the instrument panel carrier: 9 Nm

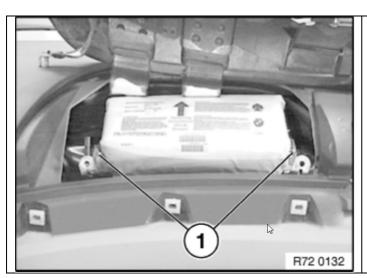
• Undo the screws (1) at the front passenger's airbag module.

Tightening torque for the passenger's airbag module on the instrument panel carrier: M8 nut, 22 Nm

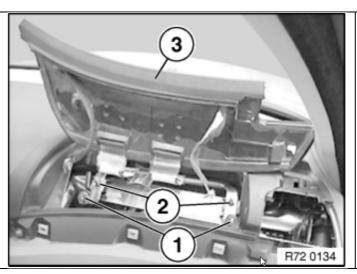
- Pull off the retaining tube (1) from the stud bolt (2) and completely remove the cover (3).
- Remove and replace the passenger's side airbag module.

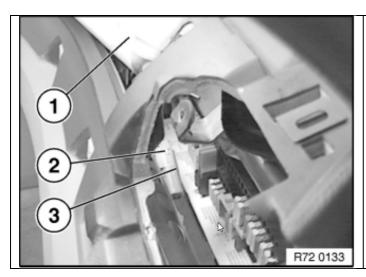
Do not tension the cable when removing the front passenger's airbag module (1)!

- Open the lock by pressing on the tab (2).
- Disconnect the plug connection (3).
- Remove the front passenger's airbag module (1).

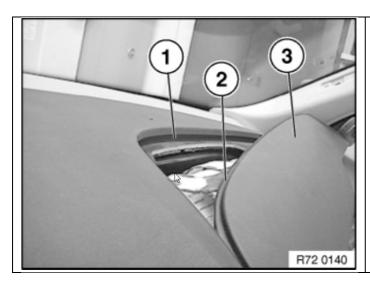
The front passenger's airbag cover (3) must engage into the all-round groove (1) of the dashboard with the lug (2).

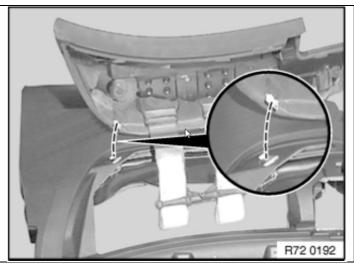
The additional retaining lug at the front passenger's airbag cover must engage in the retaining clip of the dashboard trim panel.
