# Gulf States Toyota, Inc. GST Safety Recall 14R2 2013-2014 Tundra Lug Nut Replacement

## GST Safety Recall 14R2

### 2013-2014 Tundra Lug Nut Replacement

## **Safety Recall – 14R2**

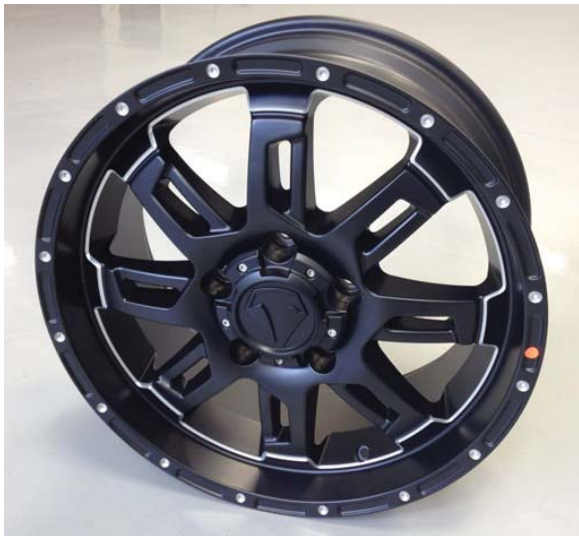
**G.S.T. P/N 00012-T1354-03**

The (2) wheels pictured below are those mentioned in the campaign documents.

It is important to know and to verify in both cases, the applicable wheel center cap is a bolt on center cap, and the lug nuts are a conical style lug nut.

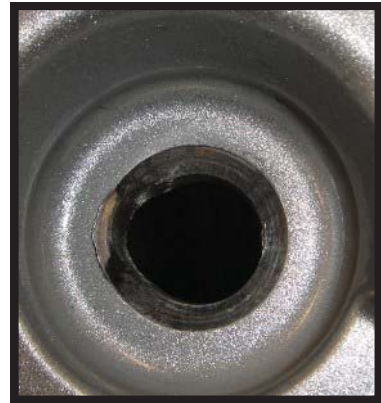
**A**

1. Pictures A and B at the right are examples of wheel lug nut seat distortion. You will notice the area is no longer round and has a slight elongation in the lug seat surface.
1. Picture C shows signs of contact of the lug stud threads on the inside diameter surface of the lug bore through the wheel. It is important to consider some 'scuffing' of this area may occur during tire rotates and that should not be confused with the actual noticeable imprint of the lug thread.

Lug seats should be round, and show no signs of elongation.

Replace the affected original GST wheel with the appropriate replacement P/N wheel, and submit a separate LIO Warranty claim for the wheel.

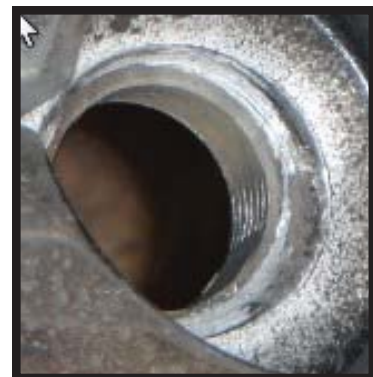
**C**

Be sure there are no indications the lug bolt thread has embedded an imprint of the thread into the sides of the wheel lug holes.
