Technical Service Bulletin

14-01-032-1

2011 SONATA (YF)

SUBJECT: SONATA (YF) BRAKE TUBE REPLACEMENT
(RECALL CAMPAIGN 122)

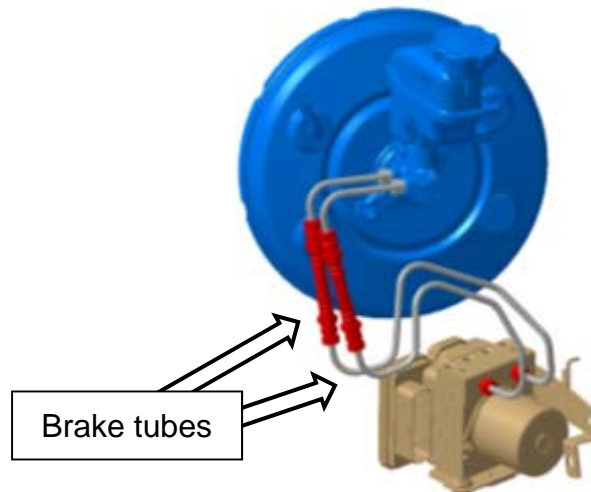
Description: This bulletin describes the procedure to replace the brake tubes for certain 2011MY Sonata (YF) vehicles. The two brake lines connecting the brake system's master cylinder to the Hydraulic Electronic Control Unit (HECU) may develop a leak over time due to an insufficient seal between the inner brake hose and metal brake line fitting.

Two symptoms can result from this condition. As the brake fluid leaks, there may be a gradual depletion of fluid in the brake fluid reservoir over time resulting in complaints of a brake fluid leak. If the leak continues unnoticed, the brake warning lamp in the instrument cluster will illuminate. Additionally, a fluid leak between the hose's inner and outer layers may restrict brake fluid flow between the master cylinder and the circuit's brake caliper(s). This may be accompanied by illumination of the Electronic Stability Control (ESC) warning lamp in the instrument cluster.

If the brake tubes leak sufficient brake fluid, the brake warning lamp in the instrument cluster will illuminate and longer stopping distance will be required, increasing the risk of a vehicle crash.

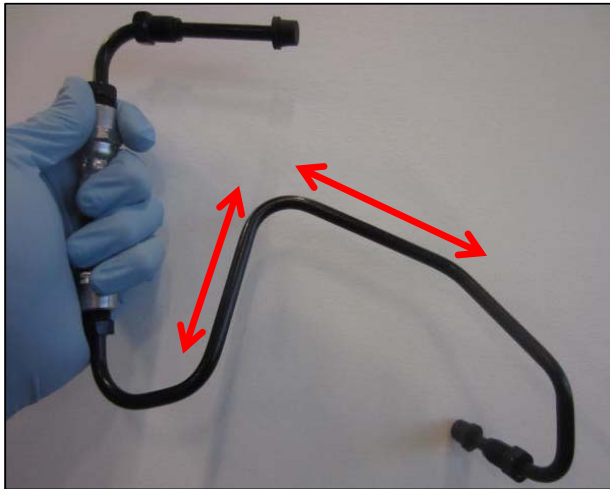
ATM Primary tube has longer lines.

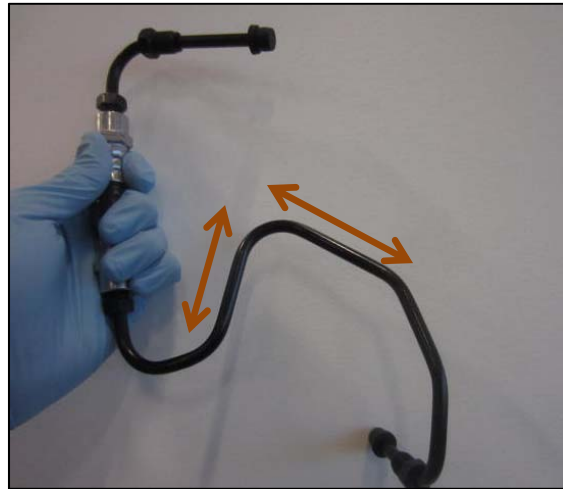
ATM Secondary tube has shorter lines.

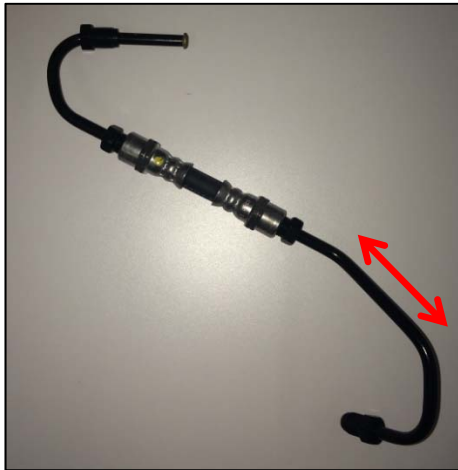
MTM Primary tube has a longer line.

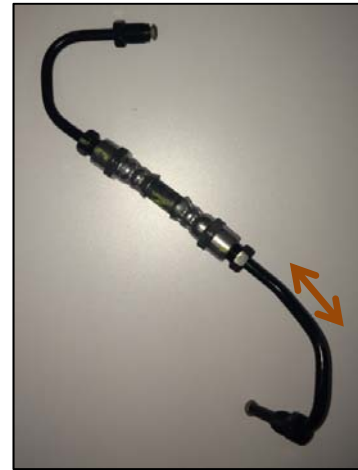
MTM Secondary tube has a shorter line.
