Recall Bulletin

PRODUCT SAFETY RECALL

SUBJECT: Lower Control Arm Ball Joint Retaining Bolt Loose

MODELS: 2014 Chevrolet Spark

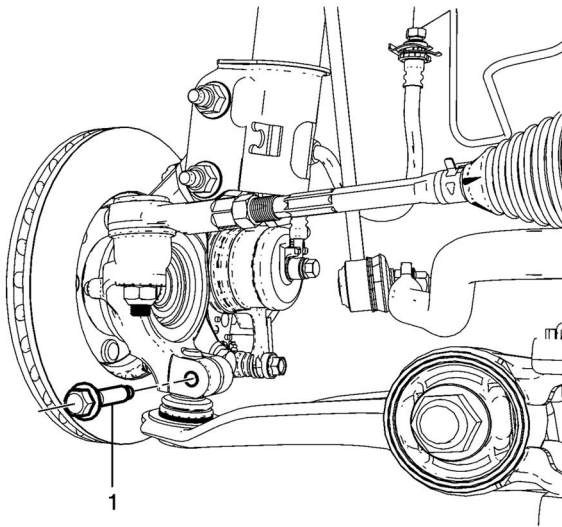
2327521

2. Locate the left and right lower control arm ball joint to steering knuckle retaining bolts (1).
