# Recall Bulletin

## PRODUCT SAFETY RECALL

**SUBJECT:** Incomplete Weld on the Seat Hook Bracket Assembly

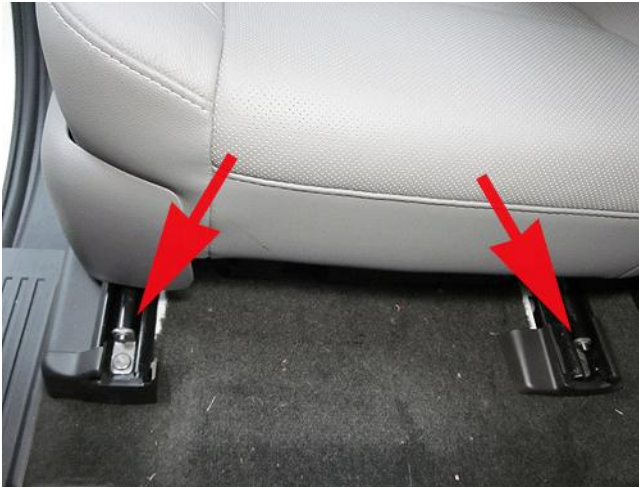
3960104

**Important:** Use the following steps to inspect the left and right front seat front mounting hook welds located in the area shown above (\*).

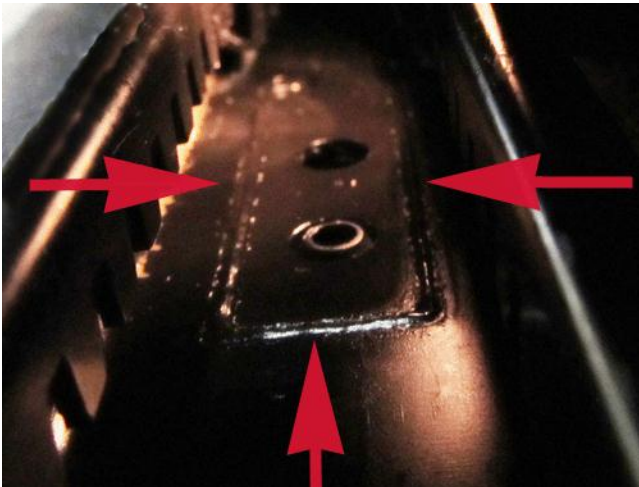
3963504

The weld should be a continuous U shape with one side longer than the other (the actual seat hook weld is on the underside of the rail but the weld penetration is visible from the top, which is what is inspected during this procedure).

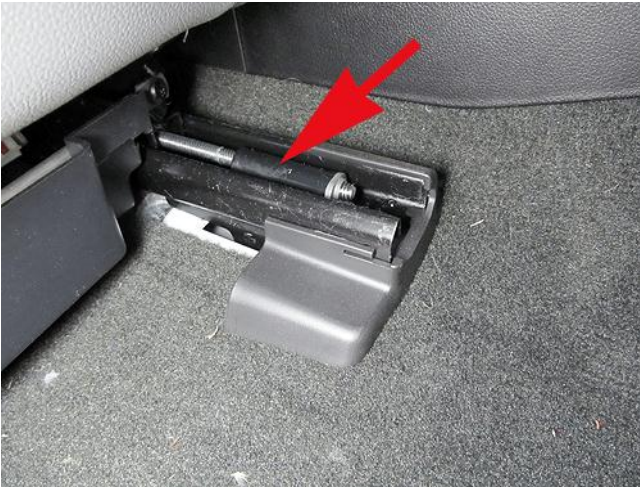
3960106

**Note:** On vehicles equipped with power seats, the inspection area is under the threaded rods on the seat track.

**Note:** The passenger seat has black plastic collars around the threaded seat adjuster rods. Use a screwdriver to push the collars rearward on the rod to allow the weld inspection. The collars will reposition themselves into the correct location when the power seat is cycled to the full forward position.

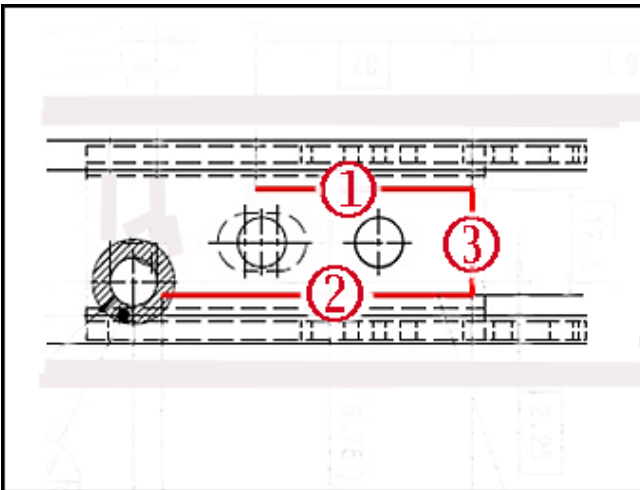
3963505

3. Illuminate the inspection area with a flashlight. Inspect the weld and ensure there are no obvious skips or gaps. For example, if the weld has an inconsistent appearance and/or texture but it contains metal from one end to the other, it is not an obvious skip/gap. An example of an obvious skip/gap would be if metal was actually missing from part of the weld. Using a ruler, measure the length of the weld penetrations on the seat track.

- Ensure the short weld length is a minimum of 35 mm (1.38") in length (1).
- Ensure the long weld length is a minimum of 51 mm (2.0") in length (2).
- Ensure the cross car weld connects to both of the parallel welds (3).
- Repeat this inspection on all four front seat tracks (\*).

4. If all of the welds pass the inspection, the repair is complete. If any of the welds **do not meet the specification**, proceed to the *Seat Cushion Frame Replacement* section below.
