# Recall Bulletin

## PRODUCT SAFETY RECALL

**SUBJECT:** Power Seat Height Adjuster Bolt

**MODELS:** 2011-2012 Buick LaCrosse, Regal  
2010-2012 Cadillac SRX  
2011-2012 Chevrolet Camaro  
2010-2012 Chevrolet Equinox  
2010-2012 GMC Terrain  
Equipped with Driver Power Seat Height Adjuster

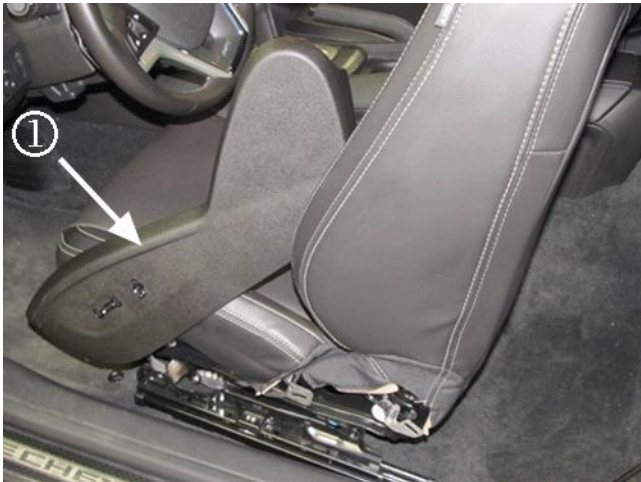
3969295

1. Adjust the driver front seat into the fully upward and forward position.

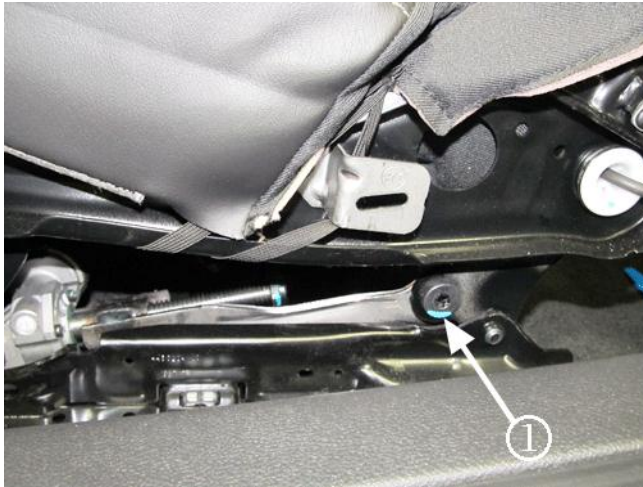
3969296

**Note:** It is NOT necessary to remove the adjuster and lever knobs, nor disconnect the electrical connector noted in the procedure below. The finish cover (1) can be detached and repositioned to gain access to the vertical adjuster actuator bolt

2. Remove the front seat outer adjuster finish cover (1) from the seat. Refer to *Driver or Passenger Seat Outer Adjuster Finish Cover Replacement (with Power Height Adjuster)* in SI.

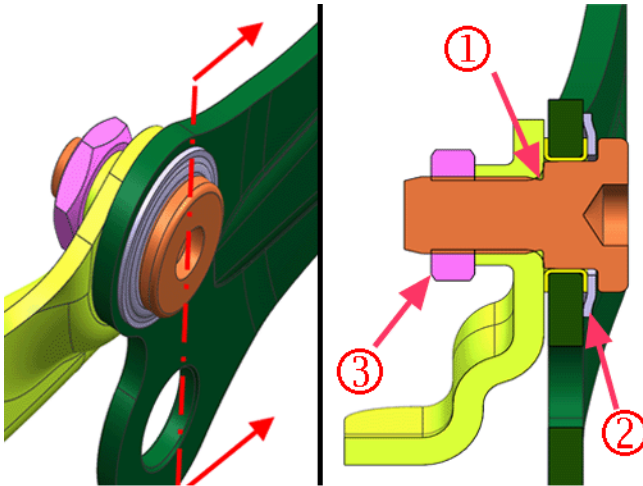
3969298

3. Remove the seat vertical adjuster actuator bolt (1) and discard.

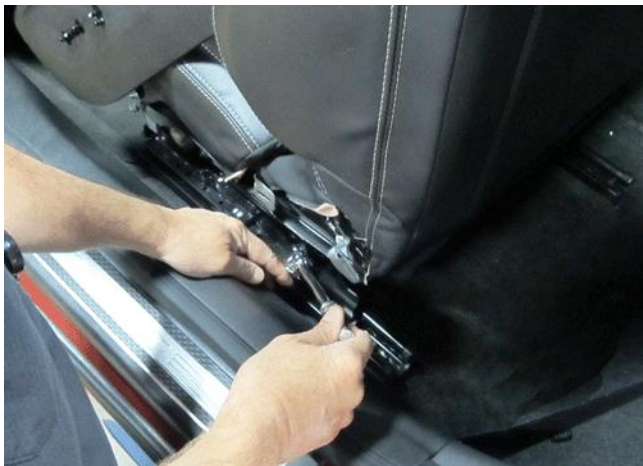
3969299

4. Install the new shoulder bolt (1) with integral washer (2), and the locknut (3) from the retainer kit.

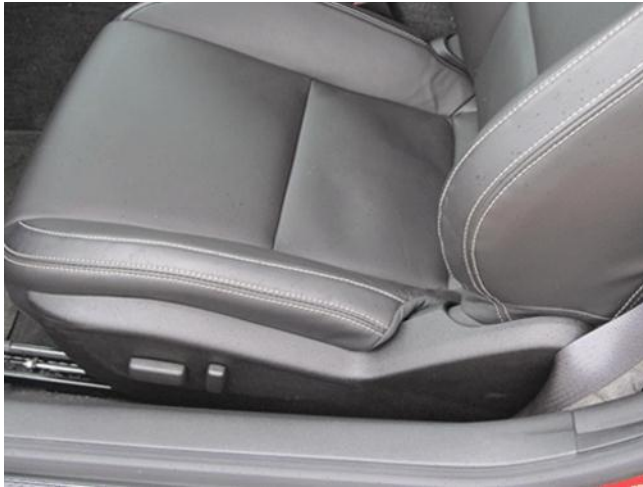
3969300

- 4.1. From the outboard side, install the shoulder bolt w/integral fastener to the bracket and torque to 42 N-m (31 lb ft).
- 4.2. From the rear underside of the seat, thread the locknut onto the threads of the shoulder bolt and torque to 25 N-m (18 lb ft).
