Bulletin No.: 14330
Date: July 2014

PRODUCT SAFETY RECALL

SUBJECT: Loss of Power Steering Assist

MODELS: 2014 Chevrolet Impala

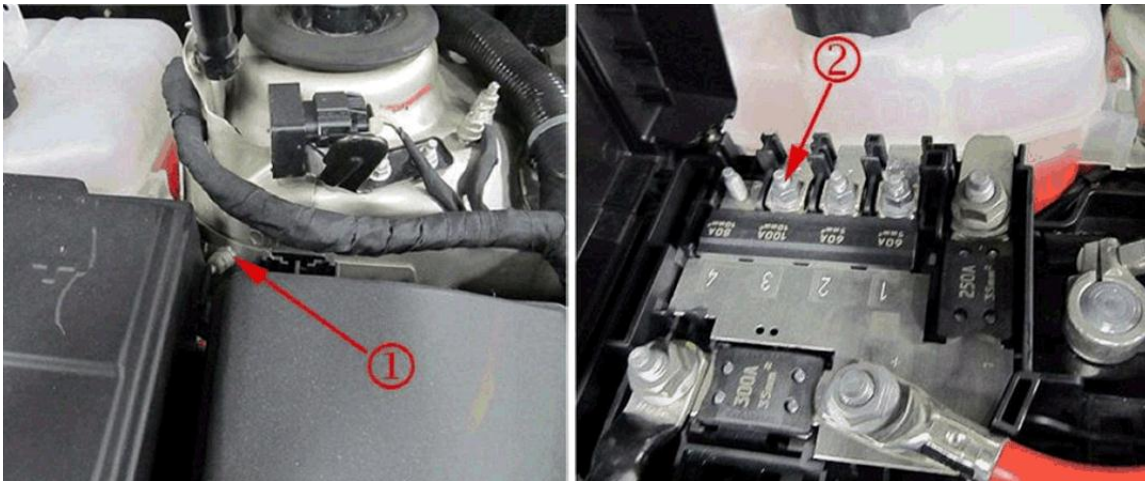
General Motors has decided that a defect which relates to motor vehicle safety exists in certain 2014 model year Chevrolet Impala vehicles. Some vehicles may experience an intermittent or lasting loss or reduction of power steering assist at startup or while driving due to a poor electrical ground connection to the Power Steering Control Module (PSCM). If power steering assist is lost or reduced, a message is displayed on the Driver Information Center and a chime sounds to inform the driver. Steering control can be maintained because the vehicle will revert to manual steering mode, but would require greater driver effort particularly at low vehicle speeds, increasing the risk of a crash.

1. Inspect the G111 ground (1) and the 100A F3UB fuse (2) for proper connection. Ensure the ground is free of paint and both connections are tight.
2. Fully charge the battery using the GR-8 Tool (EL-50313).
3. Reprogram the power steering control module using the Service Programming System (SPS) with the latest calibrations available on TIS2WEB. Refer to the *Power Steering Control Module Programming and Setup (NJ2)* procedure in SI.
