# Recall Bulletin

## F/CMVSS NONCOMPLIANCE RECALL

**SUBJECT:** Console Storage Compartment Latch

**MODELS:** 2014-2015 Chevrolet Impala LT and LTZ

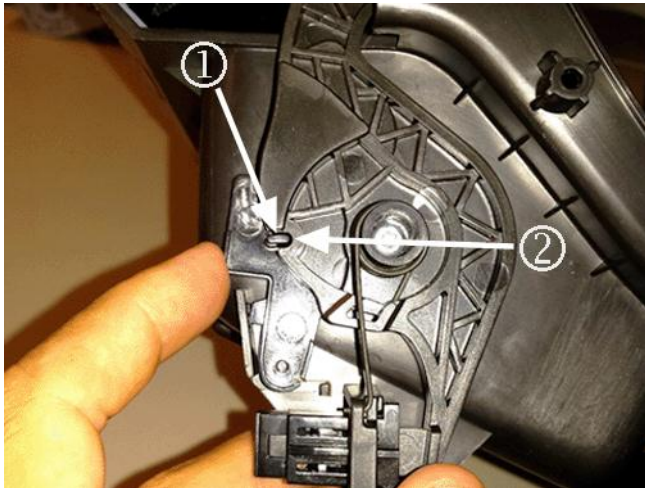
3971106

- If the tab (1) aligns to the slot (2) freely, as shown in the graphic above, no further action is required. Reinstall the console front compartment. Refer to *Front Floor Console Front Compartment Replacement* in SI.

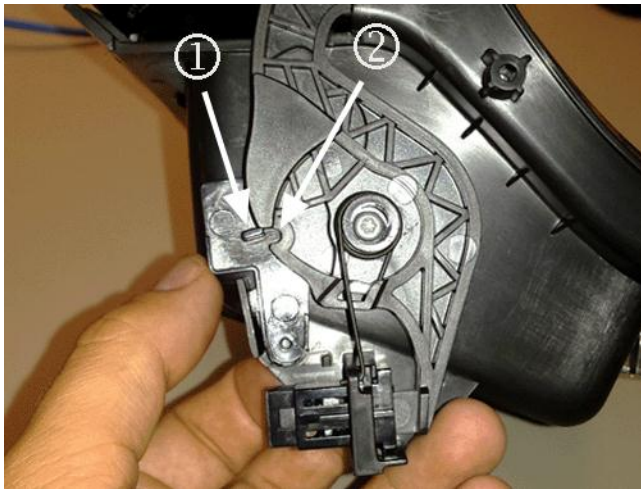
3971107

- If the tab (1) does not align to the slot (2), as shown above, continue ahead and perform the service procedure below.

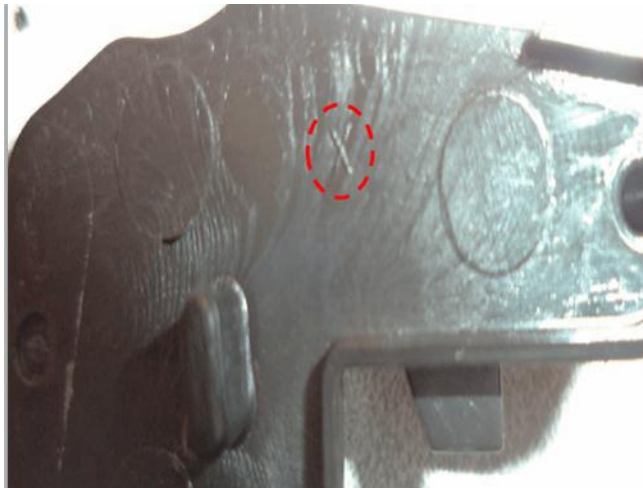
3971111

**Note:** The new inertia latch with spring installed will have an "X" located on the outer surface, as shown in the graphic above.
