Recall Bulletin

F/CMVSS NONCOMPLIANCE RECALL

SUBJECT: Console Storage Compartment Latch

MODELS: 2014-2015 Chevrolet Impala LT and LTZ

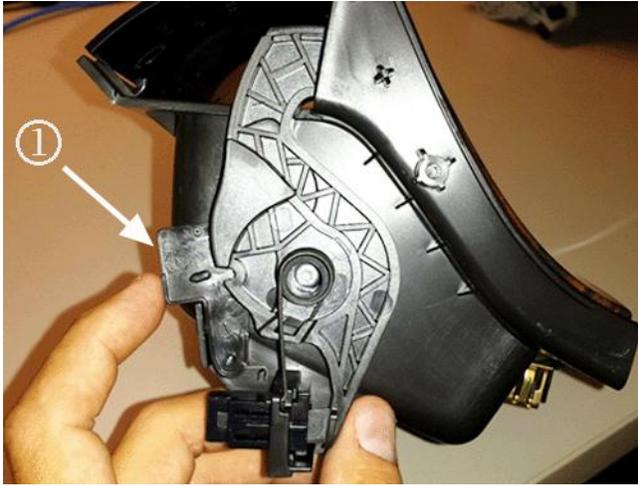
3971105

2. Locate the Inertia Latch Pendulum (1) on the left hand side of the console compartment assembly.
3. With the bin door closed, apply finger pressure to the latch pendulum to rotate it against the engagement slot on the door. Do not force the latch tab into place, the tab should engage freely in the slot.

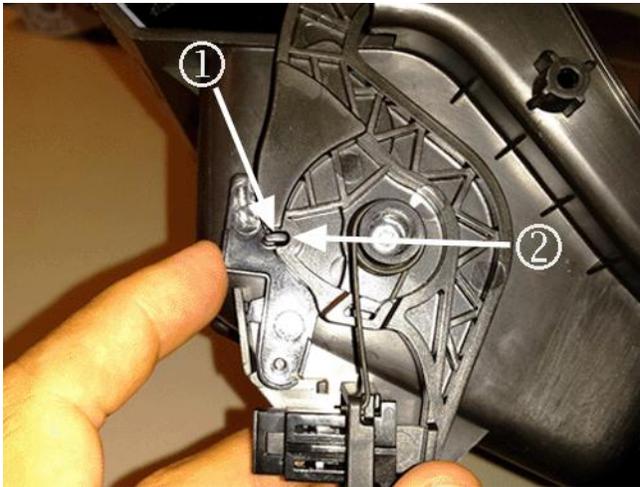
3971106

- If the tab (1) aligns to the slot (2) freely, as shown in the graphic above, no further action is required. Reinstall the console front compartment. Refer to *Front Floor Console Front Compartment Replacement* in SI.

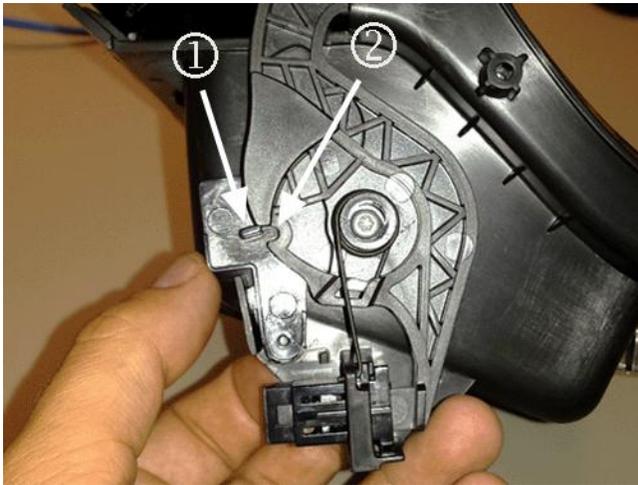
3971107

- If the tab (1) does not align to the slot (2), as shown above, continue ahead and perform the service procedure below.
