Safety Recall

Code: 47L8

**Subject: 2013 MY Audi Q7 Equipped with 3.0L TDI Engine
Vacuum Lines for Brake Booster**

September 03, 2014

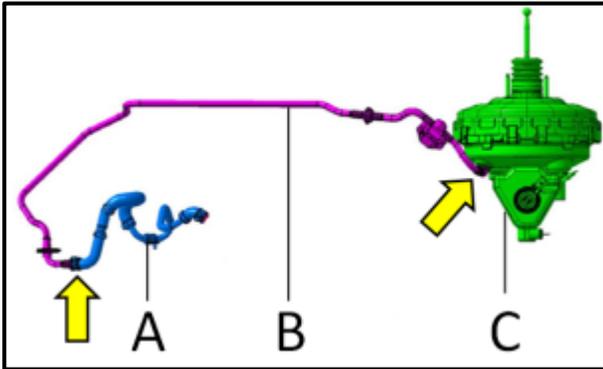
Inspect vacuum hose connections for oil contamination <arrows>.

If oil contamination is found at the connection between lines A and B, line B must also be replaced.

If oil contamination is found at the connection between line B and the brake booster, the brake booster must also be replaced.

Replace vacuum hose A .

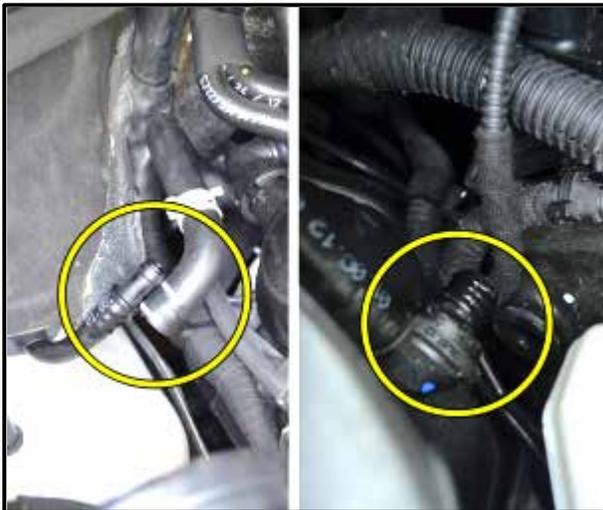
- Ü Swab both hose connections <circles> with a clean cloth, cotton swab, etc. and inspect for any oil contamination.
 - If no oil is found, perform the repair in **Section C**.
 - If oil is found at the connection near the bulkhead, but **NOT** at the brake booster, perform the repairs listed in **Section C**, **AND Section D**.
 - If oil is found at the connections near the bulkhead **AND** at the brake booster, perform the repairs listed in **Section C**, **Section D**, **AND Section E**.
