Safety Recall

Code: 47L8

**Subject: 2013 MY Audi Q7 Equipped with 3.0L TDI Engine
Vacuum Lines for Brake Booster**

September 16, 2014

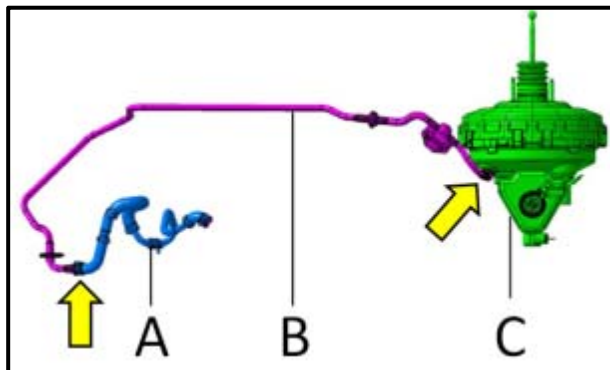
Inspect vacuum hose connections for oil contamination <arrows>.

If oil contamination is found at the connection between lines A and B, line B must also be replaced.

If oil contamination is found at the connection between line B and the brake booster, the brake booster must also be replaced.

Replace vacuum hose A.

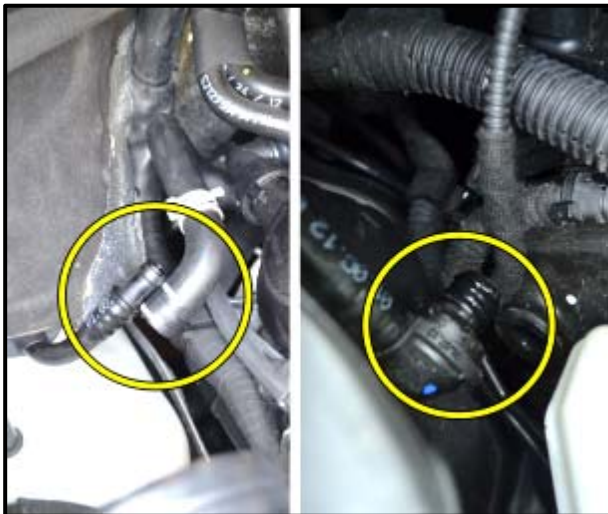
- ⇐ Swab both hose connections <circles> with a clean cloth, cotton swab, etc. and inspect for any oil contamination.
- If no oil is found, perform the repair in **Section C**.
 - If oil is found at the connection near the bulkhead, but **NOT** at the brake booster, perform the repairs listed in **Section C**, **AND Section D**.
 - If oil is found at the connections near the bulkhead **AND** at the brake booster, perform the repairs listed in **Section C**, **Section D**, **AND Section E**.
