# SAFETY RECALL BULLETIN

SUBJECT:			No: <b>SR-14-007</b>
<b>i-MiEV BRAKE VACUUM PUMP – SAFETY RECALL CAMPAIGN</b>			DATE: <b>October, 2014</b>
			MODEL: <b>2010–2014 i-MiEV</b>
CIRCULATE TO:	<input checked="" type="checkbox"/> GENERAL MANAGER	<input type="checkbox"/> PARTS MANAGER	<input checked="" type="checkbox"/> TECHNICIAN
<input checked="" type="checkbox"/> SERVICE ADVISOR	<input checked="" type="checkbox"/> SERVICE MANAGER	<input checked="" type="checkbox"/> WARRANTY PROCESSOR	<input checked="" type="checkbox"/> SALES MANAGER

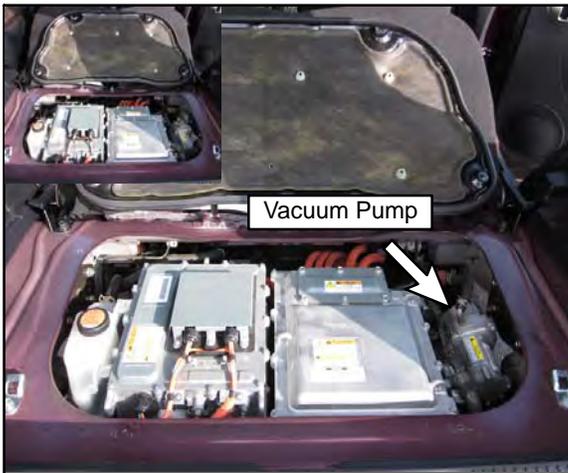
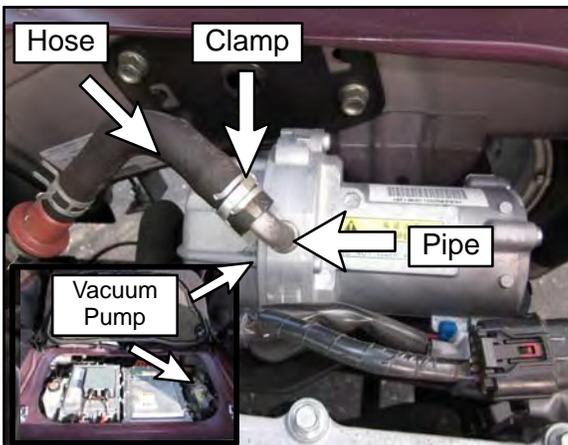
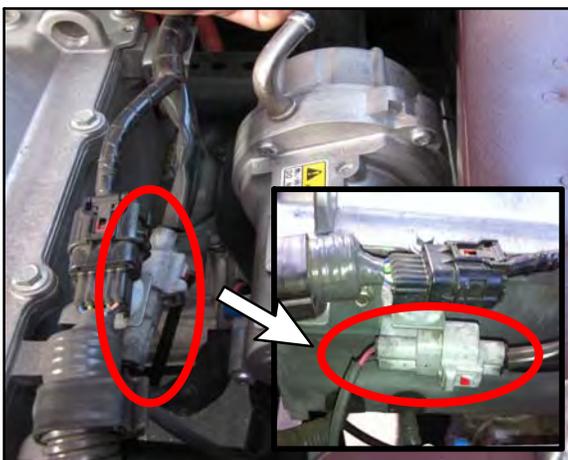
6. The vacuum pump is located on the right side of the motor compartment.

The pump assembly fitted to 2010 – early 2012 models is all metal construction.

For late 2012 models, the pump assembly can be all metal or have a black metal motor housing with a black plastic pump housing and cover.

7. Squeeze the vacuum hose clamp and slide it to the center of the vacuum hose.

8. Gently pull off the vacuum hose from the vacuum pump.

9. Disconnect the vacuum pump electrical connector.

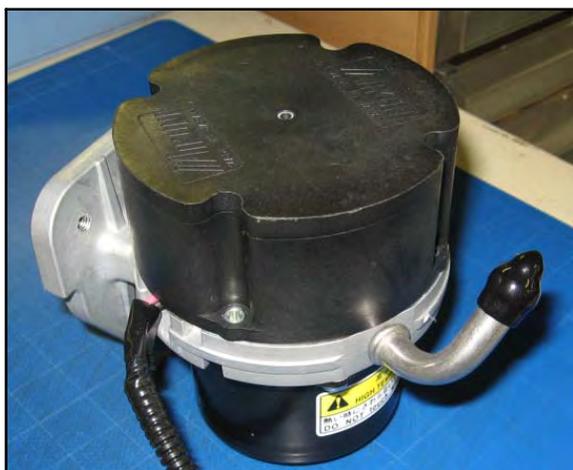
The affected vacuum pump can be all metal or have a black metal motor housing and a plastic pump housing. Replacement pumps have a black metal motor housing and a plastic pump housing.

13. Replace the vacuum pump with the new unit.

14. Reattach the wire harness clip to the bracket first, then reinstall the three 10mm bolts. Doing so will ensure the vacuum pump is installed correctly to the bracket.

**NOTE:** Use hand tools only. Torque specifications is  $44 \pm 8$  in-lb ( $5 \pm 1$  N-m).
