PRODUCT SAFETY RECALL

SUBJECT: Driver Airbag Connector Terminal Retention Loose

MODELS: 2014 Chevrolet Sonic

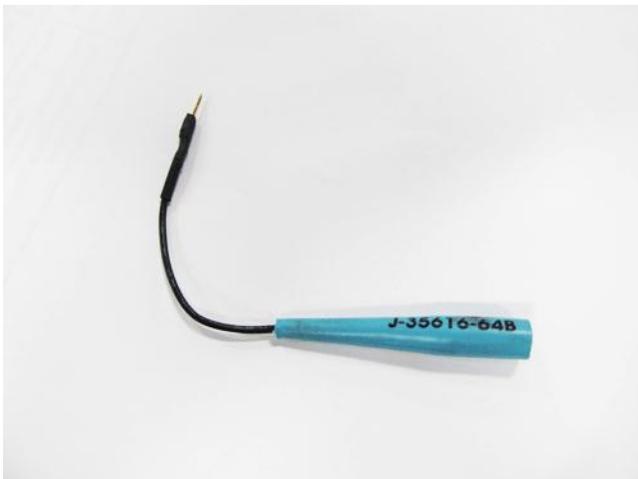
3977516

4. Using Diagnostic Test Probe J-35616-64B (L-BU), or equivalent, drag test the four female terminals in the X2 connector. Gently probe into each female terminal.
 - If slight resistance upon insertion, and slight drag upon removal is felt, no further action is necessary. Reconnect the X2 connector, reinstall the steering column upper trim cover and enable the SIR. Refer to *Steering Column Upper Trim Cover Replacement and SIR Disabling and Enabling* in SI.
 - If little or NO drag is felt, the female terminal needs replacement. Continue ahead to the *Repair Procedure* below.
