SAFETY RECALL BULLETIN

SUBJECT: 2011 OUTLANDER SPORT/RVR BRAKE BOOSTER – SAFETY RECALL CAMPAIGN		No: SR-14-008
		DATE: October, 2014
		MODEL: 2011 Outlander Sport/RVR
CIRCULATE TO:	<input checked="" type="checkbox"/> GENERAL MANAGER	<input checked="" type="checkbox"/> PARTS MANAGER
<input checked="" type="checkbox"/> SERVICE ADVISOR	<input checked="" type="checkbox"/> SERVICE MANAGER	<input checked="" type="checkbox"/> WARRANTY PROCESSOR
		<input checked="" type="checkbox"/> TECHNICIAN
		<input checked="" type="checkbox"/> SALES MANAGER

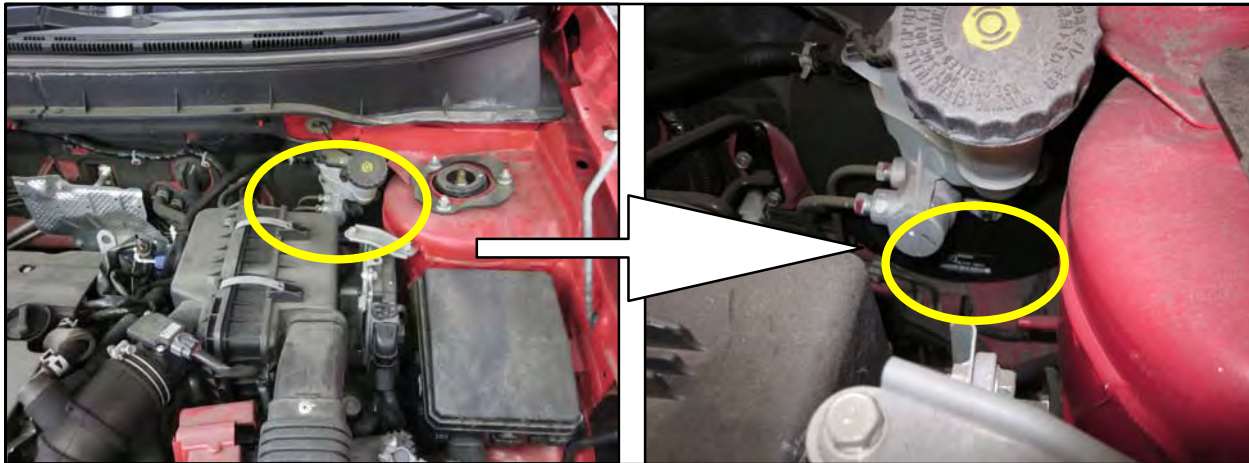
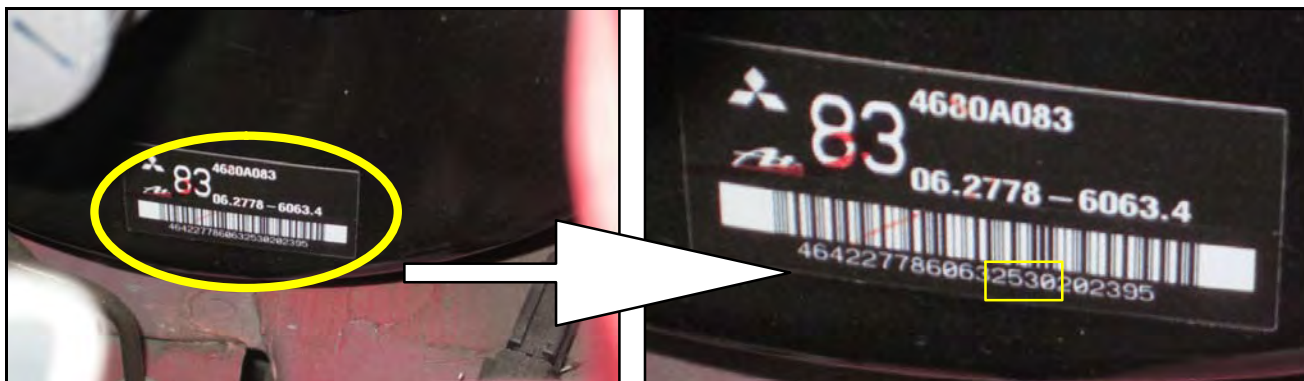
If the product ID label is illegible, replace the brake booster assembly.

- a. Locate the 13th-16th digit. Above illustration displays "2530" for the 13th-16th digit.
 - (1) If the 16th digit = 9, the brake booster assembly must be replaced. Please refer to the 2011 Outlander Sport Service Manual, Group 35A – Basic Brake > Master Cylinder Assembly and Brake Booster Assembly > Removal and Installation.
 - (2) If the 13th-15th digit is less than or equal to 071 **and** the 16th digit = 0, the brake booster assembly must be replaced. Please refer to the 2011 Outlander Sport Service Manual, Group 35A – Basic Brake > Master Cylinder Assembly and Brake Booster Assembly > Removal and Installation.
 - (3) If the 13th-15th digit is greater than or equal to 072 **and** the 16th digit = 0, brake booster assembly replacement is not required. Inspection is complete.
