# SAFETY RECALL BULLETIN

SUBJECT:			No: <b>SR-14-009</b>
<b>4B1 ENGINE DRIVE BELT DETACHMENT – SAFETY RECALL CAMPAIGN</b>			DATE: <b>October, 2014</b>
			MODEL: <b>See Below</b>
CIRCULATE TO:	<input checked="" type="checkbox"/> GENERAL MANAGER	<input checked="" type="checkbox"/> PARTS MANAGER	<input checked="" type="checkbox"/> TECHNICIAN
<input checked="" type="checkbox"/> SERVICE ADVISOR	<input checked="" type="checkbox"/> SERVICE MANAGER	<input checked="" type="checkbox"/> WARRANTY PROCESSOR	<input checked="" type="checkbox"/> SALES MANAGER

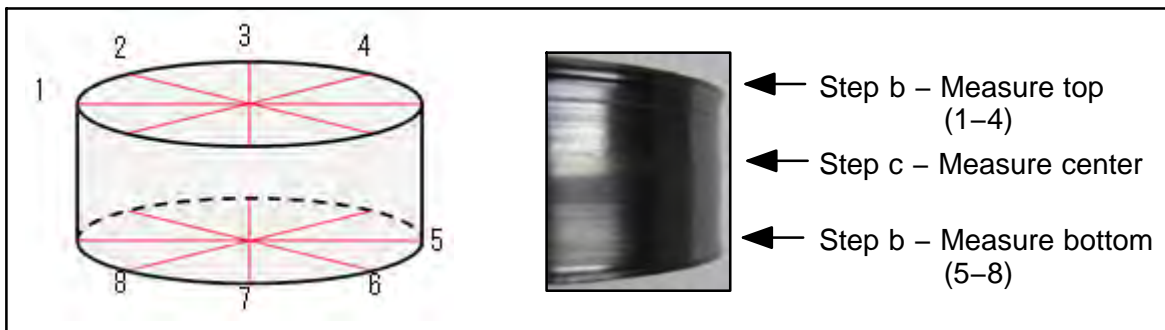
- (1) Make four measurements to the nearest hundredth decimal (e.g. 69.15mm) every 45° across the top side (Positions 1-4). Repeat on the bottom side (Positions 5-8). Record all eight measurements, determine the minimum and maximum values, and reference the table below.

If Minimum Value is	And Maximum Value is	Then	Example
Less than 69.70 mm	Anything	Replace idler pulley assembly and proceed to Step 7d	Min = 69.00mm Max = 70.00mm Result = Replace
69.70mm or more	At least 0.20mm greater than minimum value	Replace idler pulley assembly and proceed to Step 7d	Min = 69.70mm Max = 70.00mm Result = Replace
69.70mm or more	0 – 0.19mm greater than minimum value	Set caliper to 0.20mm less than maximum value and proceed to Step 7c	Min = 70.00mm Max = 70.10mm Result = Set caliper to 69.90mm
69.70mm or more	Under 69.90mm	Set Caliper to 69.70mm and proceed to Step 7c	Min = 69.70mm Max = 69.85mm Result = Set caliper to 69.70mm

- c. Place the set vernier caliper around the pulley's center (setting is determined in Step 7b above):
- (1) If the pulley's center can fit between the caliper's measurements, replace the pulley.
  - (2) If the pulley's center cannot fit between the caliper's measurement, reuse the pulley.
- d. Install the upper idler pulley and torque to  $36 \pm 5$  ft-lb ( $48 \pm 7$  N-m).
- e. Repeat Steps 7a – 7d for the lower idler pulley.

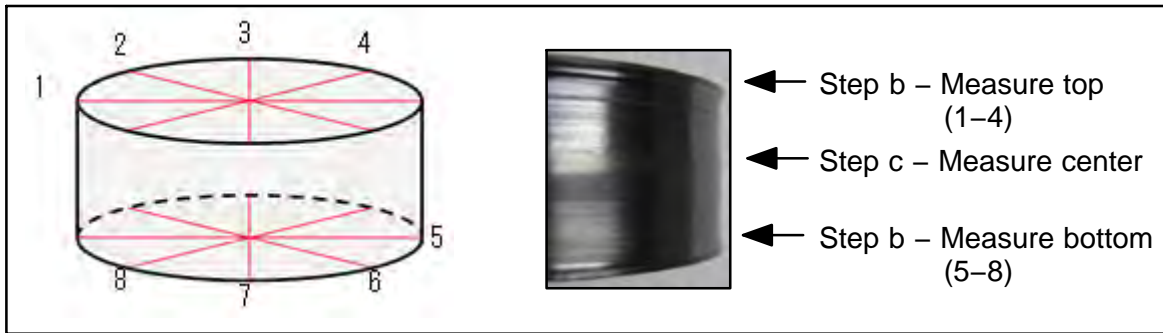
- a. Make four measurements to the nearest hundredth decimal (e.g. 69.15mm) every 45° across the top side (Positions 1–4) . Repeat on the bottom side (Positions 5–8). Record all eight measurements, determine the min and max values, and reference the appropriate table below (NA or TC).

<b>For NA Engine</b>			
<b>If Minimum Value is</b>	<b>And Maximum Value is</b>	<b>Then</b>	<b>Example</b>
Less than 64.70 mm	Anything	Replace auto-tensioner assembly and proceed to Step 9	Min = 64.50mm Max = 65.00mm Result = Replace
64.70mm or more	At least 0.20mm greater than minimum value	Replace auto-tensioner assembly and proceed to Step 9	Min = 64.70mm Max = 66.85mm Result = Replace
64.70mm or more	0 – 0.19mm greater than minimum value	Set caliper to 0.20mm less than maximum value and proceed to Step 8b	Min = 65.70mm Max = 65.80mm Result = Set caliper to 65.60mm
64.70mm or more	Under 64.90mm	Set Caliper to 64.70mm and proceed to Step 8b	Min = 64.70mm Max = 64.80mm Result = Set caliper to 64.70mm

For TC Engine			
If Minimum Value is	And Maximum Value is	Then	Example
Less than 69.70mm	Anything	Replace auto-tensioner assembly and proceed to Step 9	Min = 69.50mm Max = 71.50mm Result = Replace
69.70mm or more	At least 0.20mm greater than minimum value	Replace auto-tensioner assembly and proceed to Step 9	Min = 69.70mm Max = 72.50mm Result = Replace
69.70mm or more	0 – 0.19mm greater than minimum value	Set caliper to 0.20mm less than maximum value and proceed to Step 8b	Min = 70.00mm Max = 70.10mm Result = Set caliper to 69.90mm
69.70mm or more	Under 69.90mm	Set Caliper to 69.70mm and proceed to Step 8b	Min = 69.70mm Max = 69.80mm Result = Set caliper to 69.70mm

- b. Place the set vernier caliper around the pulley's center (setting is determined in Step 8a above):
  - (1) If the pulley's center can fit between the caliper's measurements, replace the auto-tensioner assembly.
  - (2) If the pulley's center cannot fit between the caliper's measurement, reuse the auto-tensioner assembly.
9. Install the auto-tensioner assembly and torque to  $16 \pm 3$  ft-lb ( $22 \pm 4$  N-m).
10. If the vehicle is equipped with a TC engine:
  - a. Realign the alternator and reinstall the upper alternator mounting bolt. Torque the upper and lower alternator mounting bolt to  $32 \pm 7$  ft-lb ( $44 \pm 10$  N-m).
  - b. Reinstall the negative battery terminal and torque to  $44 \pm 9$  in-lb ( $5 \pm 1$  N-m).
11. Install the new countermeasure drive belt.

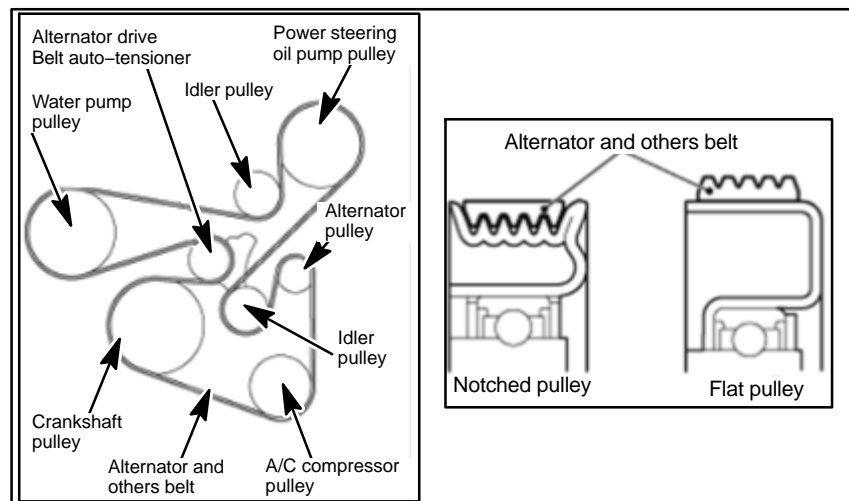
Ensure the drive belt's notched side is mated correctly to the notched pulleys.  
Ensure the drive belt's flat side is centered on the flat pulleys.
