# SAFETY RECALL BULLETIN

SUBJECT:			No: <b>SR-14-009REV</b>
<b>4B1 ENGINE DRIVE BELT DETACHMENT – SAFETY RECALL CAMPAIGN</b>			DATE: <b>June 2018</b>
			MODEL: <b>See Below</b>
CIRCULATE TO:	<input checked="" type="checkbox"/> GENERAL MANAGER	<input checked="" type="checkbox"/> PARTS MANAGER	<input checked="" type="checkbox"/> TECHNICIAN
<input checked="" type="checkbox"/> SERVICE ADVISOR	<input checked="" type="checkbox"/> SERVICE MANAGER	<input checked="" type="checkbox"/> WARRANTY PROCESSOR	<input checked="" type="checkbox"/> SALES MANAGER

*This bulletin supercedes SR-14-009, issued October 2014, to add a new tensioner and associated flange bolts part numbers for Naturally Aspirated engines. Changes are italicized and indicated by ◀.*

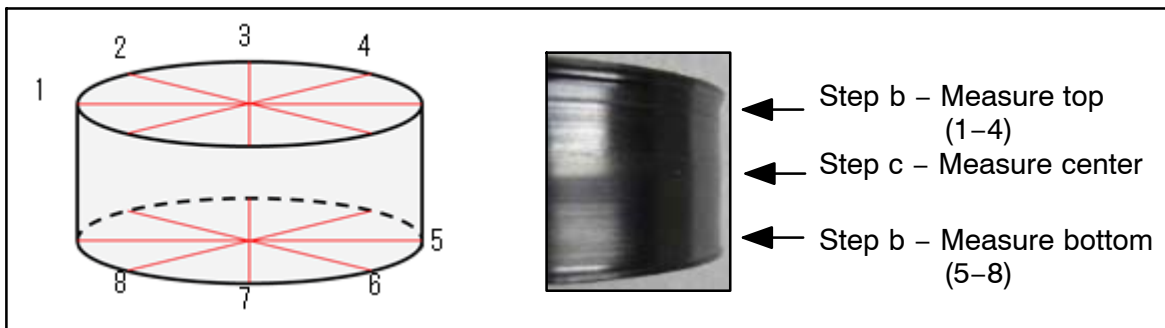
- (1) Make four measurements to the nearest hundredth decimal (e.g. 69.15mm) every 45° across the top side (Positions 1-4). Repeat on the bottom side (Positions 5-8). Record all eight measurements, determine the minimum and maximum values, and reference the table below.

**NOTE:** Avoid measuring ridges when measuring the pulley.

If Minimum Value is	And Maximum Value is	Then	Example
Less than 69.70 mm	Anything	Replace idler pulley assembly and proceed to Step 7d	Min = 69.00mm Max = 70.00mm Result = Replace
69.70mm or more	At least 0.20mm greater than minimum value	Replace idler pulley assembly and proceed to Step 7d	Min = 69.70mm Max = 70.00mm Result = Replace
69.70mm or more	0 – 0.19mm greater than minimum value	Set caliper to 0.20mm less than maximum value and proceed to Step 7c	Min = 70.00mm Max = 70.10mm Result = Set caliper to 69.90mm
69.70mm or more	Under 69.90mm	Set Caliper to 69.70mm and proceed to Step 7c	Min = 69.70mm Max = 69.85mm Result = Set caliper to 69.70mm

- c. Place the set vernier caliper around the pulley's center (setting is determined in Step 7b above):
  - (1) If the pulley's center can fit between the caliper's measurements, replace the pulley.
  - (2) If the pulley's center cannot fit between the caliper's measurement, reuse the pulley.
- d. Install the upper idler pulley and torque to  $36 \pm 5$  ft-lb ( $48 \pm 7$  N-m).
- e. Repeat Steps 7a – 7d for the lower idler pulley.

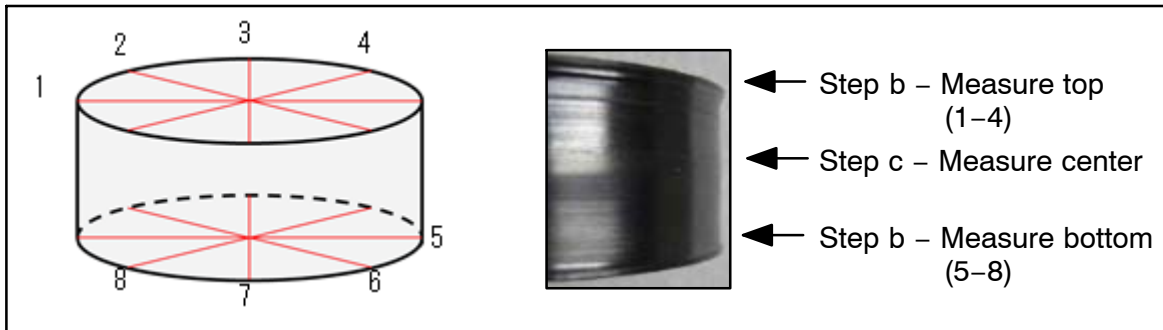
- a. Make four measurements to the nearest hundredth decimal (e.g. 69.15mm) every 45° across the top side (Positions 1–4) . Repeat on the bottom side (Positions 5–8). Record all eight measurements, determine the min and max values, and reference the appropriate table below (NA or TC).

<b>For NA Engine</b>			
<b>If Minimum Value is</b>	<b>And Maximum Value is</b>	<b>Then</b>	<b>Example</b>
Less than 64.70 mm	Anything	Replace auto-tensioner assembly and proceed to Step 9	Min = 64.50mm Max = 65.00mm Result = Replace
64.70mm or more	At least 0.20mm greater than minimum value	Replace auto-tensioner assembly and proceed to Step 9	Min = 64.70mm Max = 66.85mm Result = Replace
64.70mm or more	0 – 0.19mm greater than minimum value	Set caliper to 0.20mm less than maximum value and proceed to Step 8b	Min = 65.70mm Max = 65.80mm Result = Set caliper to 65.60mm
64.70mm or more	Under 64.90mm	Set Caliper to 64.70mm and proceed to Step 8b	Min = 64.70mm Max = 64.80mm Result = Set caliper to 64.70mm

For TC Engine			
If Minimum Value is	And Maximum Value is	Then	Example
Less than 69.70mm	Anything	Replace auto-tensioner assembly and proceed to Step 9	Min = 69.50mm Max = 71.50mm Result = Replace
69.70mm or more	At least 0.20mm greater than minimum value	Replace auto-tensioner assembly and proceed to Step 9	Min = 69.70mm Max = 72.50mm Result = Replace
69.70mm or more	0 – 0.19mm greater than minimum value	Set caliper to 0.20mm less than maximum value and proceed to Step 8b	Min = 70.00mm Max = 70.10mm Result = Set caliper to 69.90mm
69.70mm or more	Under 69.90mm	Set Caliper to 69.70mm and proceed to Step 8b	Min = 69.70mm Max = 69.80mm Result = Set caliper to 69.70mm

- b. Place the set vernier caliper around the pulley's center (setting is determined in Step 8a above):
- (1) If the pulley's center can fit between the caliper's measurements, replace the auto-tensioner assembly.
  - (2) If the pulley's center cannot fit between the caliper's measurement, reuse the auto-tensioner assembly.

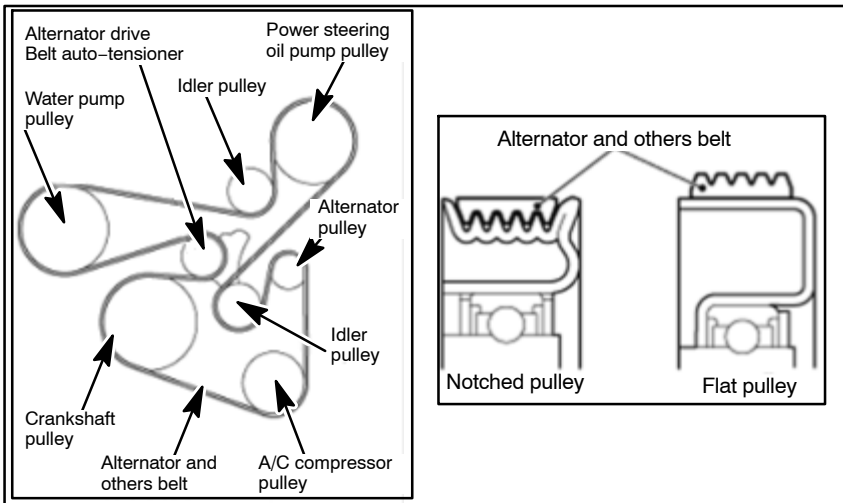
<b>CAUTION</b>	Ensure the drive belt's notched side is mated correctly to the notched pulleys. Ensure the drive belt's flat side is centered on the flat pulleys.
--	---

11. Install the new countermeasure drive belt.
