Service Bulletin

14-048

Safety Recall: Wrong A-Pillar Trim Is Installed

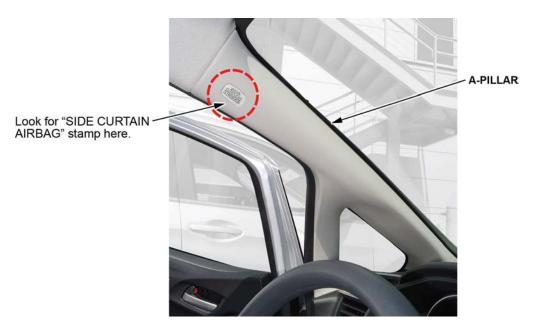
- 1. Look for a "SIDE CURTAIN AIRBAG" stamp on the left and right A-pillar trim.
 - If the A-pillar trim has "SIDE CURTAIN AIRBAG" stamped on it, the vehicle is OK. No further action is needed.
 - If the A-pillar trim does not have "SIDE CURTAIN AIRBAG" stamped on it, go to REPAIR PROCEDURE.
