PRODUCT SAFETY RECALL

SUBJECT: Rear Toe Link Adjuster Lock Nut Torque

MODELS: 2010-2015 Cadillac SRX
2011-2012 Saab 9-4X

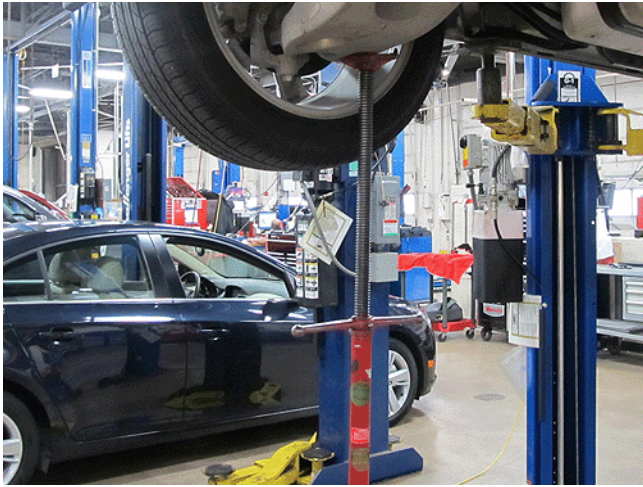
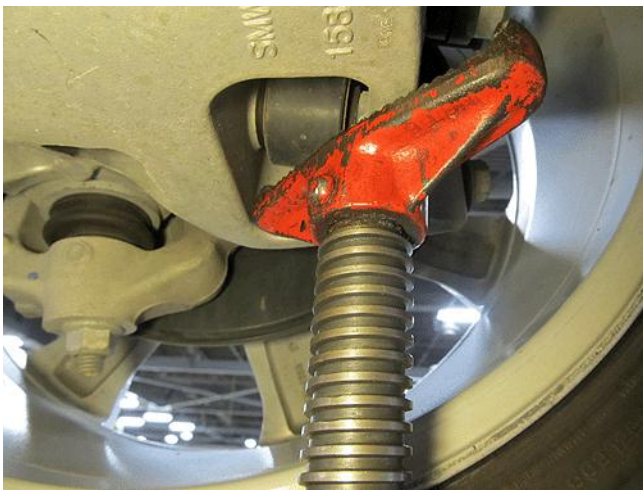
2. Place tall threaded jack stands under the left and right control arms at the shock absorber mount as shown. Using the threaded jack stands, raise the left and right control arms to the ride height level.
3. Inspect the left and right rear suspension links as follows:

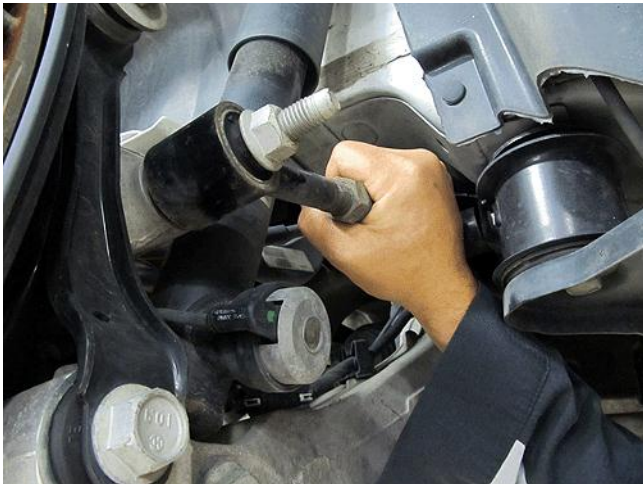
3979306

- Grasp the adjustment collar and push up and pull down firmly, note any movement in the link assembly components (the ends are rubber mounted and will have some movement)

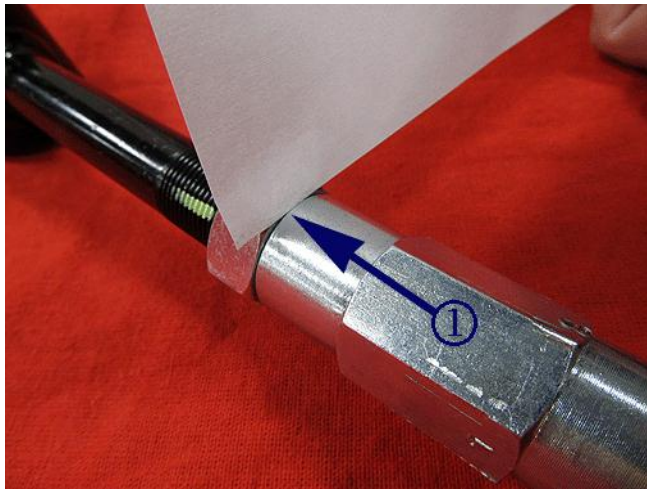
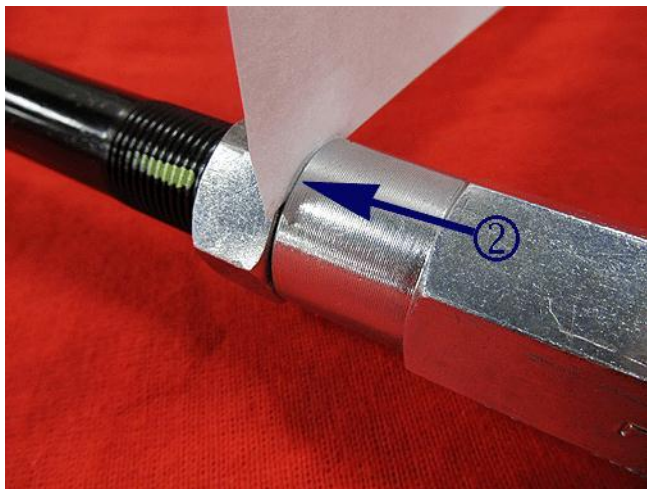
(1) Paper does NOT fit between jam nut and rear suspension adjustment link. (2) Paper fits between jam nut and rear suspension adjustment link.

- Inspect the toe link assembly for loosened jam nuts. Use a piece of paper to determine if there is a gap between the jam nut and the adjustment collar.
4. If the adjustment link fails any of the above tests, replace the adjustment link assembly. Refer to *Adjust Link Replacement* in SI.

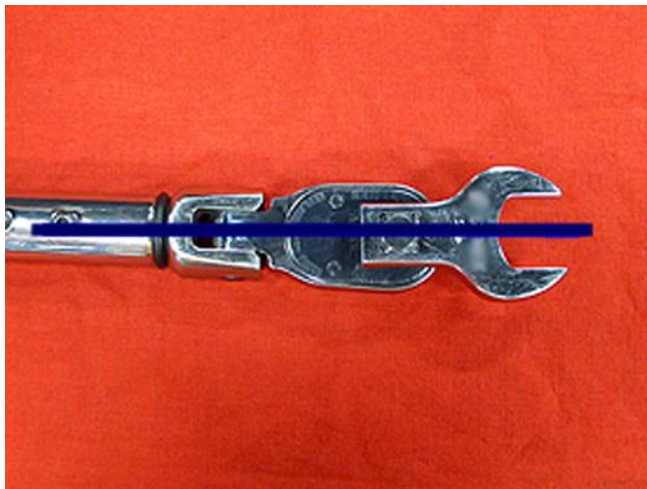
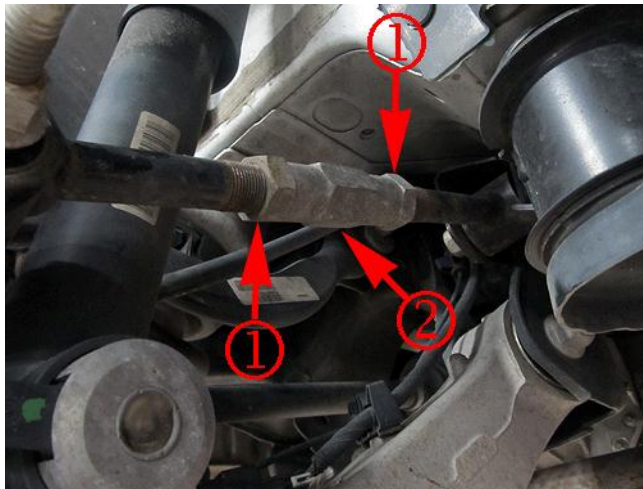
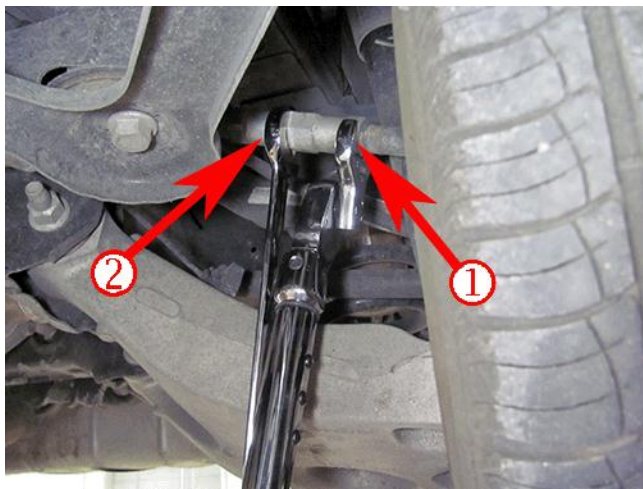
Note: Ensure the open end wrench is on the adjustment collar (2) while the jam nut (1) is checked with the torque wrench.

5. Use the following steps to verify the tightness of the adjustment link jam nuts (1) and adjustment collar (2).
