Recall Bulletin

PRODUCT SAFETY RECALL

SUBJECT: Rear Toe Link Adjuster Lock Nut Torque

MODELS: 2010-2015 Cadillac SRX
2011-2012 Saab 9-4X

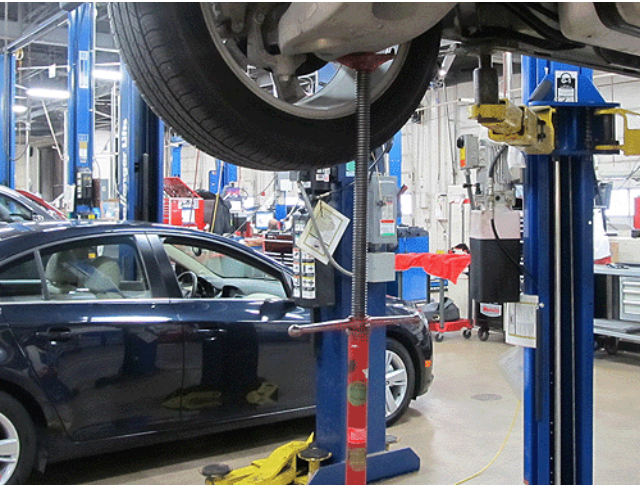
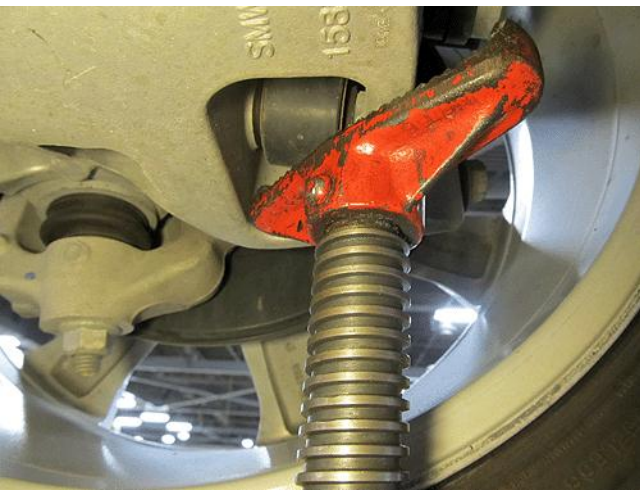
2. Place tall threaded jack stands under the left and right control arms at the shock absorber mount as shown. Using the treaded jack stands, raise the left and right control arms to the ride height level.
3. Inspect the left and right rear suspension links as follows:

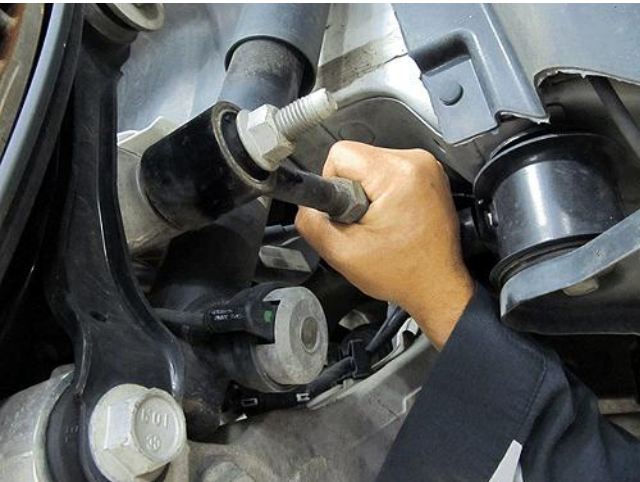
3979306

- Grasp the adjustment collar and push up and pull down firmly, note any movement in the link assembly components (the ends are rubber mounted and will have some movement)

- Inspect the toe link assembly for loosened jam nuts. Use a piece of paper to determine if there is a gap between the jam nut and the adjustment collar.
5. If the adjustment link fails any of the above tests, replace the adjustment link assembly. Refer to *Adjust Link Replacement* in SI.

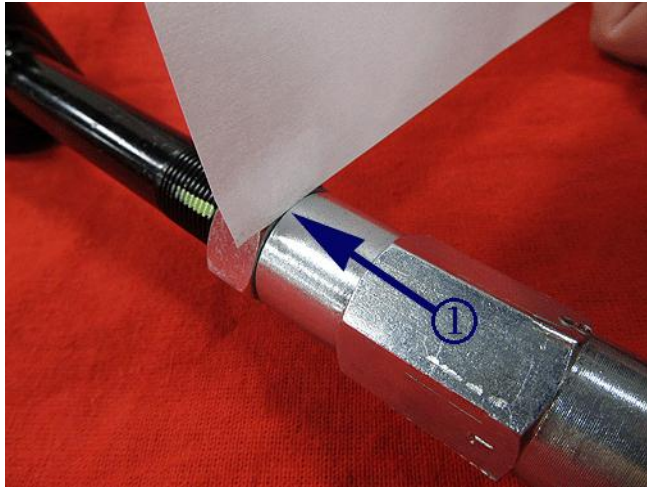
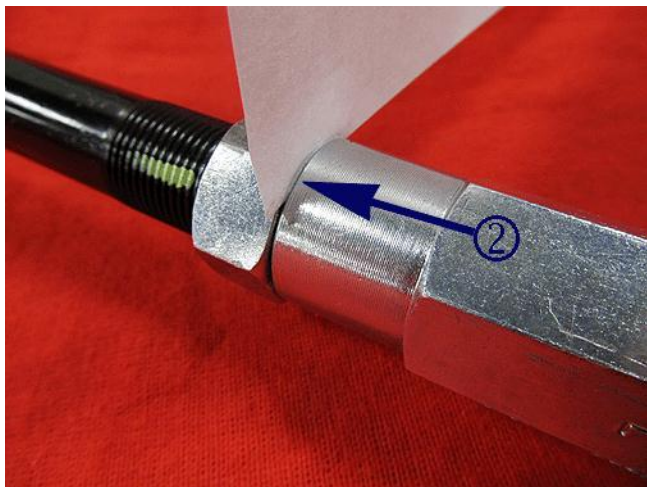
(1) Paper does NOT fit between jam nut and rear suspension adjustment link. (2) Paper fits between jam nut and rear suspension adjustment link.
