PRODUCT CAMPAIGN BULLETIN

APPLICABILITY: 2015 Subaru Outback

NUMBER: WQN-50

SUBJECT: 2015 Outback Accessory Trailer Hitch Assembly

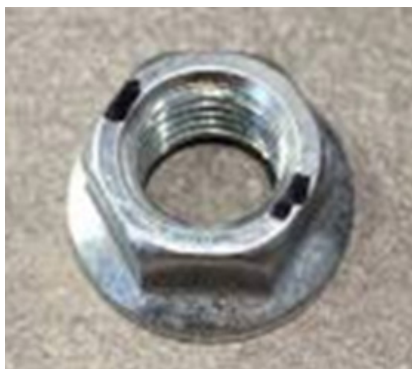
**Trial Nut
(Bright silver finish)**

- Inspect the threads of each stud bolt for damage.
 - o If severe damage to the threads is confirmed as shown in the example photo below, the affected stud bolt(s) must be replaced.
 - o If the threads do not appear to be severely damaged, take one of the bright silver Trial Nuts from the Hitch Repair Kit and thread it onto the stud bolt by hand. A 15mm socket can also be used to turn the nut by hand only (no ratchet or other turning tools). Thread the Trial Nut all the way onto the stud bolt until it contacts the body. If the Trial Nut can be threaded onto the stud bolt BY HAND, the stud bolt does not need to be replaced. Inspect all the stud bolts using the four bright silver Trial nuts included in the Hitch Repair Kit. Each Trial Nut should only be used twice (to test only two stud bolts).

- If the Trial Nut cannot be threaded all the way on by hand as described above, the affected stud bolt(s) will need to be replaced. Mark the affected stud bolt(s) with paint to identify them for replacement.

NOTE: Slight resistance may be felt at some point(s) during this testing. If the Trial Nut can be run back and forth **BY HAND ONLY** a few times and overcome the resistance, the stud bolt is acceptable for reuse.
