Campaign No. 2014090008, October 2014

SUBJECT: **Model 205, Model Year 2015**
Check Steering Coupling Lock

IMPORTANT SAFETY RECALL 2014090008

**Steering Coupling Interlock Mechanism
NHTSA Recall # 14V598**

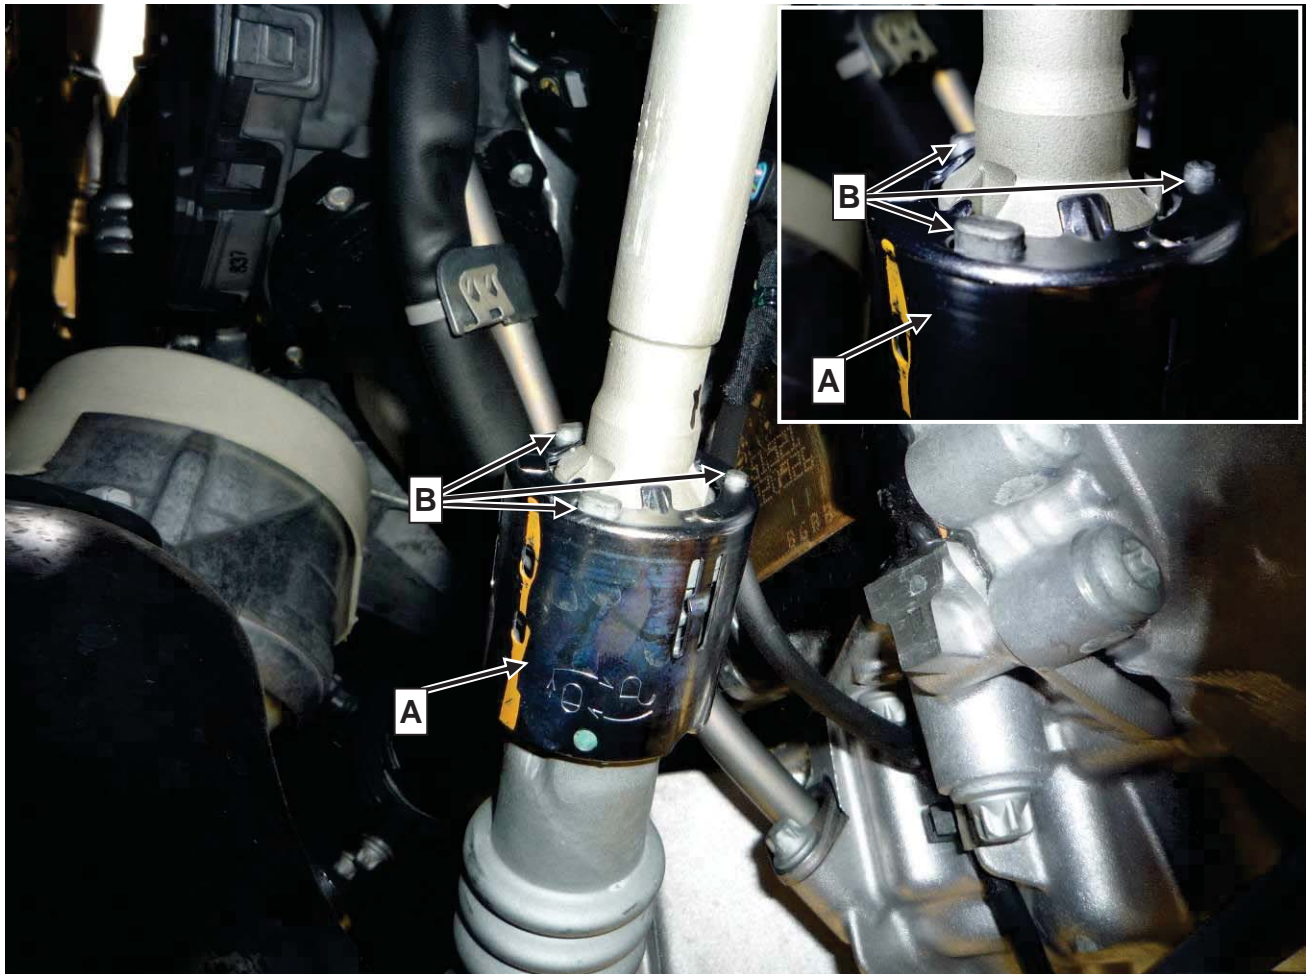
Check if steering coupling lock (A, Figure 1) is in the engaged (locked) position. Refer to WIS: AR46.10-P-8000-01LW. (See Video.)

Note: Coupling lock (A) is engaged correctly if **all** of the following conditions are met:

- The **three** journals/tabs (B) must protrude by **at least 0.5 mm** all around the top of coupling lock (A).
- Coupling lock (A) **cannot** be turned by hand (without pushing coupling lock up towards steering column).
- If the coupling lock (A) is properly engaged (**OK**) assemble in reverse order, Procedure is complete. Creation of a PTSS case is not required.
- If coupling lock (A) is not engaged or coupling lock can be turned by hand (**NOT OK**) proceed to step 3. Do not lock coupling.

Figure 1 (Steering coupling lock [A] shown in engaged/locked position: **OK**)

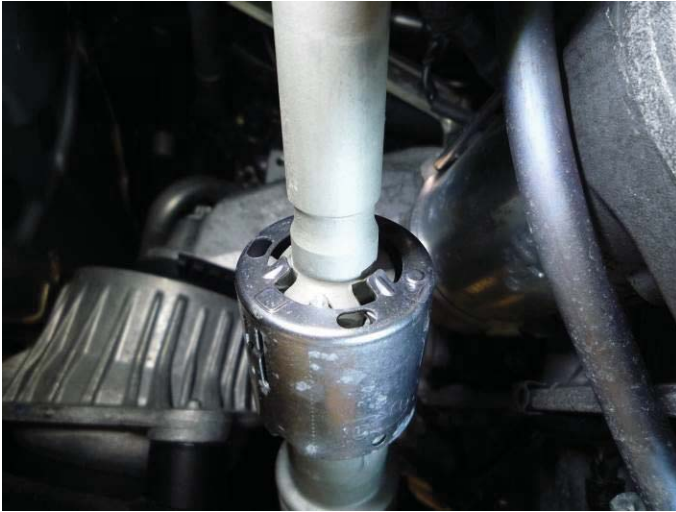
Figure 2

- If steering shaft is **fully** inserted into coupling but **not correctly** engaged (Figure 2):

- pictures ¹⁾ of the connection incorrectly engaged.
 - close steering coupling lock by rotating counterclockwise (See video). Refer to WIS: AR46.10-P-8000-01LW, step #6. (See Video.)

- pictures ¹⁾ of the connection correctly engaged (after closing steering coupling lock).
 - create PTSS case for documentation and **return vehicle to customer**
- If steering shaft is **not** fully inserted (Figure 3):
