This Service Information bulletin supersedes SI 71 02 14 dated **October 2014**.

**NEW** Recall Campaign 14V-619: F55 and F56 Retaining Nut for Compact Spare Wheel

F55 and F56 (Hardtop 4-door and 2-door)

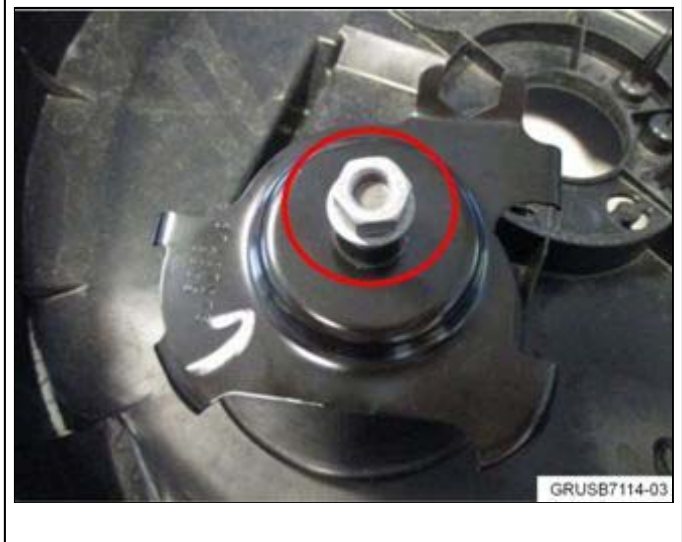
MINI USA has informed NHTSA of its intention to voluntarily recall approximately 5,800 MY 2014 vehicles in the US. On affected vehicles, a nut without self-locking was used to attach the spare wheel carrier. Therefore, due to vibrations during driving, the spare wheel carrier and wheel could separate from the vehicle's underbody.

<p>Remove the nut from the bracket holding the compact spare wheel. Fit the new self-locking flange nut (P/N 22 11 6 779 973) and torque to 19 Nm.</p>
--	--

The securing nut of the compact spare wheel to the retaining plate is located in the cargo area under the floor mat.

To access this nut, raise the trunk floor, remove the mat and tool kit, and replace the nut with the new self-locking flange nut. Torque the nut to 19Nm.
