Recall Campaign 14V-627: N20 and N26 Engine - Check Intake Camshaft

SITUATION

A defect in the intake camshaft can reduce engine oil lubrication to the engine vacuum pump, which may result in the pump's failure. Failure of the engine vacuum pump can lead to subsequent loss of power-assisted braking.

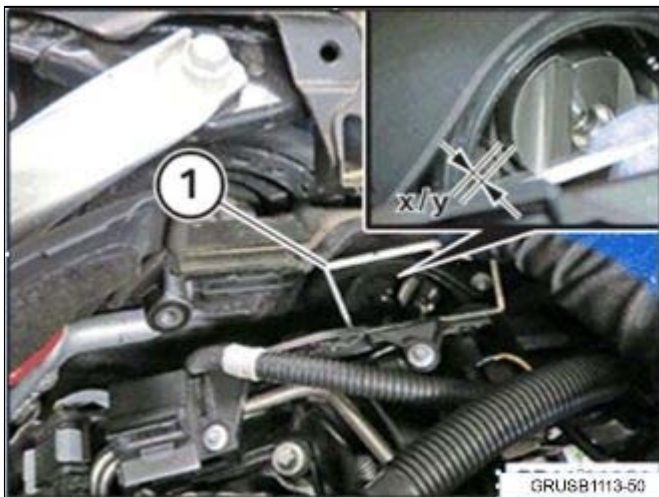
2. The width of the camshaft material near the vacuum pump drive lug must be identified. In the example, the thickness of the material is highlighted between the arrows.

Camshaft A: X = approximately 8 mm
Camshaft B: Y = approximately 4 mm

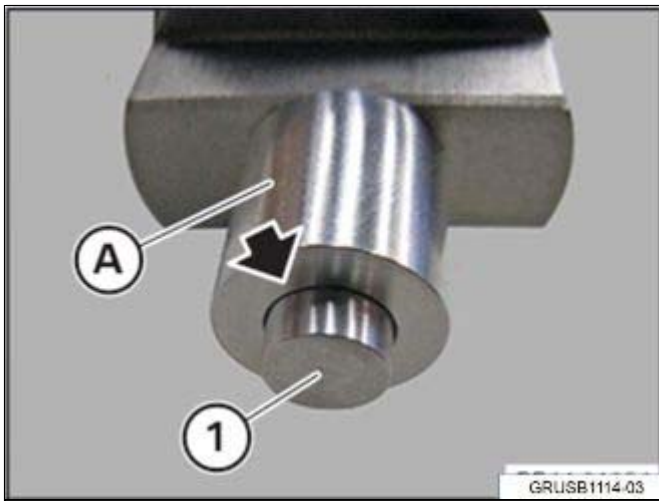
6. If the test pin (1) protrudes significantly in relation to the test sleeve (A) as seen in the illustration, the intake camshaft internal sealing cover has already moved out of position and may have restricted lubrication to the vacuum pump. **Remove the test pin and replace the intake camshaft and vacuum pump.** See the intake camshaft replacement section for proper repair instructions.

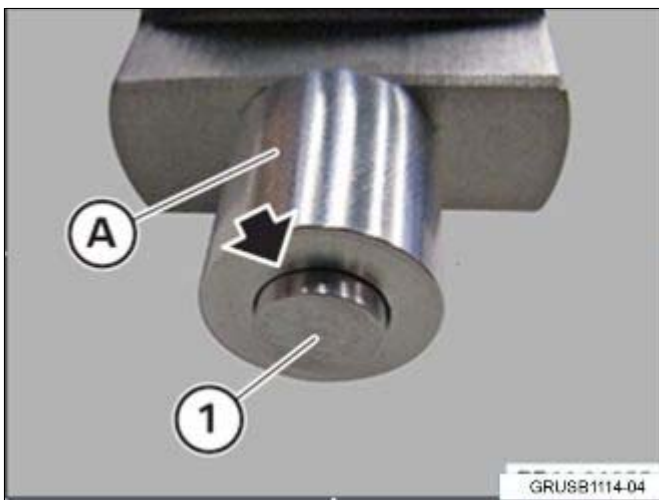
7. If the test pin (1) only protrudes approximately 1 mm in relation to the test sleeve (A) as seen in the illustration, the intake camshaft internal sealing cover has already moved out of position and may have restricted lubrication to the vacuum pump. **Remove the test pin and replace the intake camshaft and vacuum pump.** See the intake camshaft replacement section for proper repair instructions.

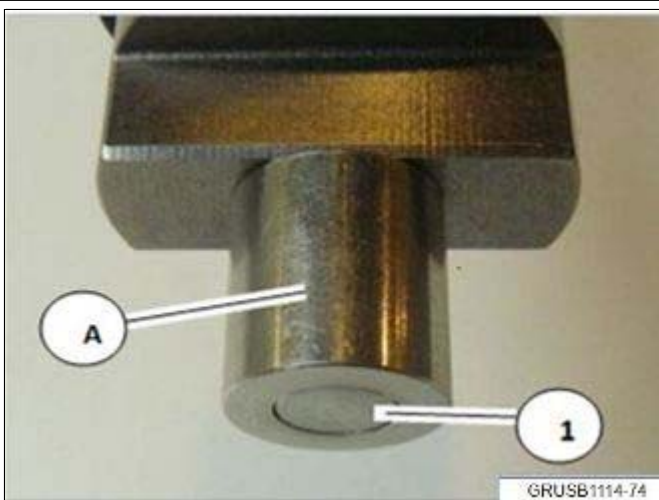
8. If the test pin (1) does not protrude and is flush with the test sleeve (A), the internal sealing cover of the intake camshaft has not moved out of position. Remove the test sleeve and test pin and retrofit the spring steel sleeve in step 9.

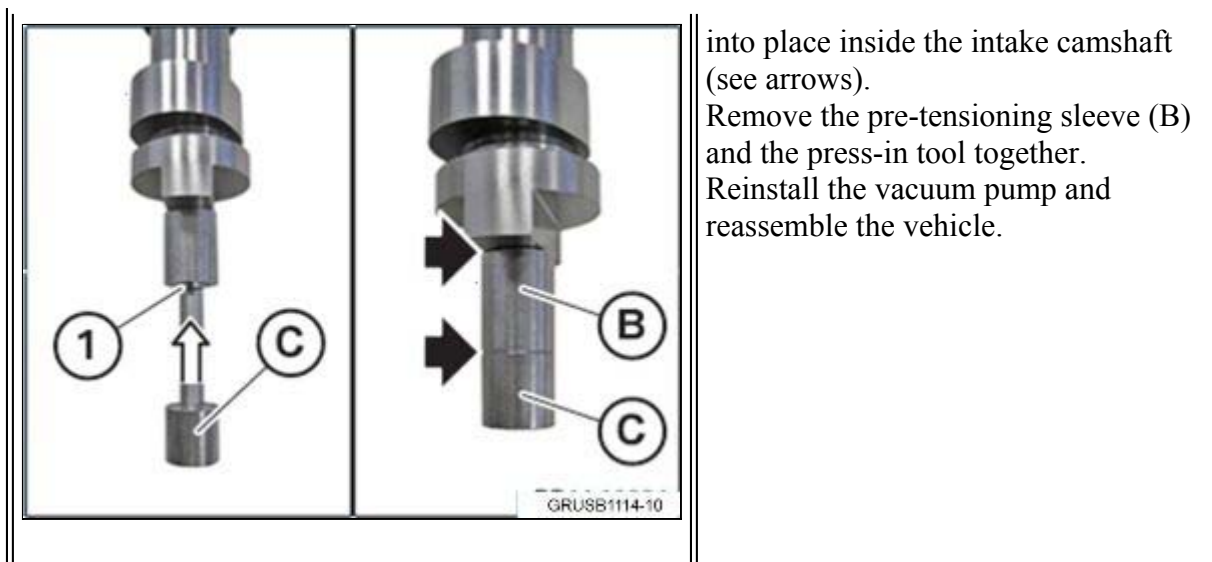
The spring steel sleeve (1) must lock in place inside the intake camshaft (2). This prevents the internal sealing cover of the intake camshaft from moving out of position (3).

12. Press the spring steel sleeve (1) fully into the camshaft in the direction of the arrow.

The pre-tensioning sleeve (B) and the press-in tool (C) must be seated to ensure the spring steel sleeve locks

into place inside the intake camshaft (see arrows).
Remove the pre-tensioning sleeve (B) and the press-in tool together.
Reinstall the vacuum pump and reassemble the vehicle.

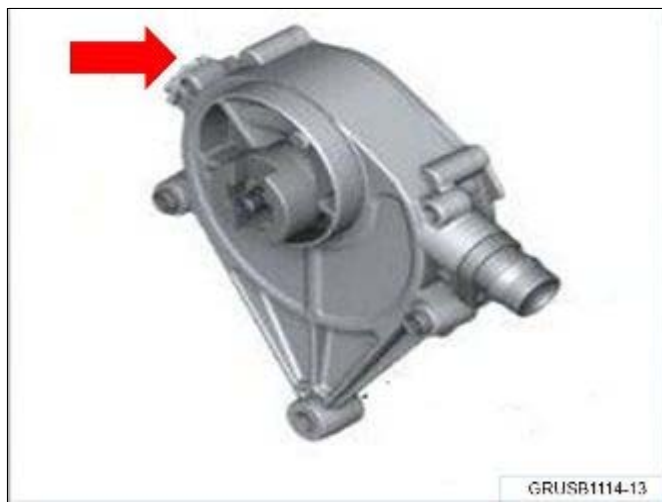
<p>P/N 11 66 7 622 380 Without the additional vacuum port: see the arrow. Application: Vehicles without the vacuum-actuated</p>
--	--

turbocharger waste gate
Vehicles **with** the electrically actuated exhaust flap
Note: The vacuum pump has one large vacuum port.

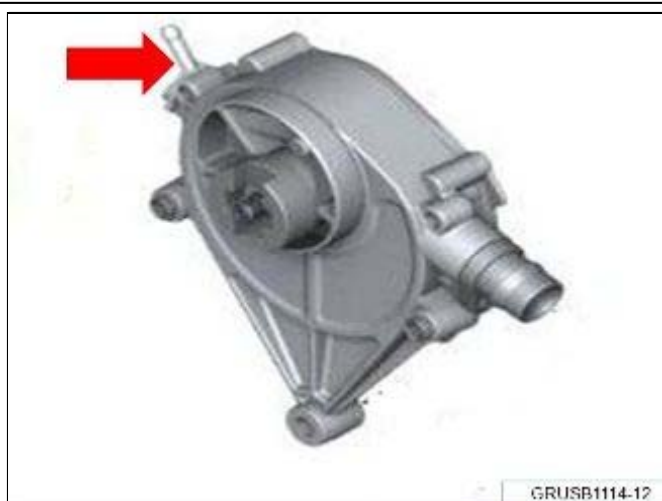
P/N 11 66 7 640 279
With the additional vacuum port; see the arrow.

Application:
Vehicles **with** the vacuum-actuated turbocharger waste gate
Vehicles **with** the vacuum-actuated exhaust flap
