# Safety Recall – Interim Inspection

Code: 42G7

**Subject: 2011-2013 MY Jetta and 2012-2013 MY Beetle  
Rear Axle Safety Inspection**

December 02, 2014

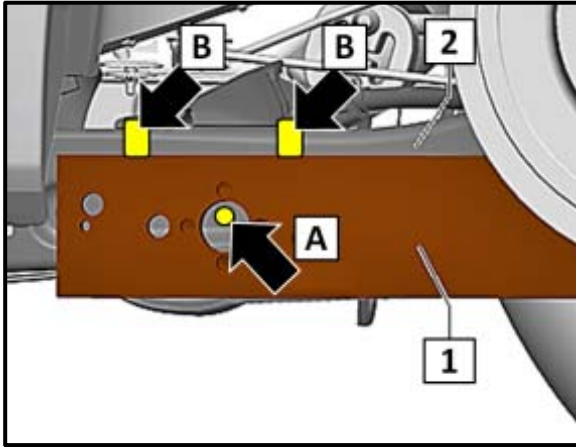
- Raise vehicle on hoist.
- Remove both rear wheels.
- ⇐ Clean both rear trailing arms in the area <arrows> highlighted in yellow.

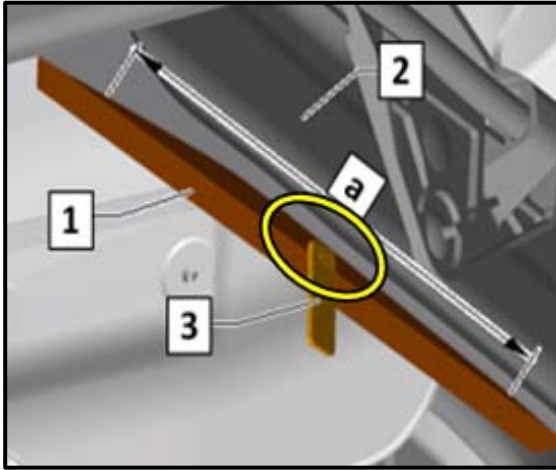
← Use tool 3371 <3> to check for a gap between the straight edge tool <1> and the trailing arm <2>.

← Measure the gap in center of the trailing arm where shown <circle>.

- If the gauges fit between the straight edge and the trailing arm (greater than 2.25mm) on either or both side(s) of the vehicle, the rear axle must be replaced. **Inform the customer of the concern, note findings on the repair order accordingly, and Continue to Section C.**
- If the gauges do not fit between the straight edge and the trailing arm (less than 2.25mm) on both sides of the vehicle, the rear axle is within tolerance. **No further work required. Lower vehicle on hoist, and then Continue to Section D.**

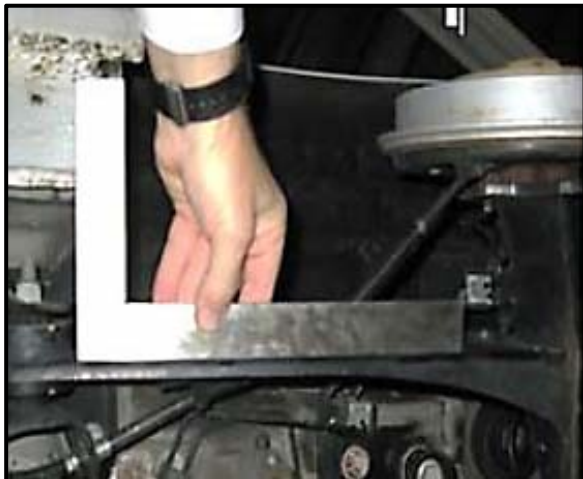
**i** Tip: Example showing carpenter square alternative. Hold the edge of the square against the trailing arm.

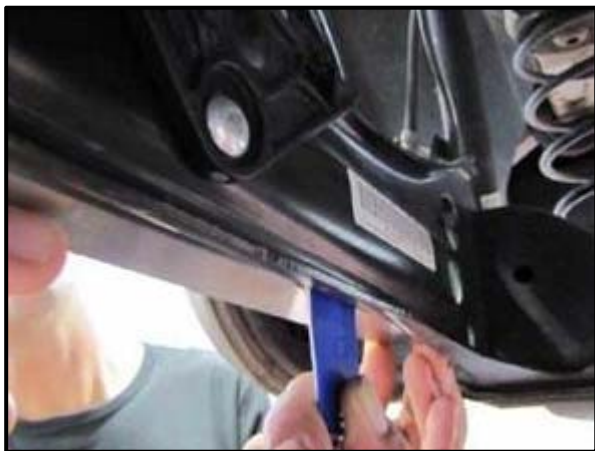
**i** Tip: Example showing carpenter square alternative measuring method. Use tool 3371 inserted along the edge to inspect for trailing arm deformation.

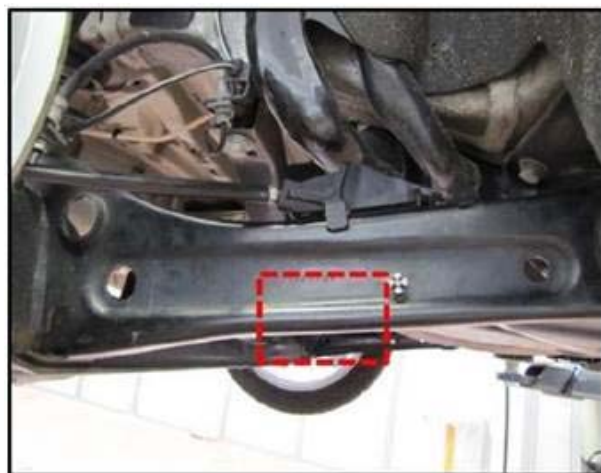
**i** Tip: Example showing where the trailing arm measurement should be taken. Measure the gap between the square and the trailing arm in the center of the trailing arm.
