Safety Recall **REVISION**

Code: 42G8

**Subject: 2011-2013 MY Jetta and 2012-2013 MY Beetle
Rear Axle Trailing Arm Inlay Installation**

April 08, 2015

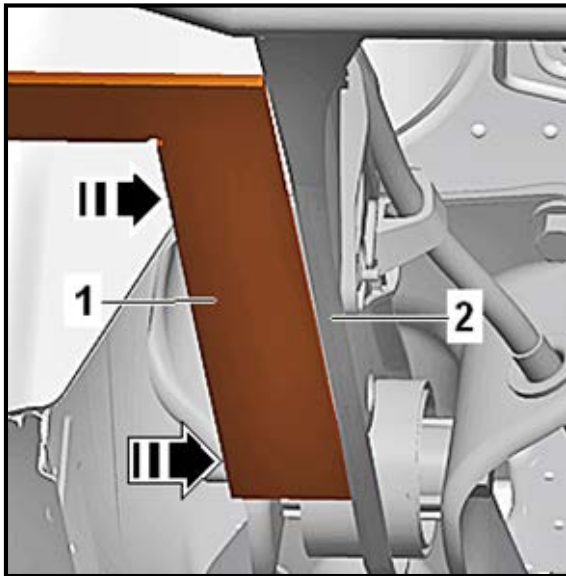
- ⇐ Hold the longer side of the measuring square, VAS241001 <1> against the trailing arm <2> at the bottom <direction of arrows>.

The measuring square <1> must rest flat against the trailing arm <2>.

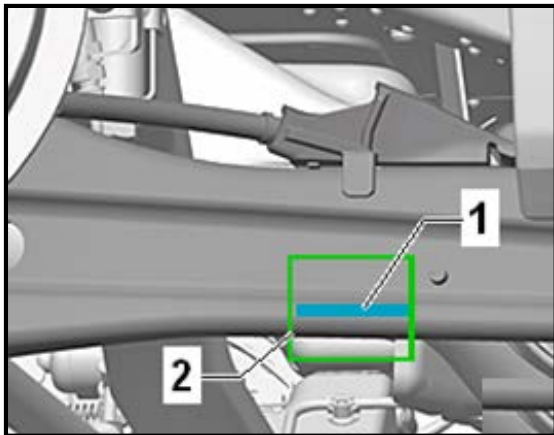
- ⇐ Use the measuring square to check for a gap on the surface of the trailing arm <1> inside the test area shown <2>.

- If gap is greater than 2.25 mm on either or both trailing arm(s), **the rear axle must be replaced PRIOR to completing this procedure.**
- If gap is less than 2.25 mm on both trailing arms, the rear axle is within tolerance. **Continue to Section C.**

Due to damage root cause attributed to outside influence, coverage for axle replacement is the responsibility of the customer or their insurance company.

Due to limited parts availability, parts have been blocked for all service needs. If damage is found, and authorization is provided from the customer to replace the rear axle, you must first obtain a parts release authorization. To obtain a parts release authorization for a rear axle, create a VTA ticket and contact the Volkswagen Technical Assistance Helpline.
