TECHNICAL SERVICE BULLETIN- "THIS IS NOT A RECALL"

| DOC # | PROCESS NAME | PAGE | REVISION | STATION | BY | DATE |
|---|--|---|---|---|---|---|
| TSB1401 | MANDATORY FUEL EXTENSION HARNESS REPLACEMENT, 191/210 GAS UNITS | 1 OF 1 | | SER | DBaker | 5/5/2014 |

The Purpose of TSB1401 is to notify the Dealers of a change in the Fuel Extension Harness to prevent possible breakdown of the unit.

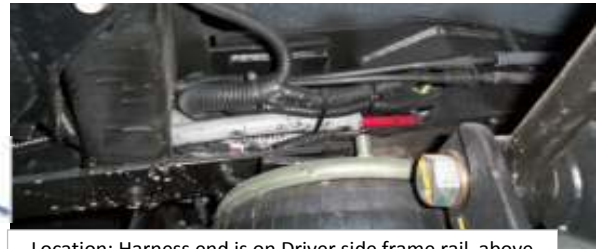
Location: Harness end is on Driver side frame rail above

Step 2: Unplug other end of harness on chassis rail as indicated in picture.

Step 6: Plug new harness into existing wiring on frame rail.

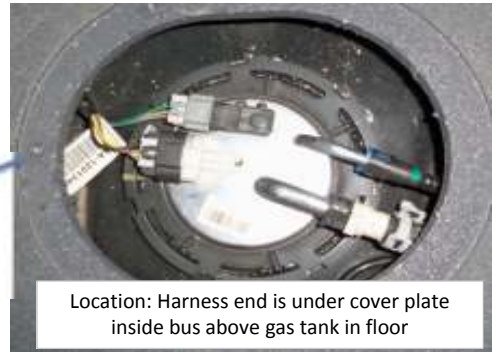
Location: Harness end is under cover plate inside bus above gas tank in floor

Step 1: Remove cover plate on floor inside bus above gas tank and unplug harness as indicated in picture.

Step 5: Plug new harness into location above gas tank and feed the rest of the harness down hole in floor. Re-install cover plate on floor.
