**Recall Campaign 14V-674: I12 Check Fuel Tank**

I12 (i8)

**FUEL TANK GROUND STUD INSPECTION**

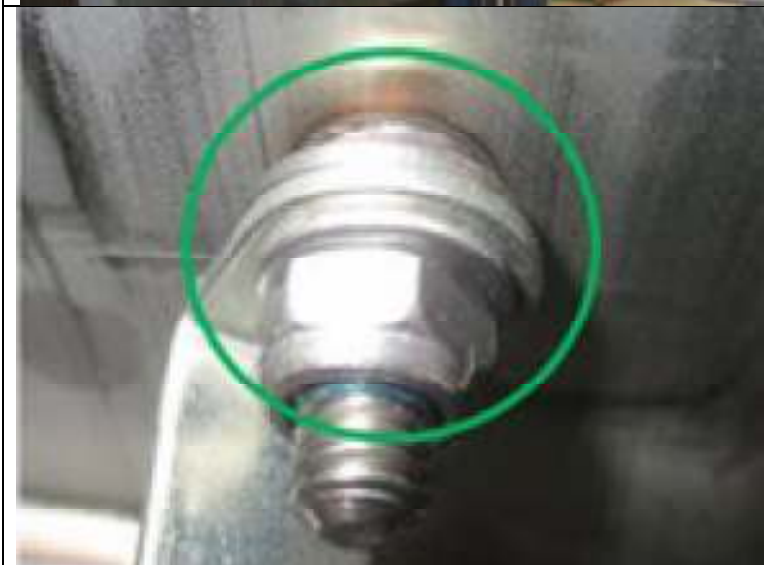
2. Visually inspect the weld of the fuel tank ground stud through the wheel arch.

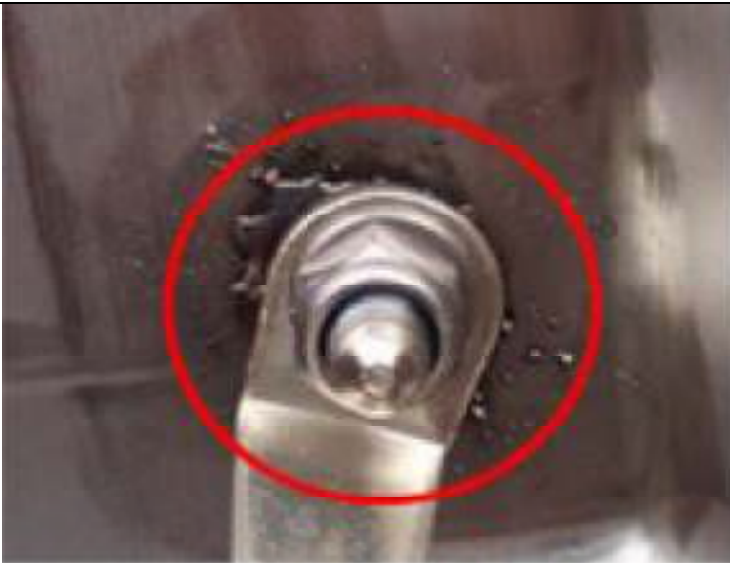
3. If the weld is clean and free of weld spatter and is not leaking, no further steps are required and the vehicle can be delivered to the customer.

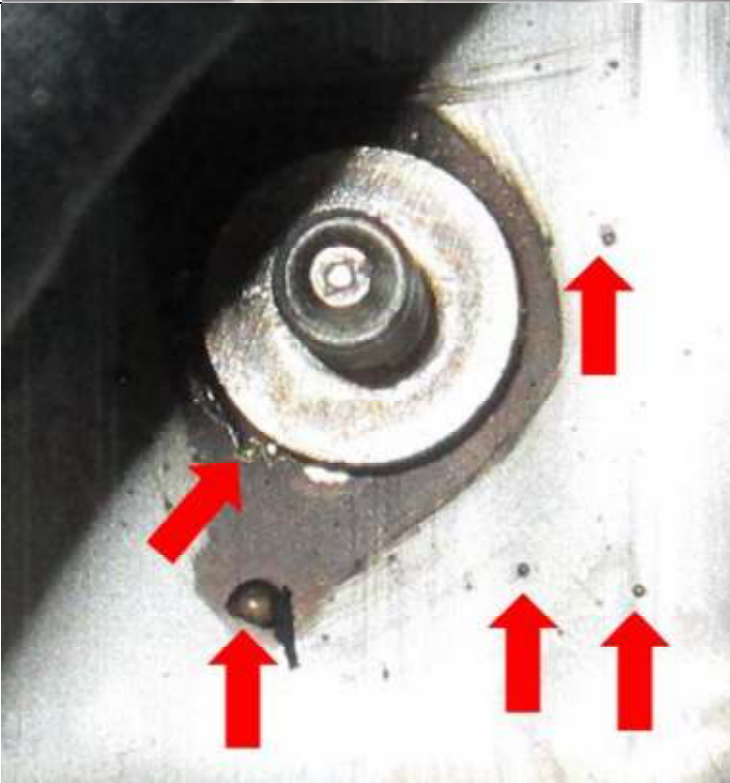
4. If weld spatter is found, the weld is leaking or the weld is questionable, Submit a standard PuMA case, with clear pictures of the weld, titled "Recall Campaign 14V-674: I12 Check Fuel Tank."

Further information will be provided once the PuMA case is received. **Do not retail or deliver these vehicles.**

5. In some cases weld spatter might not be visible with the ground cable installed. If you encounter this situation, remove the ground cable for further inspection.

As you can see in the picture, the weld spatter was hidden under the ground cable.
