Recall Campaign 14V-674: I12 Check Fuel Tank

I12 (i8)

A Recall Campaign has been issued on certain Model Year 2014 I12 (i8) vehicles produced from May 16, 2014 through September 16, 2014. The bolt for attaching a ground cable at the bottom of the fuel tank may not be welded correctly, which could result in a fuel leak.

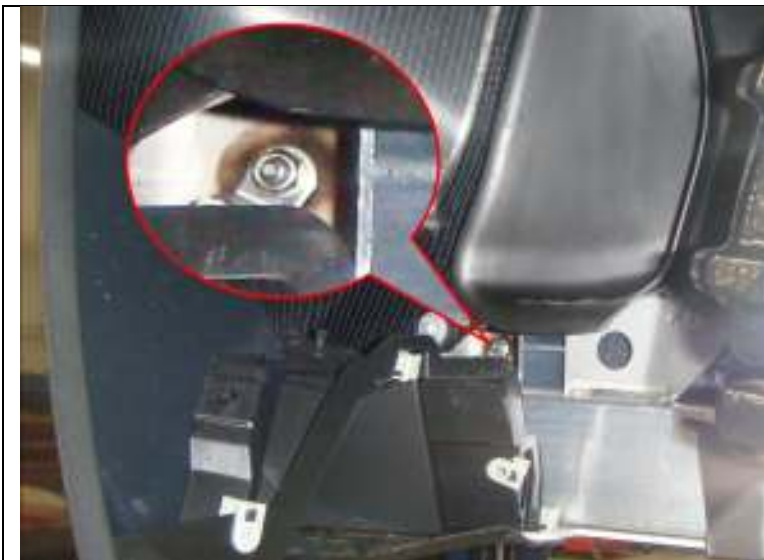
1. Remove the rear left wheel arch cover per Repair Instruction REP 51 71 041, "Removing and installing/replacing rear left or right wheel arch cover."
