RECALL CAMPAIGN BULLETIN

NTB14-112a

VOLUNTARY SAFETY RECALL CAMPAIGN 2011 - 2014 JUKE FUEL PRESSURE SENSOR

CAMPAIGN ID #: R1418

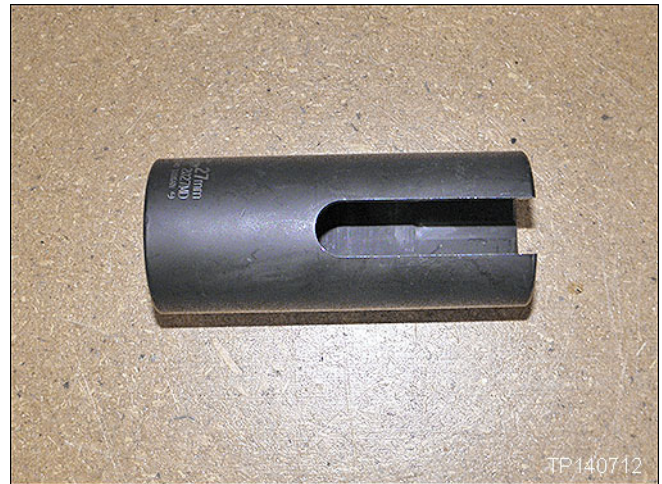
Figure A

REQUIRED SPECIAL TOOL J-51813

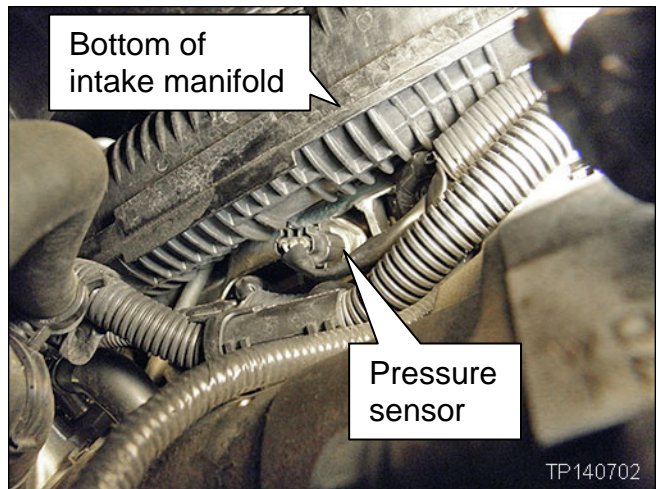
Figure 5

Nissan recently discovered that on some of the affected vehicles, the fuel pressure sensor connection may not have been tightened to the correct specification. As a result, the fuel pressure sensor connection may loosen gradually due to heat and vibration. If this occurs, over time, a small amount of fuel may leak from the fuel pressure sensor connection which could increase the risk of a fire in the presence of an ignition source.

7. Locate the fuel rail pressure sensor shown in Figure 5.

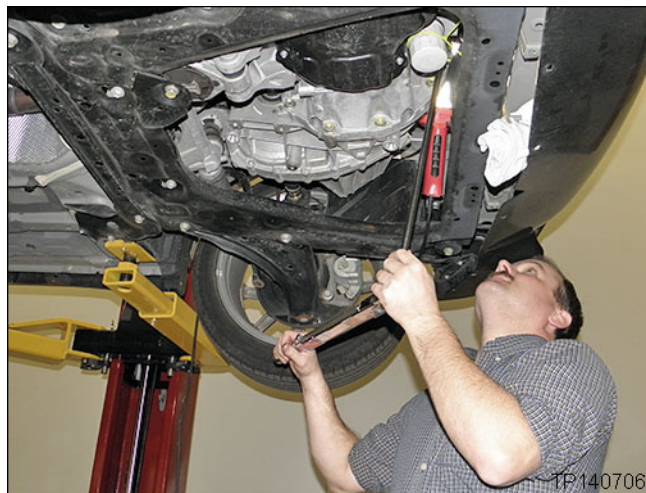
Figure 8

- If special tool J-51813 is not completely fitted on the sensor, the correct torque may not be applied.
- Do not push too hard while performing the torque. Pushing too hard may cause too much angle on the universal joint, which may cause a poor fit of special tool J-51813 on the sensor.

11. Torque the pressure sensor as follows:

- a. Make sure special tool J-51813 is completely fitted onto the sensor.
- b. Keep light pressure (push lightly) to keep special tool J-51813 fitted on the sensor while performing the torque.

c. Torque to 50 N•m (5.1 kg-m, **37 ft-lb**).
