Test Report No. 1000

Ice House Shackle Mount Testing

Test Date: October 24, 2014

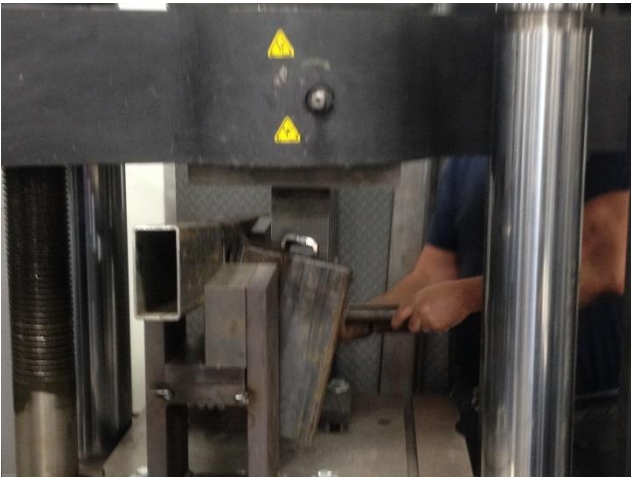
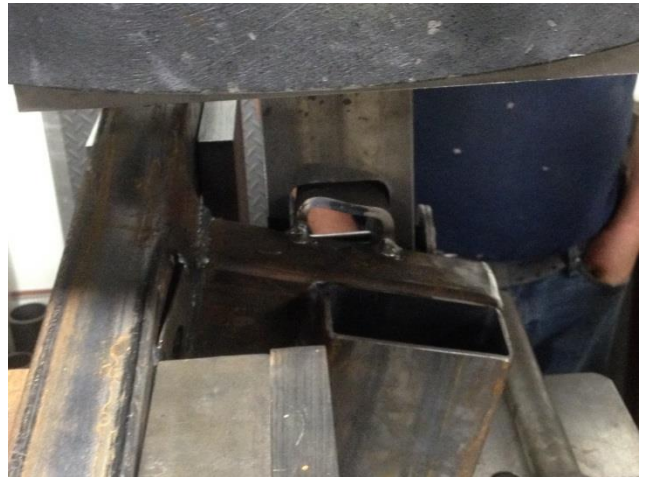
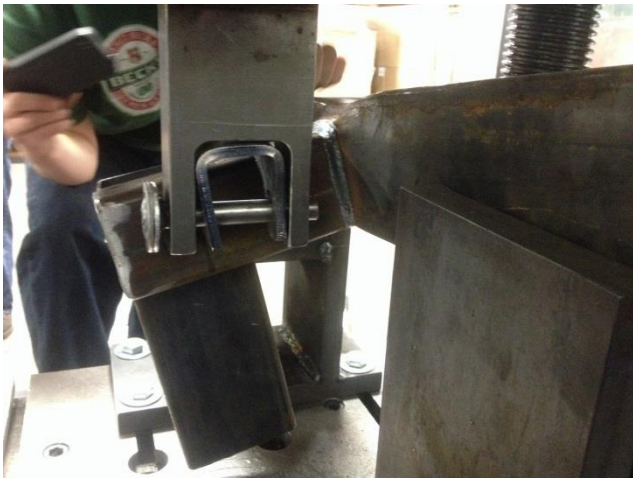
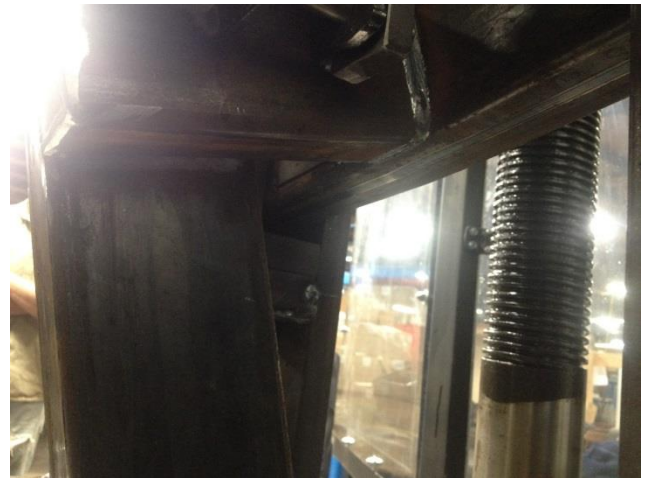
The force applied to the shackle mount resulted in the weld starting to separate from the mount. The tube that the shackle mount is located on began pulling the frame rail and bending it at the location in question. The deformation continued until the jack mount contacted the Instron table ending the test.

Figure 5: Current shackle mount #1 after testing

Figure 6: Current shackle mount #1 after testing

Figure 7: Current shackle mount #1 after testing

Figure 8: Current shackle mount #1 after testing

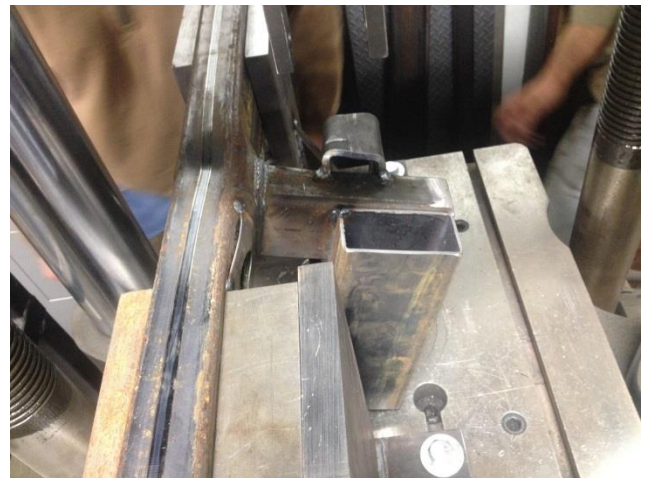
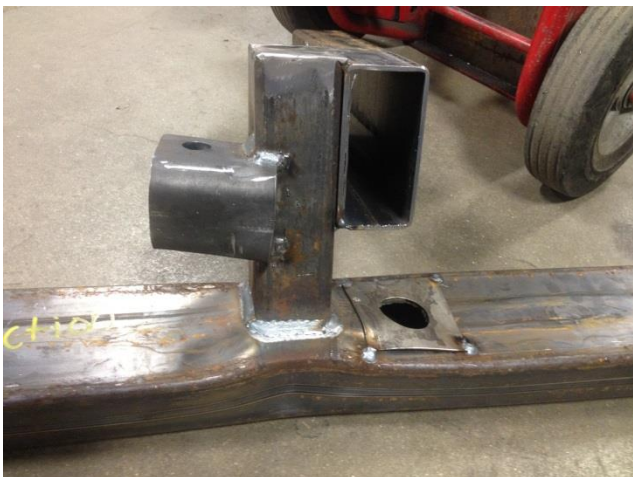
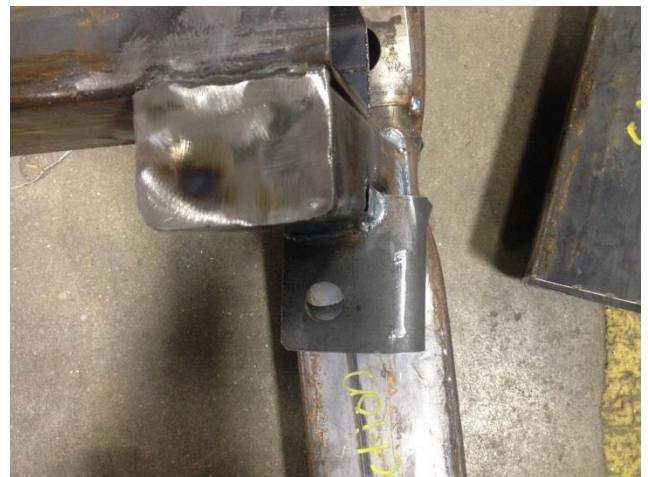
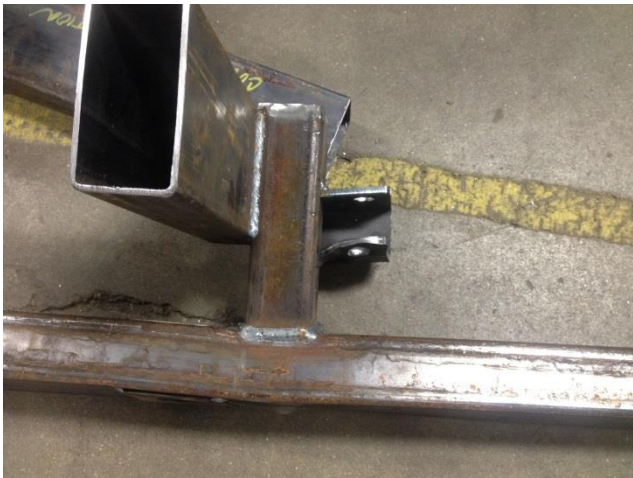
The results for this sample closely mimic those from the first sample. A couple of the welds began to separate from the steel under the pressure of the load and the steel frame began to twist.

Figure 10: Current shackle mount #2 after testing

Figure 11: Current shackle mount #2 after testing

Figure 12: Current shackle mount #2 after testing

Figure 13: Current shackle mount #2 after testing

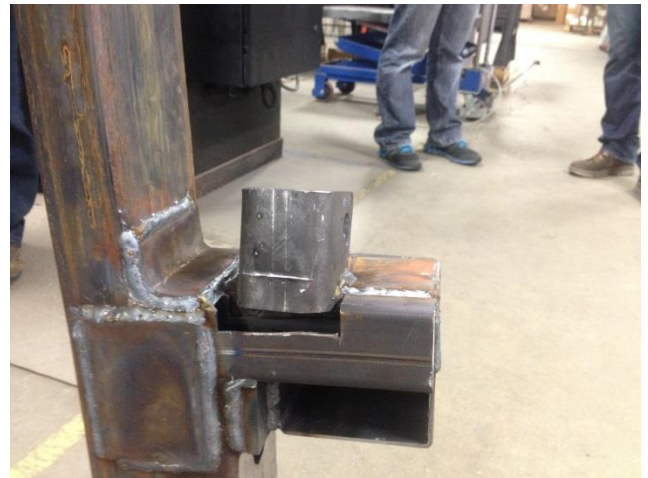
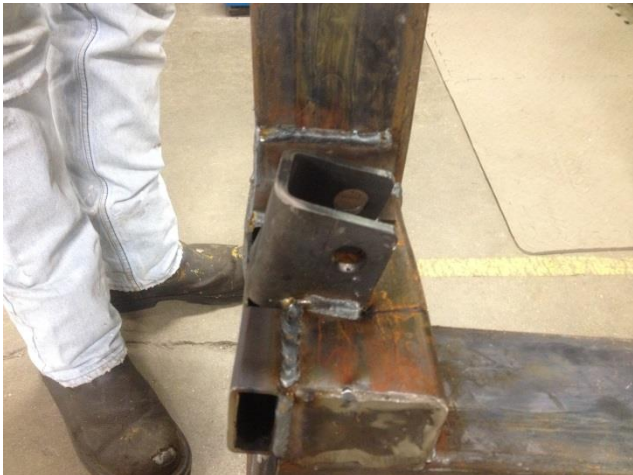
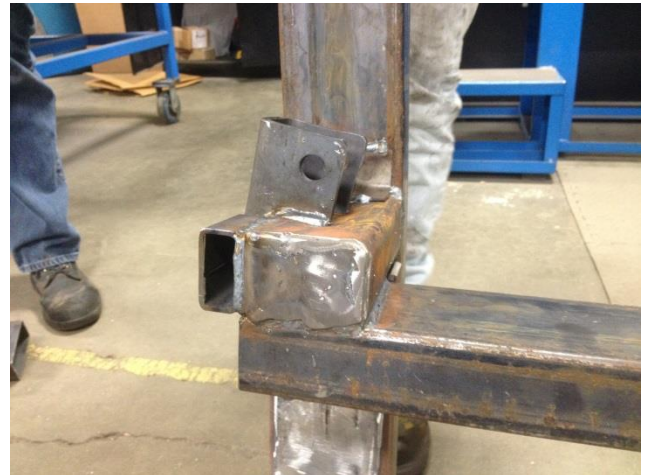
The reinforced frame on this sample proved beneficial. The total load increased by 13,001 pounds, while the deflection decreased by approximately half an inch. The shackle mount was damaged by the load, and bent into the side of the frame. The material in question held together, no flaws.

Figure 14: Proposed repair #1 after testing

Figure 15: Proposed repair #1 after testing

Figure 16: Proposed repair #1 after testing

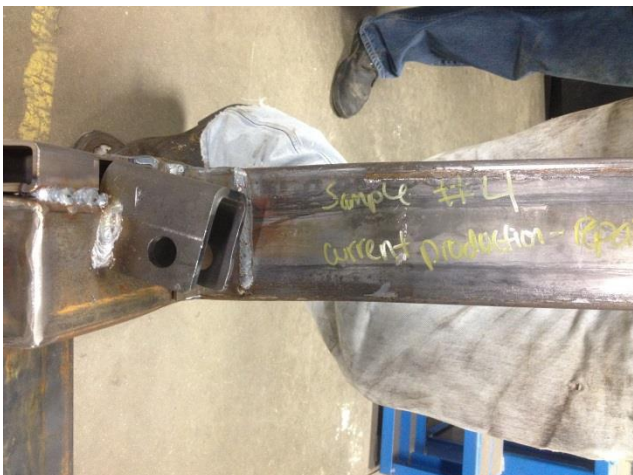
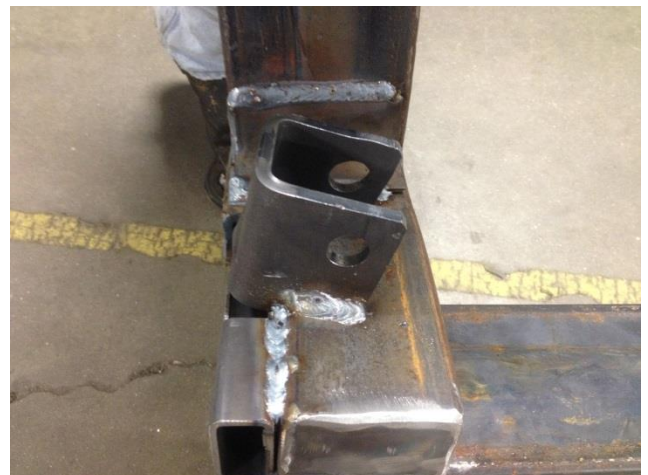
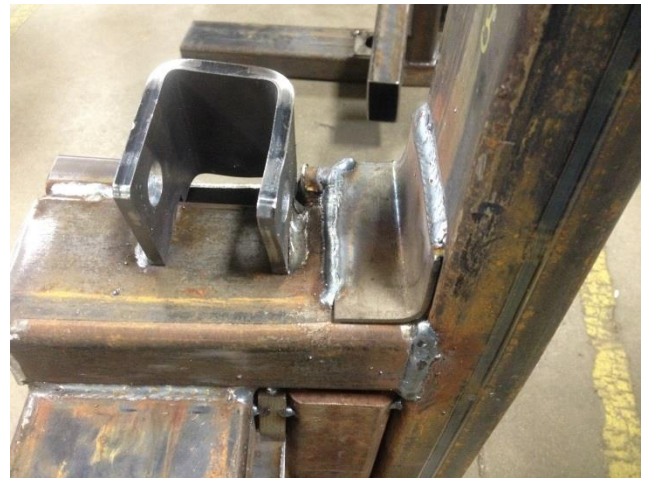
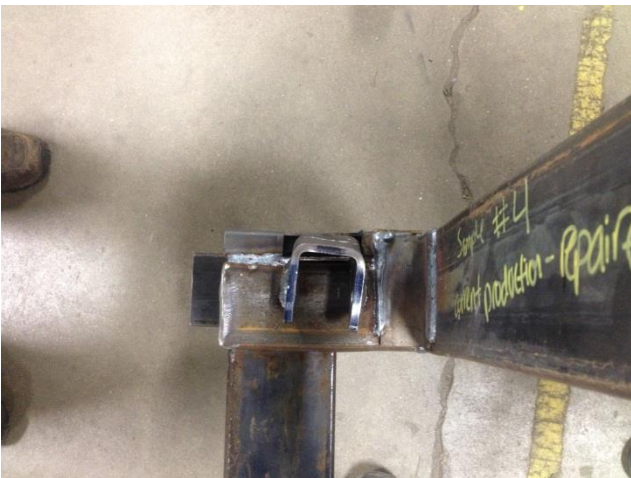
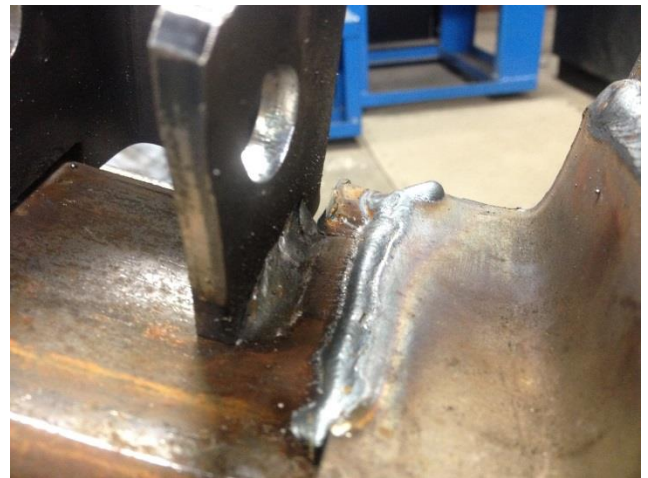
Figure 17: Proposed repair #2 after testing

Figure 18: Proposed repair #2 after testing

Figure 20: Proposed repair #2 after testing

Figure 21: Proposed repair #2 after testing

Figure 22: Proposed repair #2 after testing

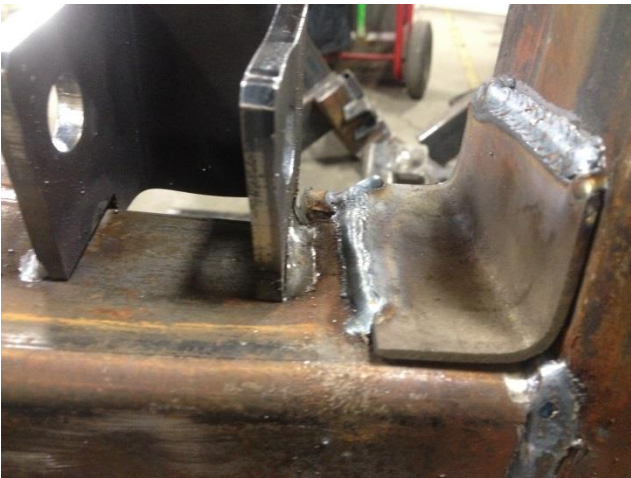
The results closely mimic those of sample three. In Figure 19, it can be seen where one of the welds connected to the shackle mount began to separate from the steel.

Figure 19: Proposed repair #2 after testing

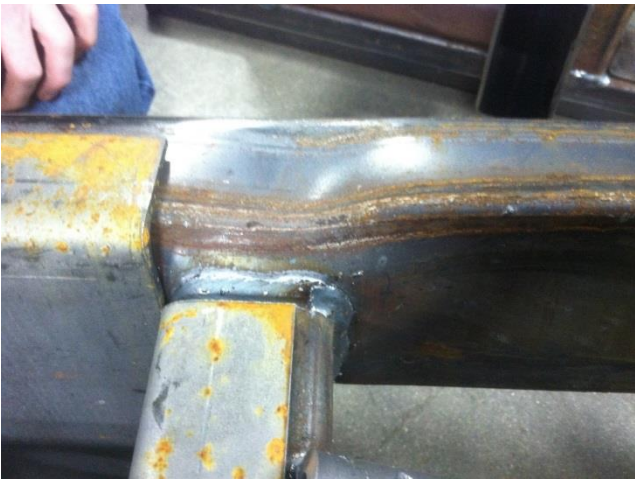
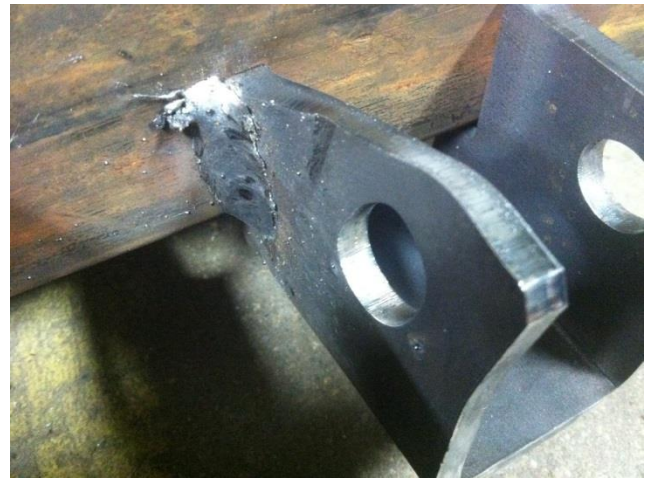
Figure 25: Past design #1 after testing

Figure 26: Past design #1 after testing

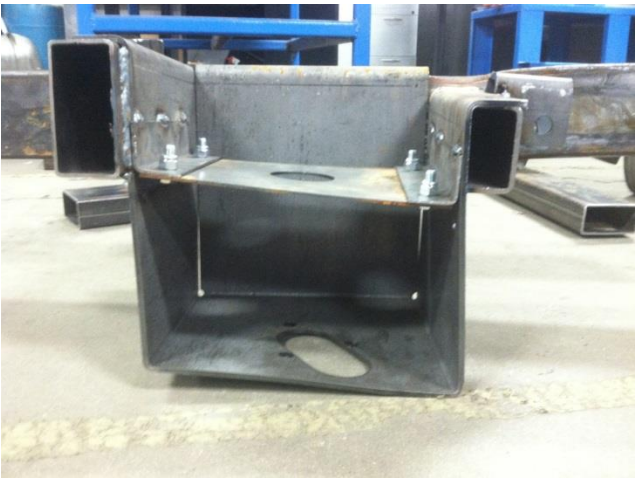
The welds at the material in question and the shackle mount began to separate. The entire "box" on this sample twisted under the pressure of the load, which is visible in Figure 27.

Figure 27: Past design #1 after testing

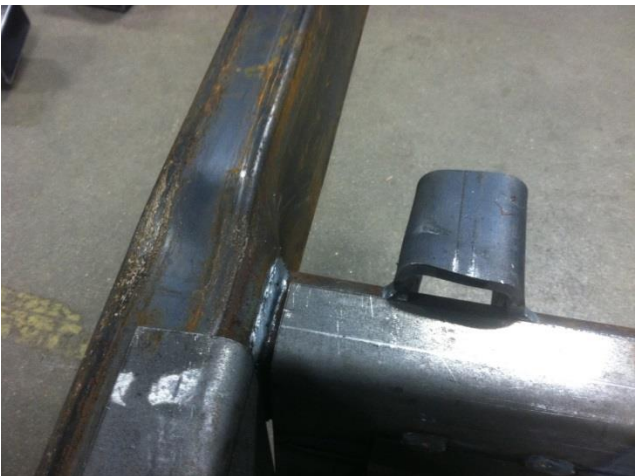
Figure 29: Past design #2 after testing

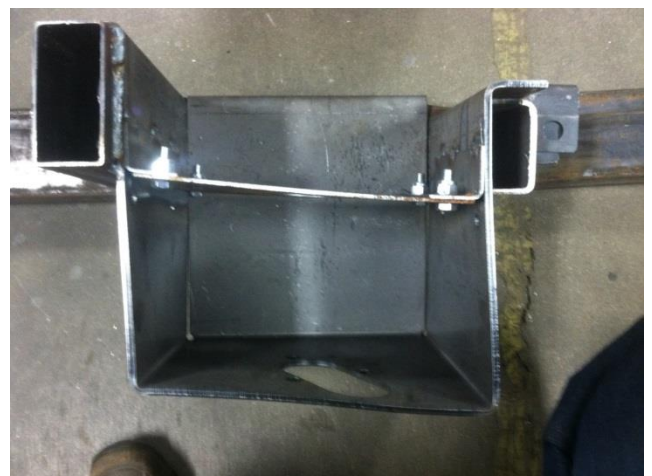
The weld to the material in question began to separate from the steel, same as in the last sample. Additionally, the twist in the "box" and in the frame is very prevalent as seen in Figure 30.

Figure 30: Past design #2 after testing
