# **SERVICE PROCEDURE**

14517

**SUBJECT: SAFETY RECALL**

**Wheelchair Lifts on certain BE, CE, FE, and RE commercial bus models built 23 January 2006 thru 12 May 2014 with Ricon Public Use,"S" 2000 and 5500 Series Lifts**

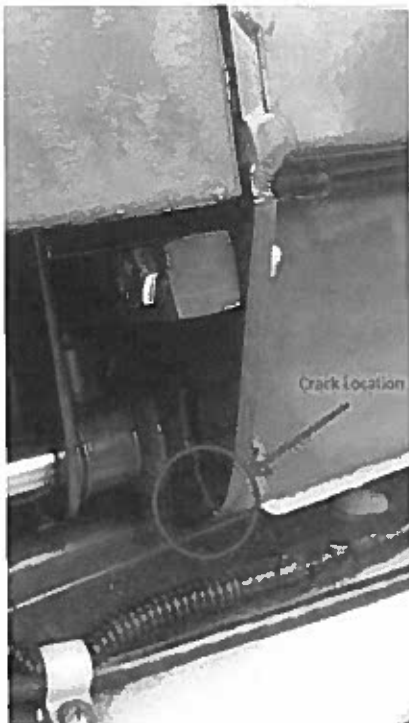
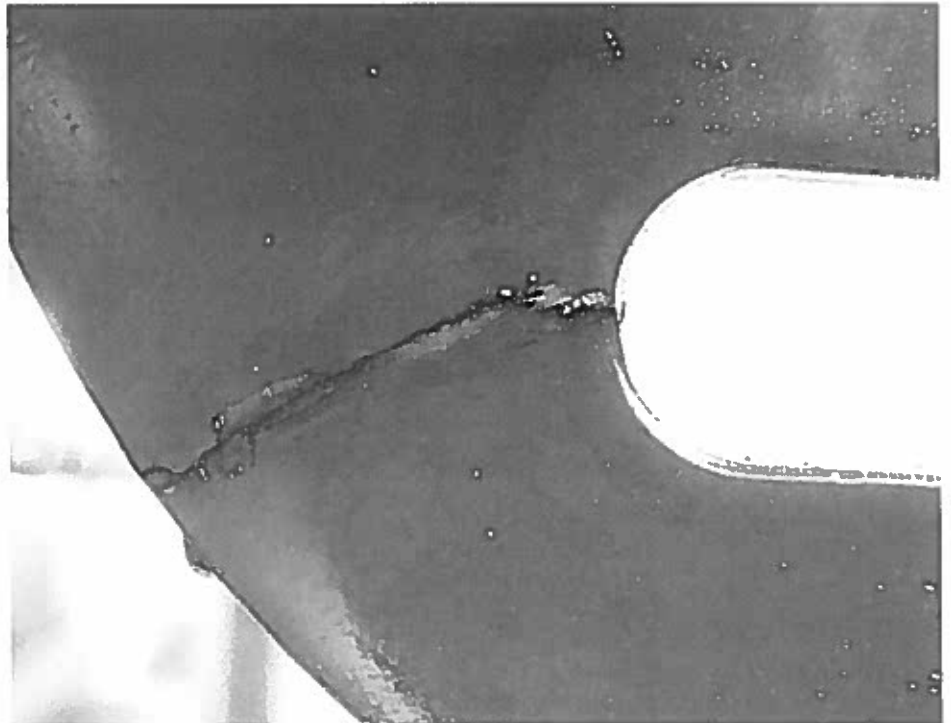
Under certain conditions the side plate of the larger platforms included on the subject S-Series model wheelchair lifts can exhibit cracking while in the stowed position which, if left unchecked can propagate to the point where separation of the rear portion of the side plate occurs rendering the lift inoperable and possibly unsafe to use.
