TECHNICAL BULLETIN

J047NAS1
10 NOV 2014

Safety Recall: Seatbelt Tension Sensor Connector Wiring

F-TYPE (X152)

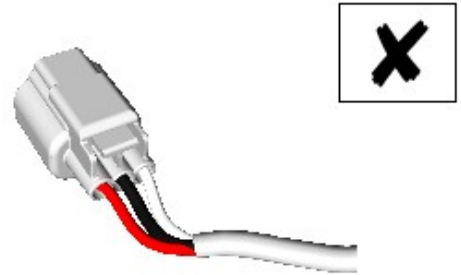
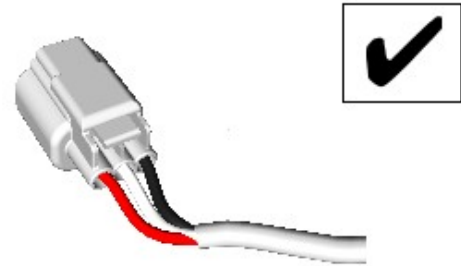
E172955

4. At the Seatbelt Tension Sensor side of connector C3R210, check that the electrical connector wires are positioned in the correct pin location as shown.

- If the wires are in the correct position, reverse steps 1-3 and release the vehicle.
- If the wires are not in the correct position, proceed to step 5.
