TECHNICAL BULLETIN  
J048NAS1  
21 NOV 2014

Safety Recall: Brake Pipe Torque Integrity

| <b>XJ Range (X351)</b> | |
| <b>Model Year:</b> | 2014-2015 |

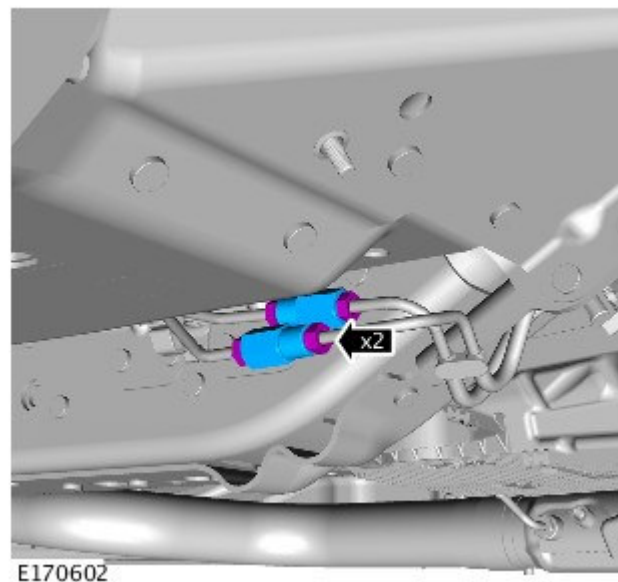
3.

Inspect the brake pipe unions for signs of moisture or brake fluid leakage.

- If there are no signs of moisture / brake fluid leakage, reverse steps 1-2. No further action required.
- If there are signs of moisture / brake fluid leakage, continue to the next step.

Check the tightness of the brake pipe unions.

- Torque: 17.5Nm.
