RECALL BULLETIN:
14117ARG

PRODUCT(S) AFFECTED:
Fleetwood Excursion (MY 2014-15)

Holiday Rambler Ambassador (MY 2015)

SUBJECT:
Inspection/Correction of Bucket Seat Pedestal Mounting Components

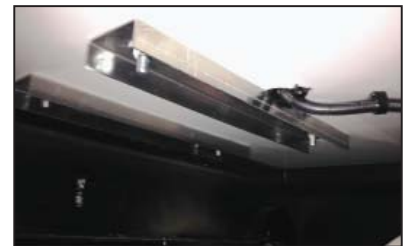
Figure 1

2. Begin the inspection by accessing the steering axle wheel well under the vehicle on the driver's side. On the bottom exterior of the floor there should be two "C-channel" brackets attaching the seat pedestal to the floor. Each bracket should be secured with (2 ea.) bolts, washers and lock nuts, as shown in Figure 1. Record the inspection results.
3. Repeat the inspection procedure for the passenger's side and record the results.

8. Install the new seat pedestal C-channel support brackets (2 per seat) over the existing bolts as shown in Figure 1. Secure each with a flat washer and lock nut, following the stacking order shown in Figure 3. Torque nuts to 30 ft.-lbs.

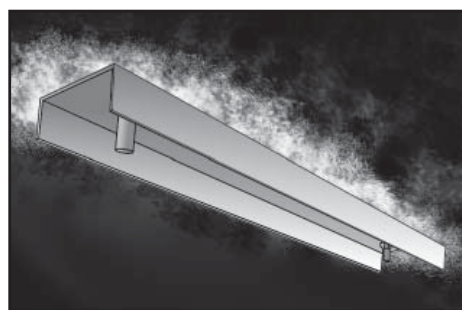
Figure 2

Scrape off the majority of the undercoating in the installation area before attaching the new seat pedestal support brackets

7. Use a putty knife, scraper or wire wheel to remove the majority of the undercoating in the area where the new seat pedestal C-channel support brackets are to be installed. Avoid contact with any wire harnesses. See Figure 2.
