PRODUCT CAMPAIGN BULLETIN

APPLICABILITY: 2003-2005 Subaru Legacy and Outback
 2003-2005 Subaru Baja
 2004-2005 Subaru Impreza**
 (including WRX and STI)

NUMBER: WQP-51R
DATE: January 2015
NHTSA ID: 14V-763
REVISED: October 5, 2017

SUBJECT: Regional Front Passenger Air Bag Inflator Replacement

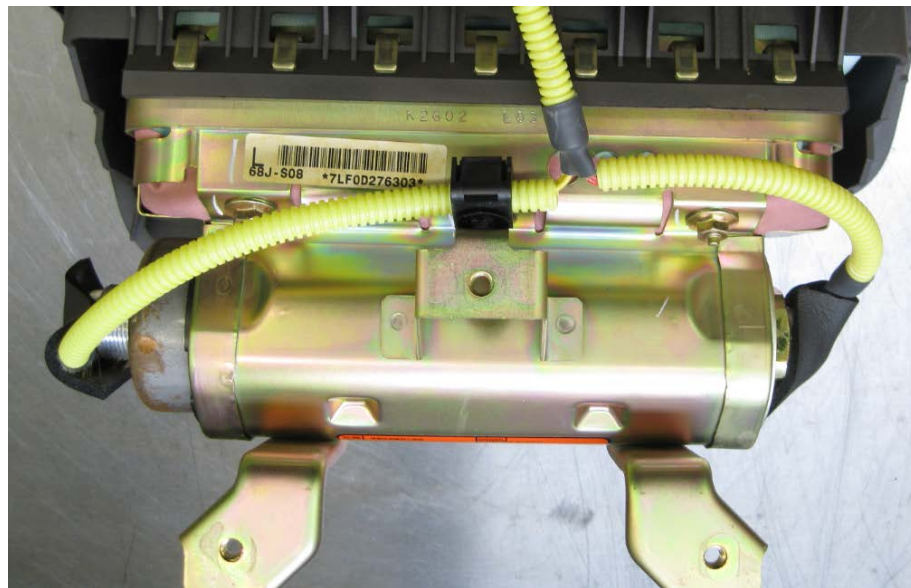
Inflator WITHOUT Ammonium Nitrate- Serial Number Label Location (2003 Legacy, Outback and Baja models only): Record this 12-digit number for claims purposes.

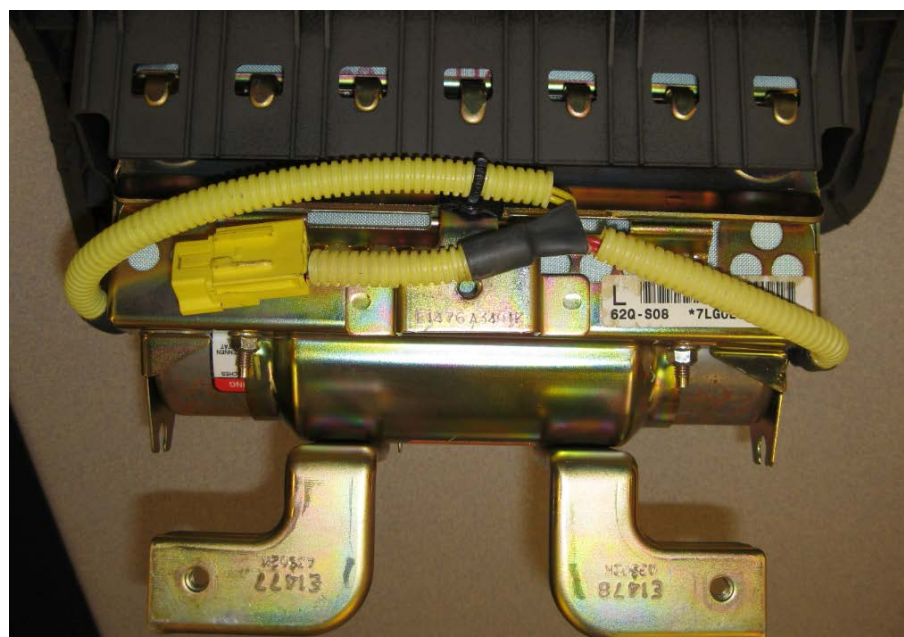
Inflator WITH Ammonium Nitrate- Serial Number Label Location
