**HYUNDAI**NEW THINKING.  
NEW POSSIBILITIES.**Technical Service Bulletin**

**14-01-056**

**SONATA (LFA) 1.6T****SUBJECT:** SONATA 1.6T LEFT FRONT DRIVESHAFT INSPECTION AND REPAIR (RECALL CAMPAIGN 126)**\* IMPORTANT****\*\*\* Dealer Stock and Retail Vehicles \*\*\***

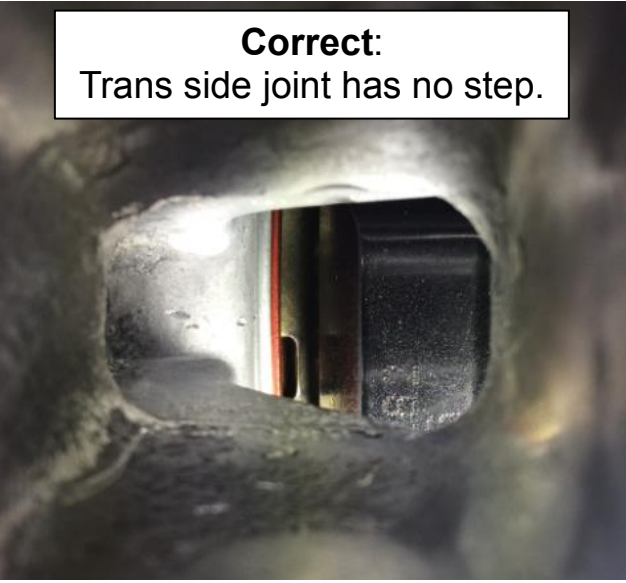
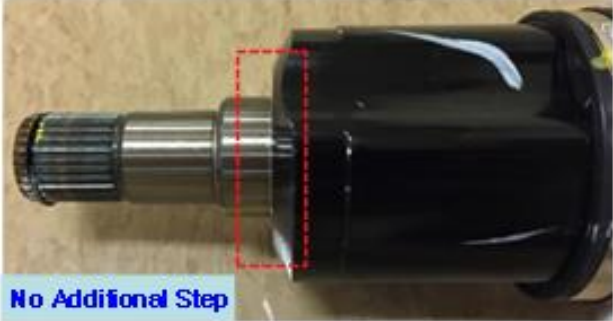
Correct LH driveshaft	Incorrect LH driveshaft
Transmission side	<p><b>Correct:</b> Trans side joint has no step.</p>

<p>No Additional Step</p>

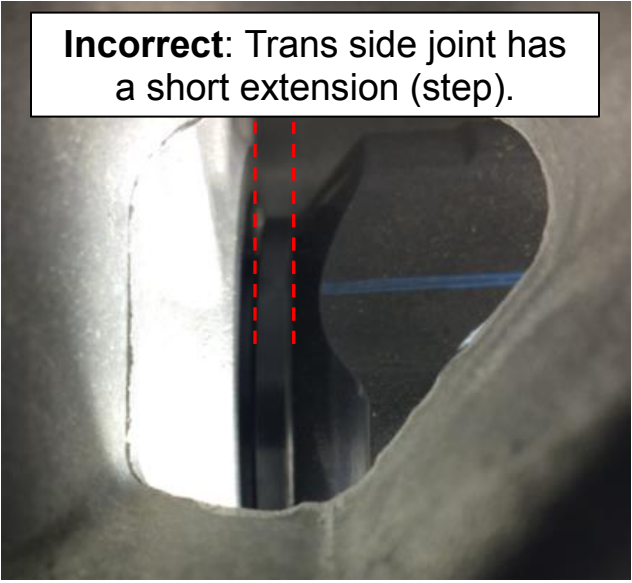
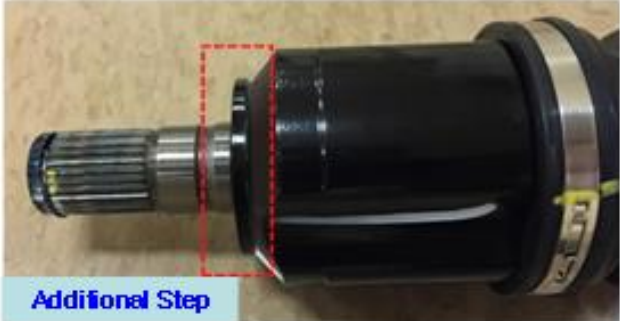
<p><b>Incorrect:</b> Trans side joint has a short extension (step).</p>

<p>Additional Step</p>
Wheel side

5.
  - If an incorrect driveshaft is installed, the driveshaft must be replaced as per shop manual instructions.
    - If an incorrect driveshaft is installed, inspect the shaft for damage. If any damage is noted on the transmission side splines, it is also required to replace the transmission per the shop manual instructions.
    - If transmission needs to be replaced, submit a warranty claim for transmission replacement.
  - If a correct driveshaft is installed, the inspection is complete and driveshaft does not need to be replaced.

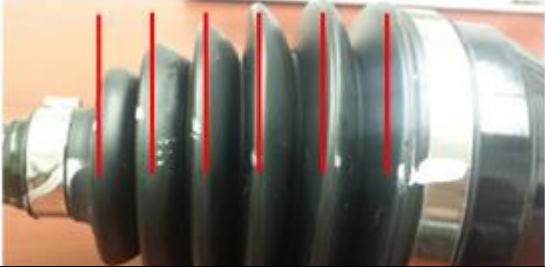
<p><b>Correct:</b> Wheel side boot has 6 ridges.</p>

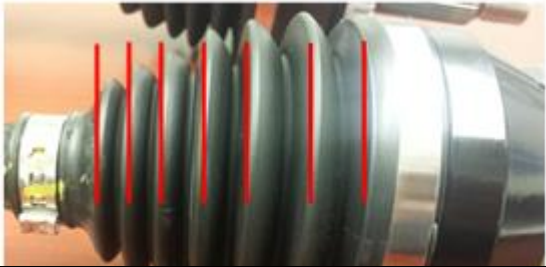
<p><b>Incorrect:</b> Wheel side boot has 7 ridges.</p>
