ATB 01263 (1412)

Safety Recall: Passenger's (Right) Side Curtain Airbag May Not Inflate Properly

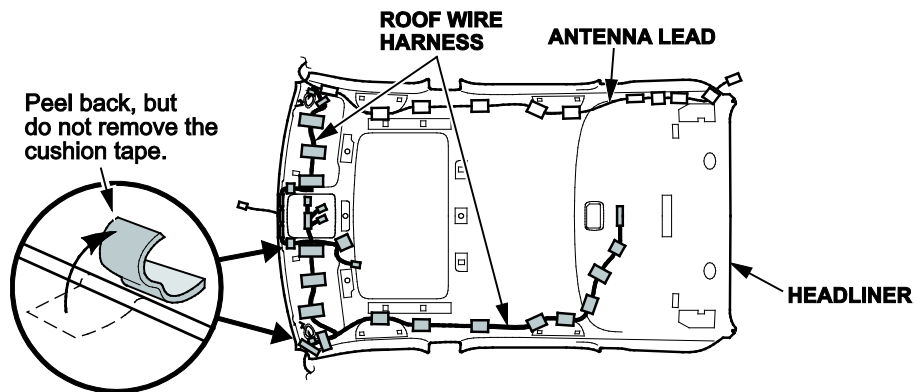
Do not disconnect the roof wire harness from the driver's dash area; once the headliner is lowered, detach the roof wire harness from the headliner by carefully peeling back just enough tape to remove the harness.

- Do not remove all of the tape; it will be reused.
- Make sure the roof wire harness is out of the way so that it does not get tangled with the headliner when you remove it from the vehicle.
- Leave the AM/FM antenna attached to the headliner.
