Safety Recall

Code: 57F6

**Subject: 2015 MY Jetta
BCM Update to Correct Headlight Noncompliance**

December 16, 2014

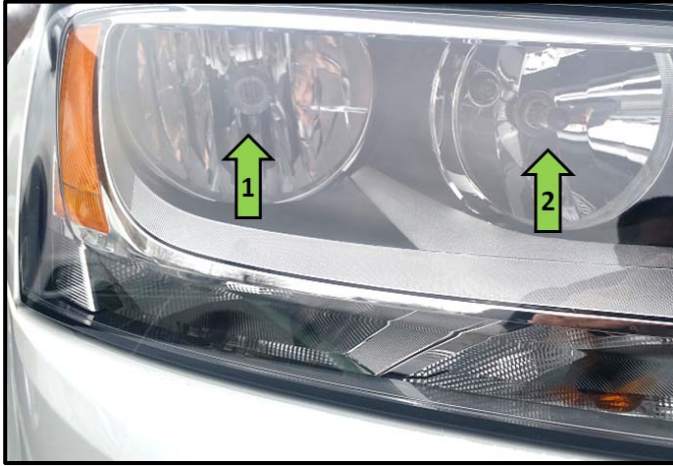
- Inspect headlamp operation.
- ⇐ With the low beam headlamps turned on, ONLY the outboard light bulb should be illuminated <arrow 1>.
- ⇐ When the high beams are switched on, BOTH bulbs should be illuminated <arrows 1 and 2>.

If the headlamps function as described above, **Work Complete – Proceed to Section E.**

If the headlamps do not operate as described above, **Proceed to Section C.**

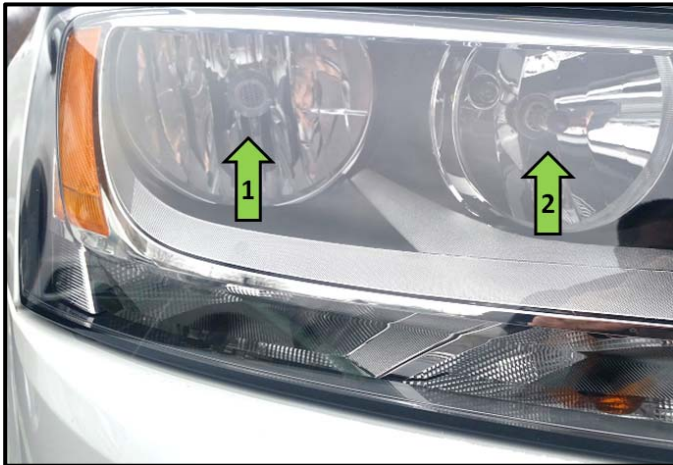
- ← Inspect headlight operation
- ← With the low beam headlamps turned on ONLY the outboard light bulb should be illuminated <arrow 1>.
- ← When the high beams are switched on BOTH bulbs should be illuminated <arrows 1 and 2>.
