RECALL CAMPAIGN BULLETIN

NTB15-002

VOLUNTARY SAFETY RECALL CAMPAIGN 2015 ARMADA TRANSMISSION PARKING PAWL

CAMPAIGN ID #: PC334
NHTSA #: 14V-803
APPLIED VEHICLES: 2015 Armada (TA60)

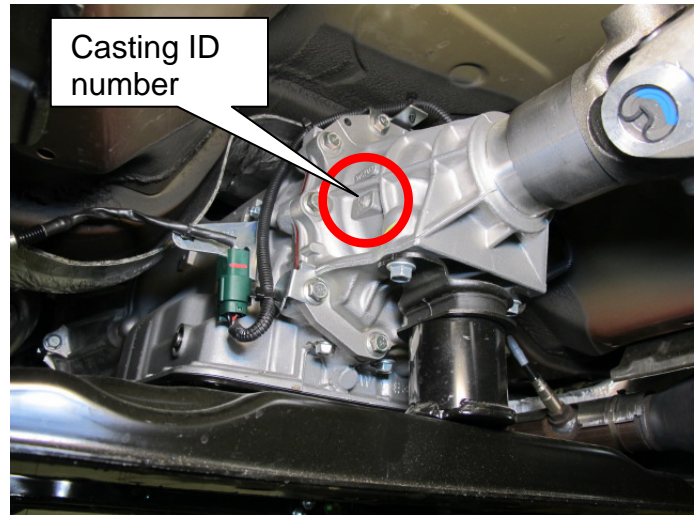
Figure A

1. Lift the vehicle.
2. Locate and read the casting ID number (see Figures A, B, and C).

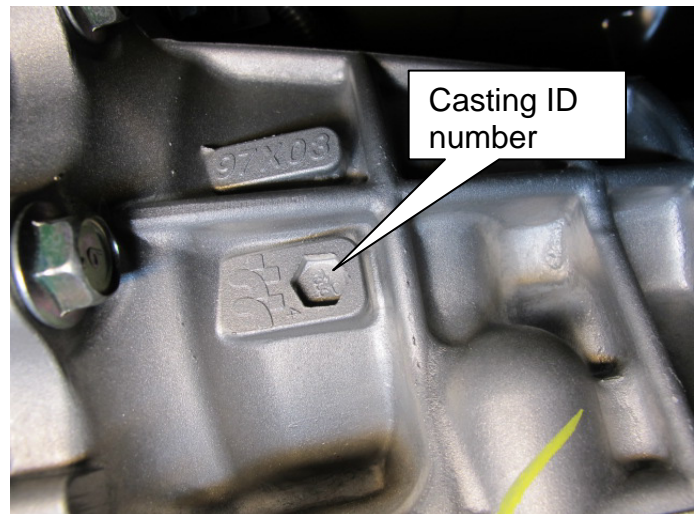
- The casting ID number is located on the driver side of the transmission tail housing in a six sided hole (see Figure B).

- The casting ID number shown in Figure B may be difficult to read due to limited space between the vehicle body and the transmission.
- It is recommended that you use a camera to take a photo, and then read the number from the photo.

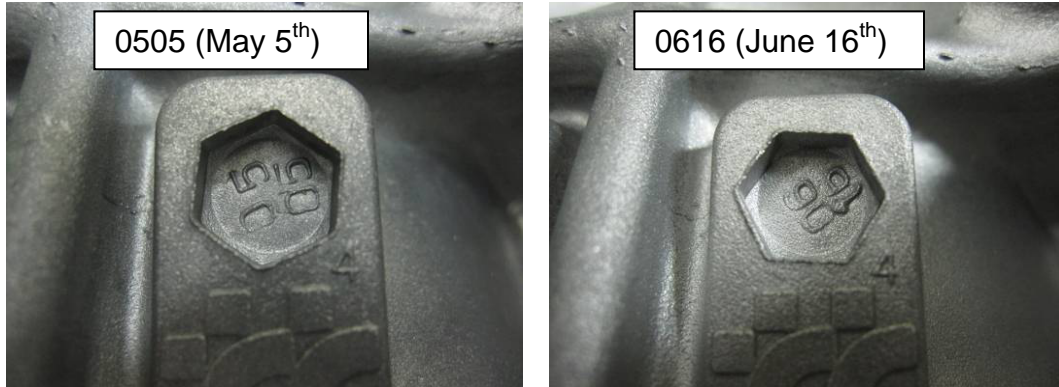
Figure C

Casting ID number is four digits (2 digit Month, 2 digit Day). See examples in Figure C.

If casting ID number is 0501 (May 1st) or before:

If casting ID number is 0502 (May 2nd) or After:

- Make sure the vehicle is affected by this campaign (use Service COMM).
- Replace the transmission assembly.
- Continue with the Service Procedure on the next page.

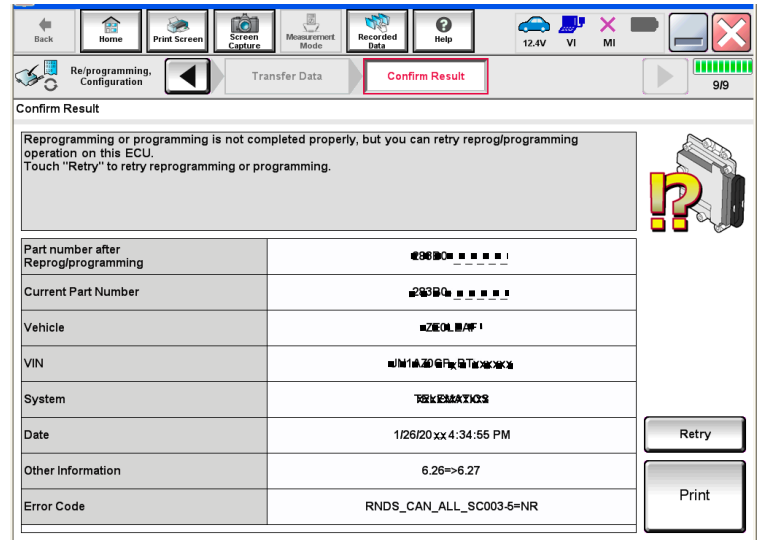
Figure 17

If programming does not complete and the “!?” symbol displays as shown in Figure 17:

- Check battery voltage (12.0 – 15.5V).
- The ignition is ON and the engine is OFF.
- External Bluetooth® devices are OFF.
- All electrical loads are OFF.
- **Select Retry and follow the on screen instructions.**

NOTE: Retry may not go through on the first attempt. It can be selected more than once.

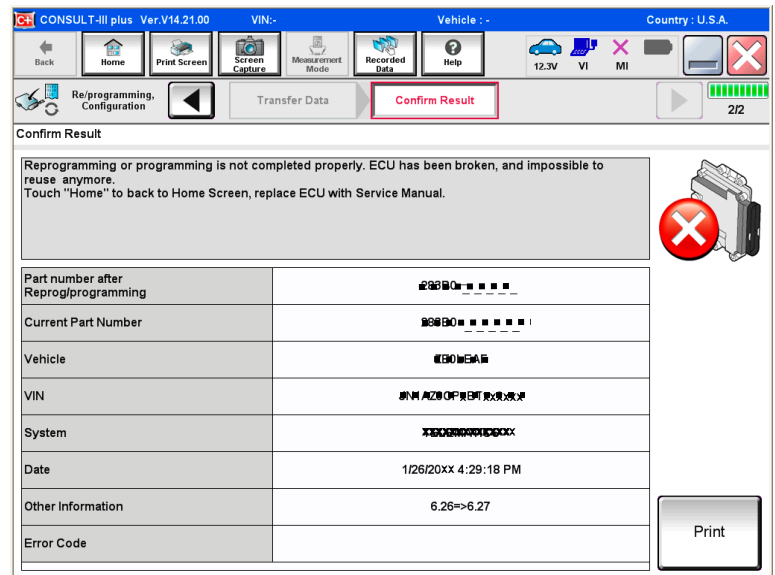
Figure18

If programming does not complete and the “X” symbol displays as shown in Figure 18:

- **Do not disconnect the plus VI or shut down C-III plus if reprogramming does not complete.**
- Check battery voltage (12.0 – 15.5V).
- The CONSULT A/C adapter is plugged in.
- The ignition is ON and the engine is OFF.
- The transmission is in Park.
- All C-III plus / plus VI cables are securely connected.
- All C-III plus updates are installed.
- **Select Home, and then restart the program procedure from the beginning.**
