Recall Bulletin

PRODUCT SAFETY RECALL

SUBJECT: Incorrect Drivers Outboard Front Seat Hook Bracket

MODELS: 2015 Cadillac SRX

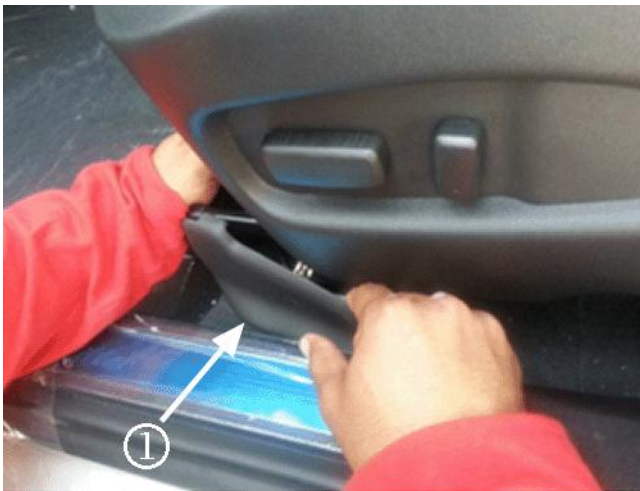
4051021

1. Adjust the driver seat to the full upward, full rearward position.

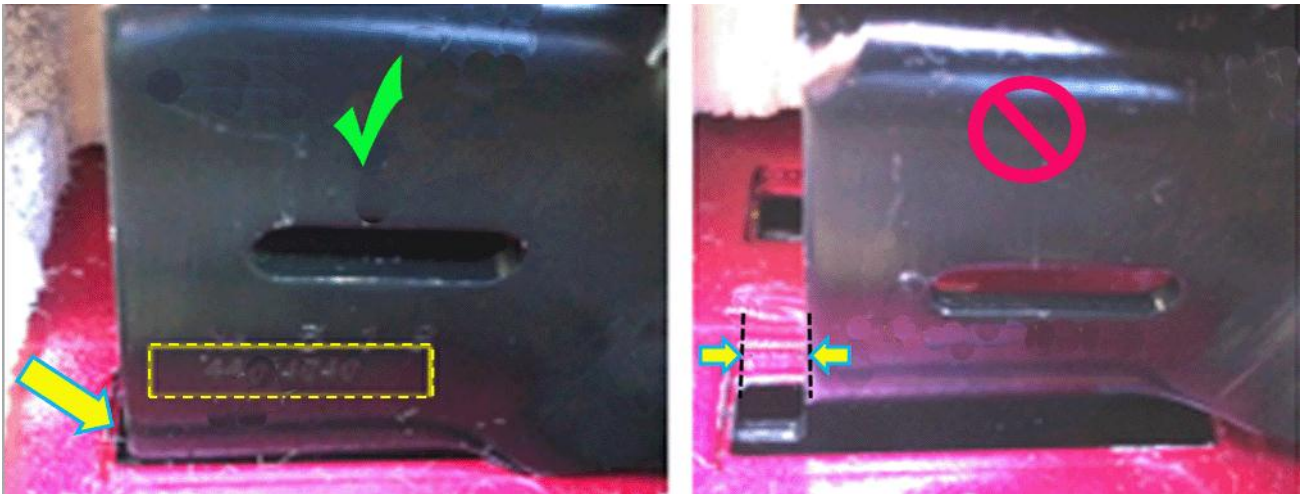
3. Inspect the driver front outboard seat hook bracket for a part number identification stamping (1) AND for the proper gap between the bracket and the slot in the floor sheet metal (2).

- Correct parts can be identified one or two ways: 1) a very small gap of 0 - 3mm (0.118 in) (in photo at left) should exist between the hook bracket and the forward edge of the floor slot or 2) a part number identification stamp (P/N 44816740 in the dashed box above) should be visible below the A-Clip attachment hole. If either of these conditions exist, the seat track cover can be reinstalled and no further action is required.
- If the hook bracket has a large gap of 7mm (0.275 in) (as shown above on the right) or greater and/or DOES NOT have the part number identification stamp, the bracket will need replacement. Proceed to **Seat Bracket Service Procedure below**.
