# Spartan Motors Chassis, Inc.

## SERVICE BULLETIN

RSB14-250-006

**SUBJECT:** IFS Ball Joints

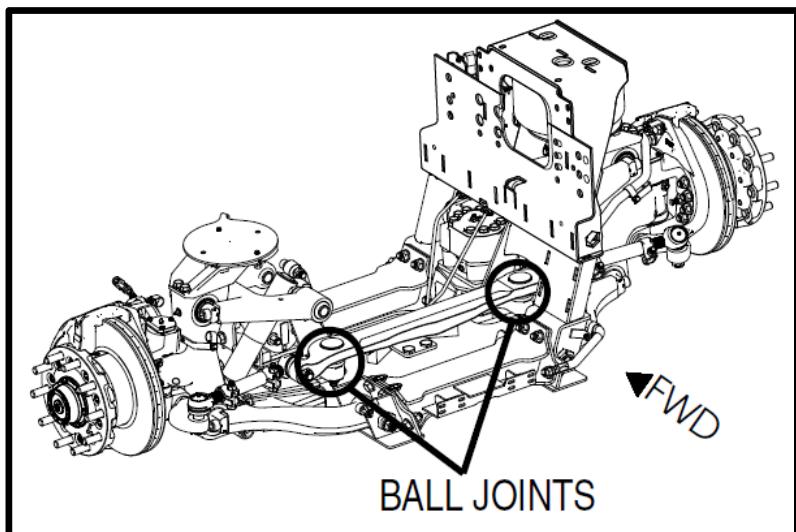
**FIG. 2-1**

1. Follow normal maintenance and safety procedures to gain access to the pitman arm ball joints. Refer to FIG. 2-1.

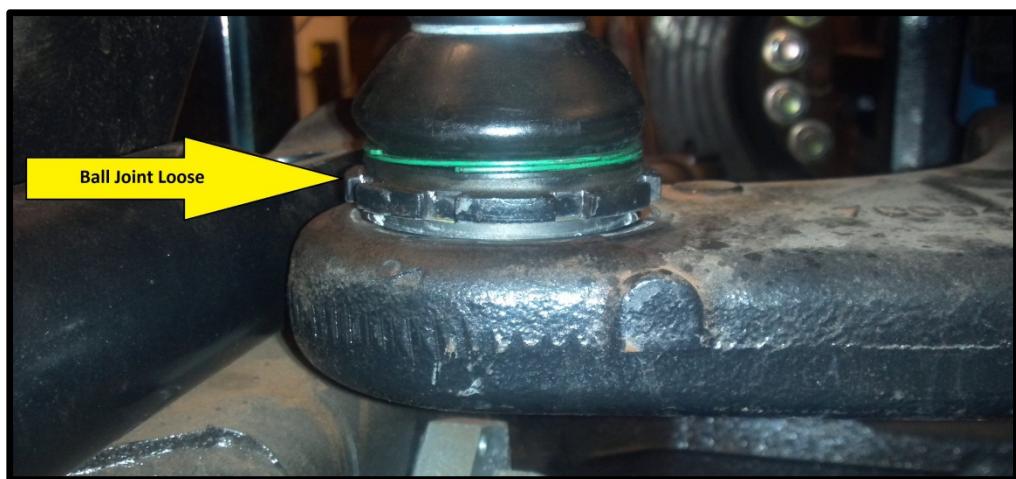
**FIG. 2-2**

2. Visually inspect the ball joints located in pitman arms, the ball joints will be seated in both pitman arms off of the steering gears. The ball joint shall be fully engaged with the notched flange in contact with the surface of the pitman arms. If it is not, please proceed to the repair procedure. Refer to FIG. 2-2 and 3-1 (pictures may not represent suspension you are working on).
