Recall Campaign Bulletin

Campaign No. 2014120006, January 2015

SUBJECT: Models 212 Model Year 2015

Replace Second Row Double Seat Belt Buckle

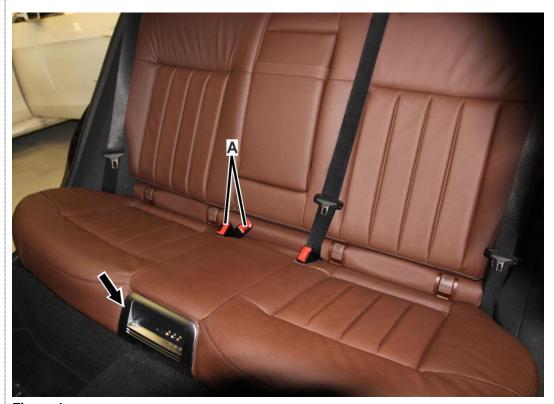
Figure 1

Daimler AG (DAG), the manufacturer of Mercedes-Benz vehicles, has determined that on certain Model Year 2015 E-Class vehicles the double seat belt buckle in the second row may not have been manufactured according to specifications. Subject vehicles are equipped with seat belt load limiters on all seats except for the rear middle passenger seat. Even in the event of a severe frontal crash, the seat belt load limiter will ensure that the belt load magnitude reached at the right rear passenger seat remains at a non-critical level for an affected double seat belt buckle. However, in the event of a severe frontal crash for the rear middle passenger seat, an affected double seat belt buckle may fail under such loading. This could increase the risk of injury for buckled middle seat passengers under these circumstances. An authorized Mercedes-Benz dealer will therefore replace the second row double seat belt buckle.

1. Replace double seat belt buckle (A, Figure 1) for right rear seat belt; refer to WIS: AR91.40-P-1516EW and perform steps 1, 3, 7.

- Note (regarding above WIS instructions)
- Disconnection of seat belt buckle switches does not apply to this campaign.
- Removal of circlip on seat belt buckle mounting bolt does not apply to this campaign.
- For vehicles with rear entertainment system, the paneling (arrow) on the DVD player must be removed prior to removing the rear seat; refer to WIS: AR82.60-P-7505-01EW.
- 2. Reassemble in reverse order.
