# Recall Bulletin

## SERVICE PARTS SAFETY RECALL

**SUBJECT:** Ignition Lock Cylinder Binding

**MODELS:** Various Serviced Vehicles

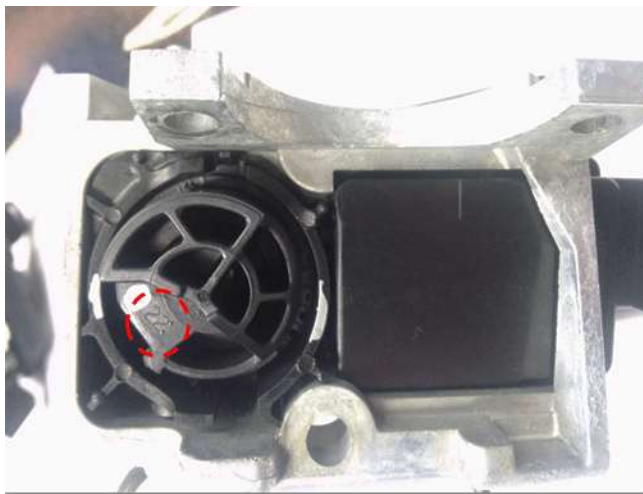
4064725

2. Inspect the inboard side of the housing for the mold cavity number, at the location shown circled in the graphic above:

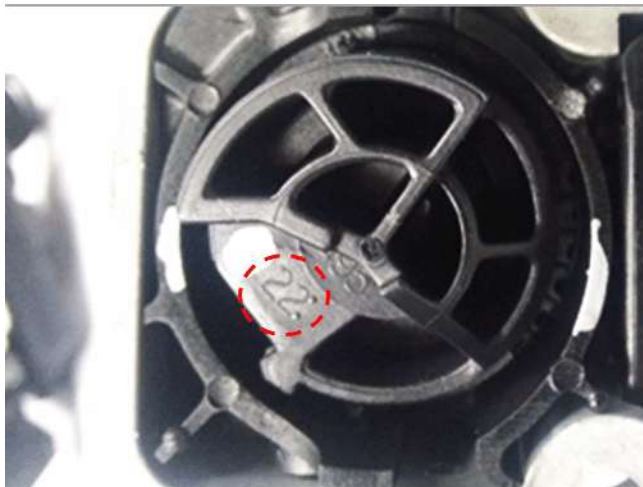
4064727

- If the cavity number reads “22”, the ignition lock cylinder case MAY contain the failure issue and you should move directly to the Service Procedure below.

- If the cavity number reads anything other than “22”, the case can be reinstalled and no further action is required. For reinstallation, refer to Ignition Lock Cylinder Case Replacement in SI.
