# Recall Bulletin

## PRODUCT SAFETY RECALL

**SUBJECT:** Ignition Lock Cylinder Binding

**MODELS:** 2011-2012 Cadillac Escalade, Escalade ESV, Escalade EXT  
2011-2012 Chevrolet Avalanche, Silverado, Suburban, Tahoe  
2011-2012 GMC Sierra, Yukon, Yukon XL

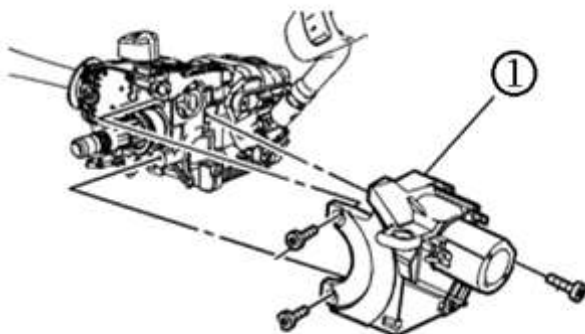
1. Remove the ignition lock cylinder case (1) from the steering column. Refer to Ignition Lock Cylinder Case Replacement in SI.

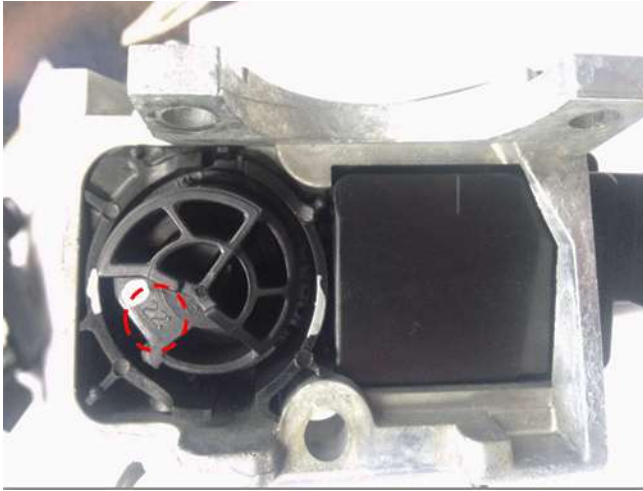
4064725

2. Inspect the inboard side of the housing for the mold cavity number, at the location shown circled in the graphic above:

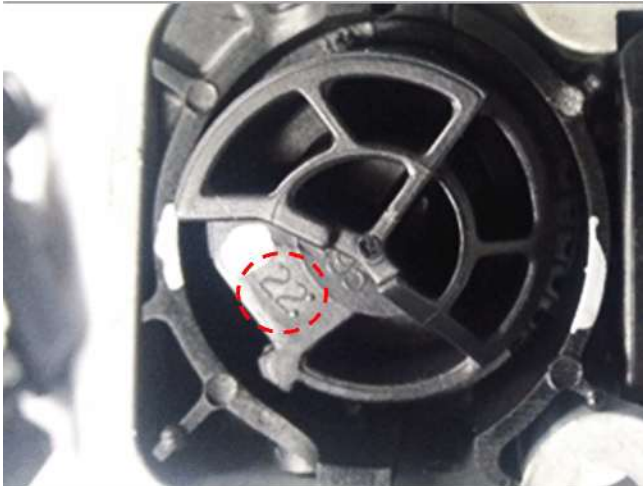
4064727

- If the cavity number reads “22”, the ignition lock cylinder case MAY contain the failure issue and you should move directly to the Service Procedure below.
- If the cavity number reads anything other than “22”, the case can be reinstalled and no further action is required. For reinstallation, refer to Ignition Lock Cylinder Case Replacement in SI.
