**BLUE BIRD**

**SUBJECT: RECALL R14XE  
STEERING SHAFT CLAMP MAY CONTACT RUBBER  
CLOSEOUT BOOT**

**IMPORTANT SAFETY RECALL NOTICE**

**NHTSA RECALL NO. 14V-309 SCHOOL BUS  
NHTSA RECALL NO. 14V-306 NON-SCHOOL BUS**

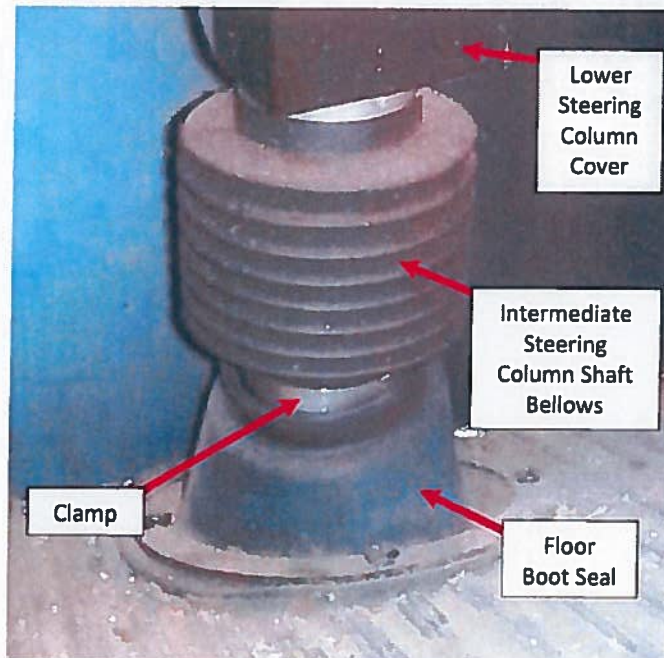
Fig. 1

Clamp on intermediate steering column shaft bellows may contact steering shaft floor boot seal and tear floor boot seal and bind steering shaft causing increased steering effort.

1. Park bus on a level surface, apply parking brake, turn off ignition, remove ignition key and chock rear wheels.
2. Inspect steering shaft floor boot seal for wear or damage and slit is toward front of bus.
3. If damaged or worn, complete section **Steering Shaft Floor Boot Seal Replacement** before continuing.
4. After completing section **Steering Shaft Floor Boot Seal Replacement** or if there is no damage or wear to the floor boot seal, complete section **Intermediate Steering Column Shaft Bellows Adjustment**.
