# Recall Bulletin

## PRODUCT SAFETY RECALL

**SUBJECT:** Ignition Key

**MODELS:** 2010-2014 Chevrolet Camaro

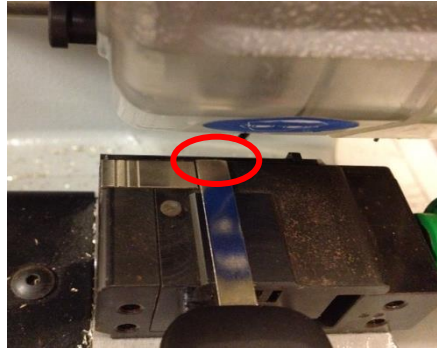
3947698

**Note:** The key blank should fit into the Jaw as shown in the picture. Make sure there is no gap in the area circled in the picture. Remove the guard if necessary.
