Recall Bulletin

PRODUCT SAFETY RECALL

SUBJECT: Unintended Ignition Key Rotation

MODELS: 2011-2014 Cadillac CTS (VIN D and Built After December 12, 2010)
Equipped with Traditional Key Ignition

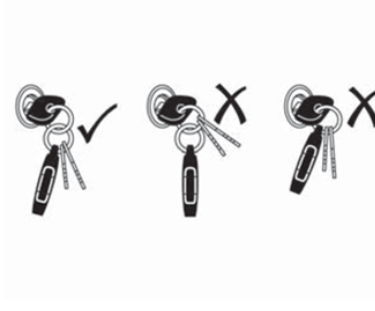
The combination and size of the rings that came with your keys were specifically selected for your vehicle. The rings are connected to the key like two links of a chain to reduce the risk of unintentionally moving the key out of the RUN position. Do not add any additional items to the ring attached to the ignition key. Attach additional items only to the second ring, and limit added items to a few essential keys or small, light items no larger than an RKE transmitter.
