# Recall Bulletin

**SUBJECT:** Lapbelt Pretensioner Locking Performance

**MODELS:** 2013 Buick Encore  
2013 Cadillac ATS 4-Door  
2013 Chevrolet Trax  
and  
Vehicles that were serviced with a suspect part:  
2013-2014 Buick Encore  
2013-2014 Cadillac ATS 4-Door  
2014 Cadillac CTS Sedan (VIN A)

GM Recall #14171

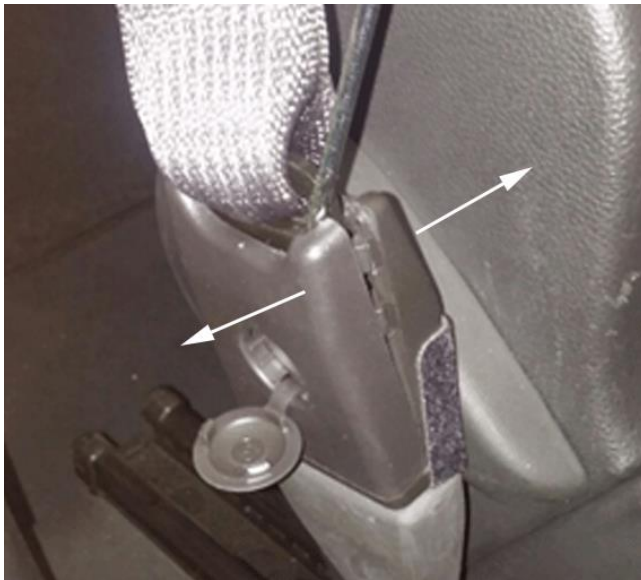
4282852

**Caution:** Carefully separate the seat belt tensioner covers using a flat-blade screw driver. Apply light pressure to the covers using the flat-blade screw driver to avoid damaging the covers or cover key.

1. Remove the driver seat belt tensioner cover.
2. Remove the seat belt with latch from the front seat belt tensioner.
3. Remove the driver seat belt tensioner fastener.

4. Remove the driver seat belt tensioner assembly.
5. Discard the tensioner assembly.
6. Install a new lapbelt tensioner.
7. Tighten seat belt tensioner fastener to 45 Nm (33 lb ft).
8. Tighten seat belt tensioner cover fastener to 5 Nm (44 lb-in).
9. Follow SI instructions included in *Front Seat Belt Anchor Plate Tensioner Replacement* to complete the repair.
