PRODUCT SAFETY RECALL

SUBJECT: Unintended Ignition Key Rotation

MODELS: 2011-2013 Chevrolet Caprice PPV
2008-2009 Pontiac G8

GM Recall Number: 14445

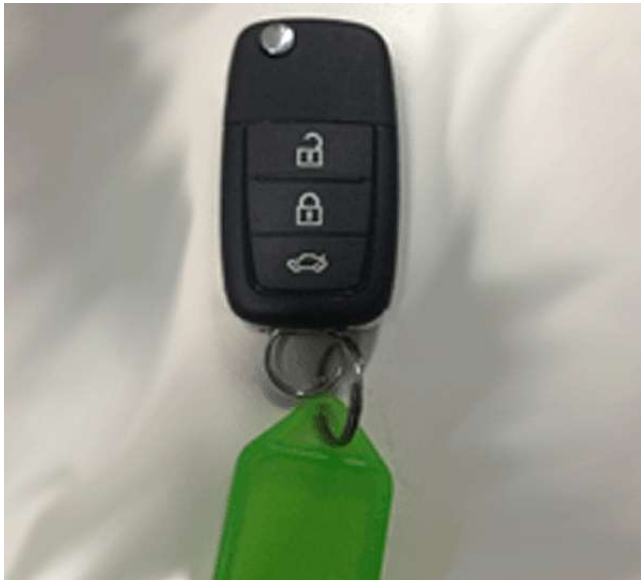
4036253

1. Identify the original customer keys (the original keys may be flip blade type or fixed blade type). Both the flip and fixed type will need to be replaced with the NEW design FIXED blade type.

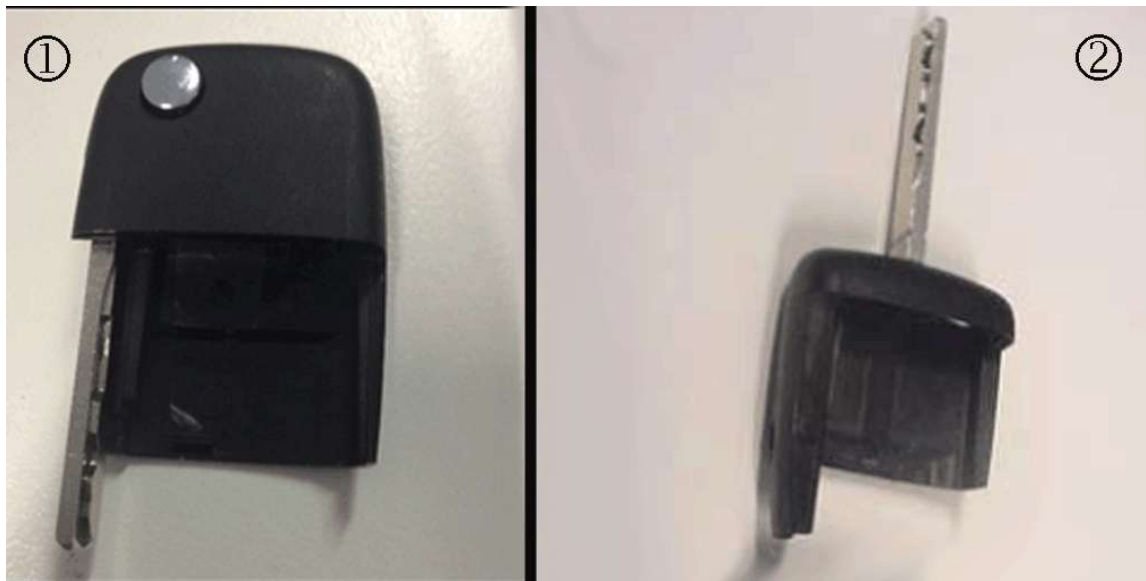
4036264

(1) Flip Style Key Blade (2) Fixed Style Key Blade. Discard the original key blade and housing.

- 3. **DISCARD the ORIGINAL key blade and housing (it is very important that the original key blade is not given back to the customer).**

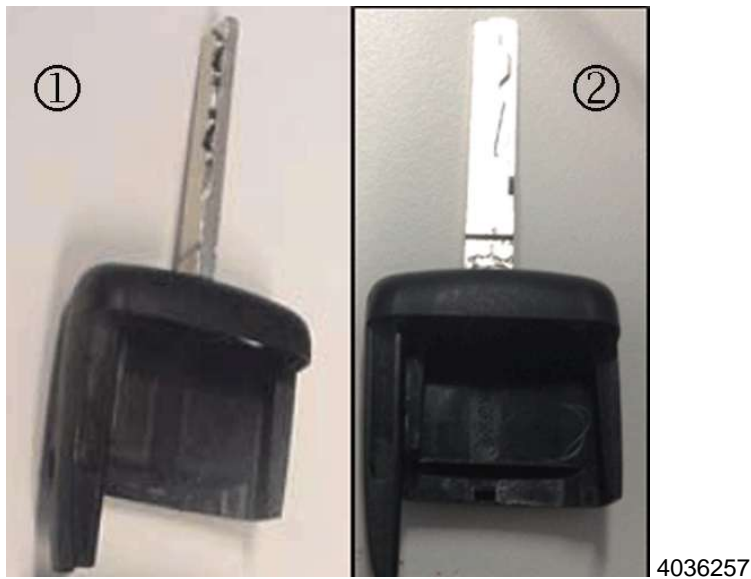
(1) Old Key (2) New Key

4. Identify the replacement key blade and housing assembly (2), noting that the key blade has been indexed by 90 degrees and now aligns parallel to the housing assembly.
5. CUT the new key blade assembly to match the original key cut profile.
