February 23, 2015

**SUBJECT:** **DEMONSTRATION / DELIVERY HOLD - Safety Recall 15S02**  
Certain 2010-2013 Model Year Taurus and Police Interceptor Sedan,  
and 2011-2013 Model Year MKS Vehicles  
Interior Door Handle Inspection and Repair

**CERTAIN 2010-2013 MODEL YEAR TAURUS AND POLICE INTERCEPTOR SEDAN  
AND 2011-2013 MODEL YEAR MKS VEHICLES — INTERIOR DOOR HANDLE  
INSPECTION AND REPAIR**

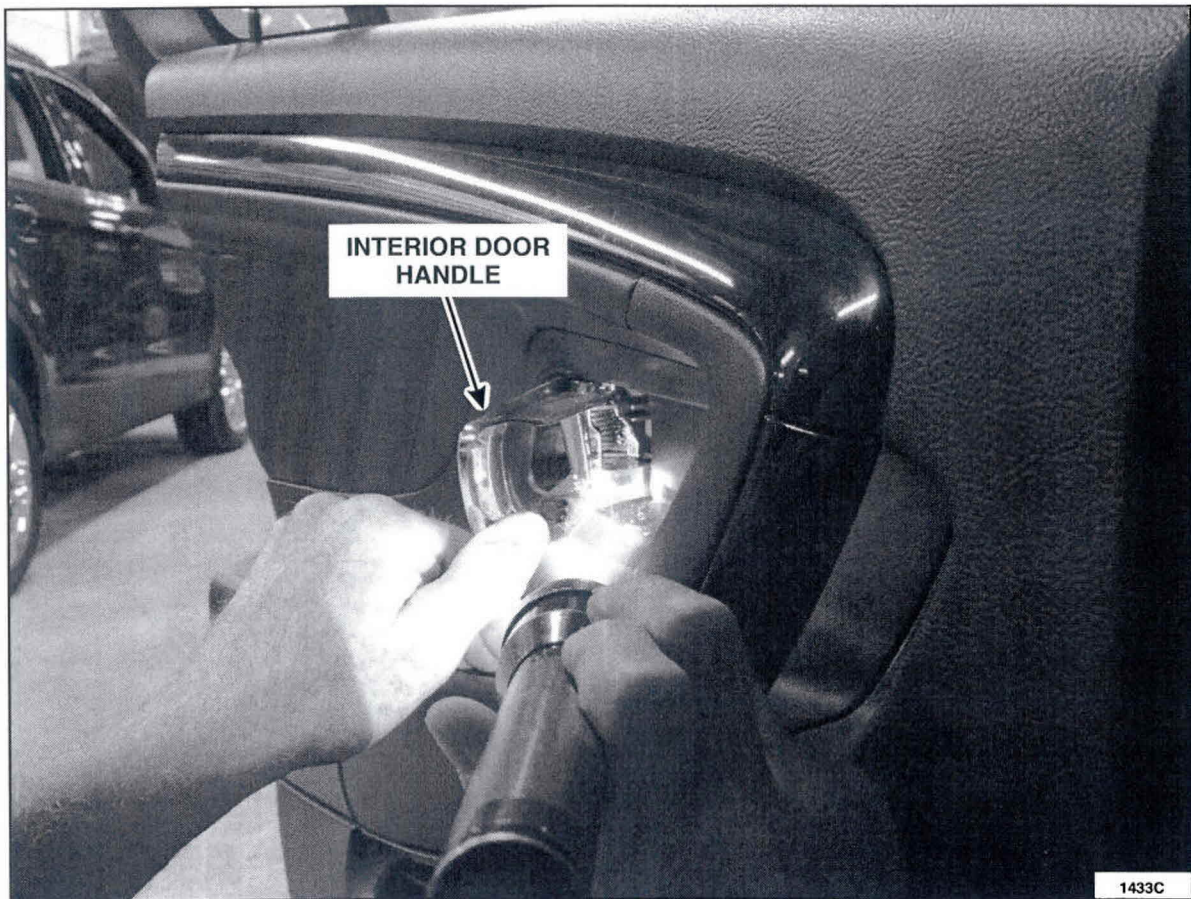
**FIGURE 1**

1. Hold the interior door handle in the open position. Using a flashlight, locate the return spring and return spring retainer wall. See Figure 1 below and Figure 2 on Page 2.

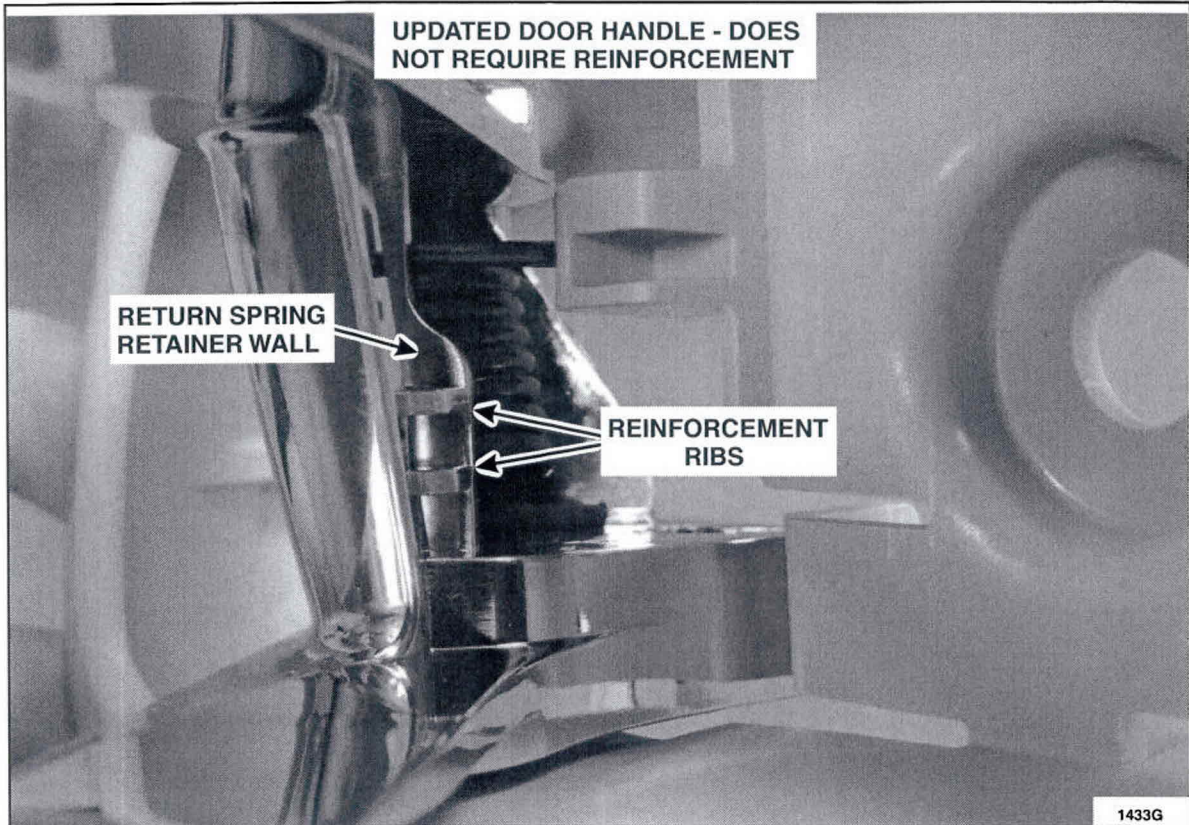
**FIGURE 3**

3. Interior door handle is equipped with two (2) reinforcement ribs on the return spring retainer wall. See Figure 3.

- No service is required on this interior door handle design.

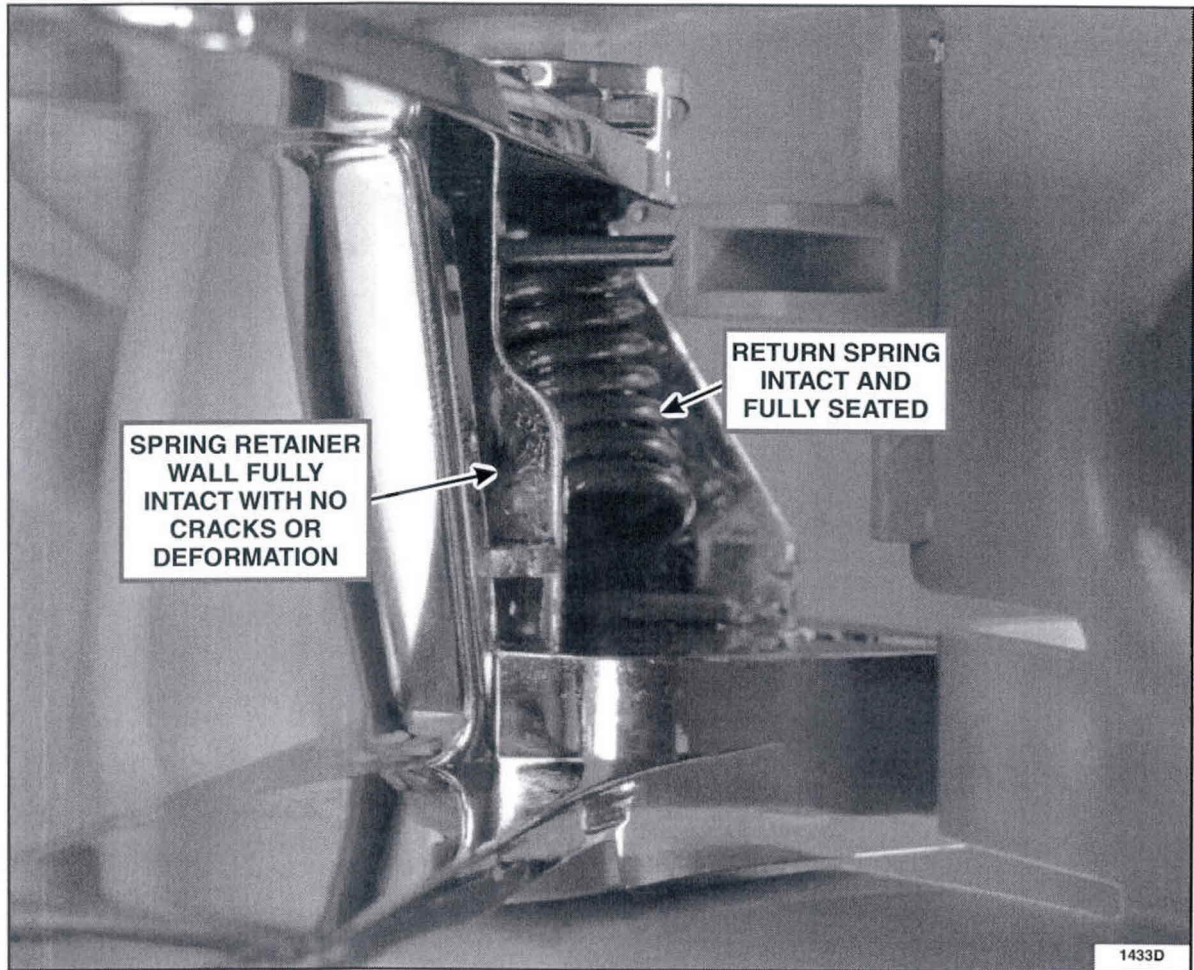
FIGURE 4

4. Return spring is intact and fully seated. The spring retainer wall is not deformed and is fully intact with no cracks. See Figure 4.

- Proceed to step 8.

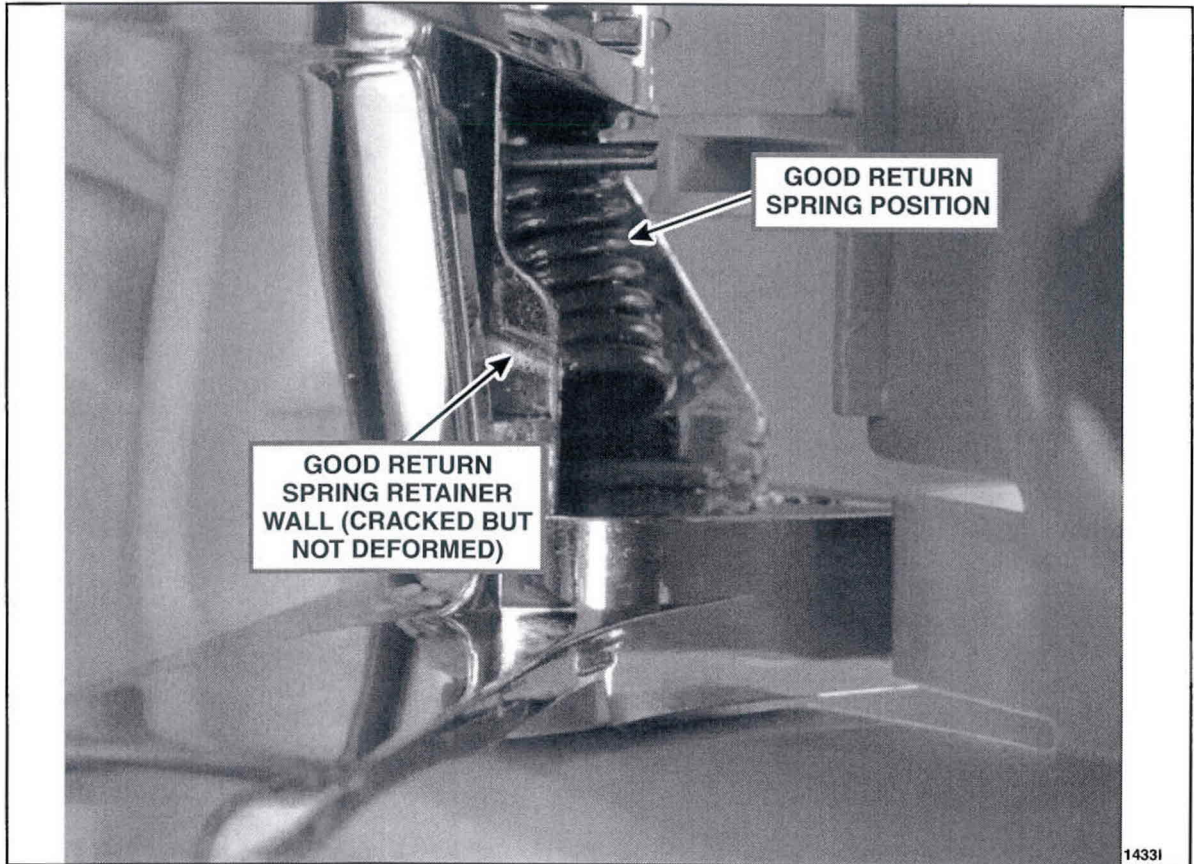
FIGURE 5

5. Return spring is intact and fully seated. The spring retainer wall has a single crack, but is not deformed and is fully intact. See Figure 5.

- Proceed to step 8.

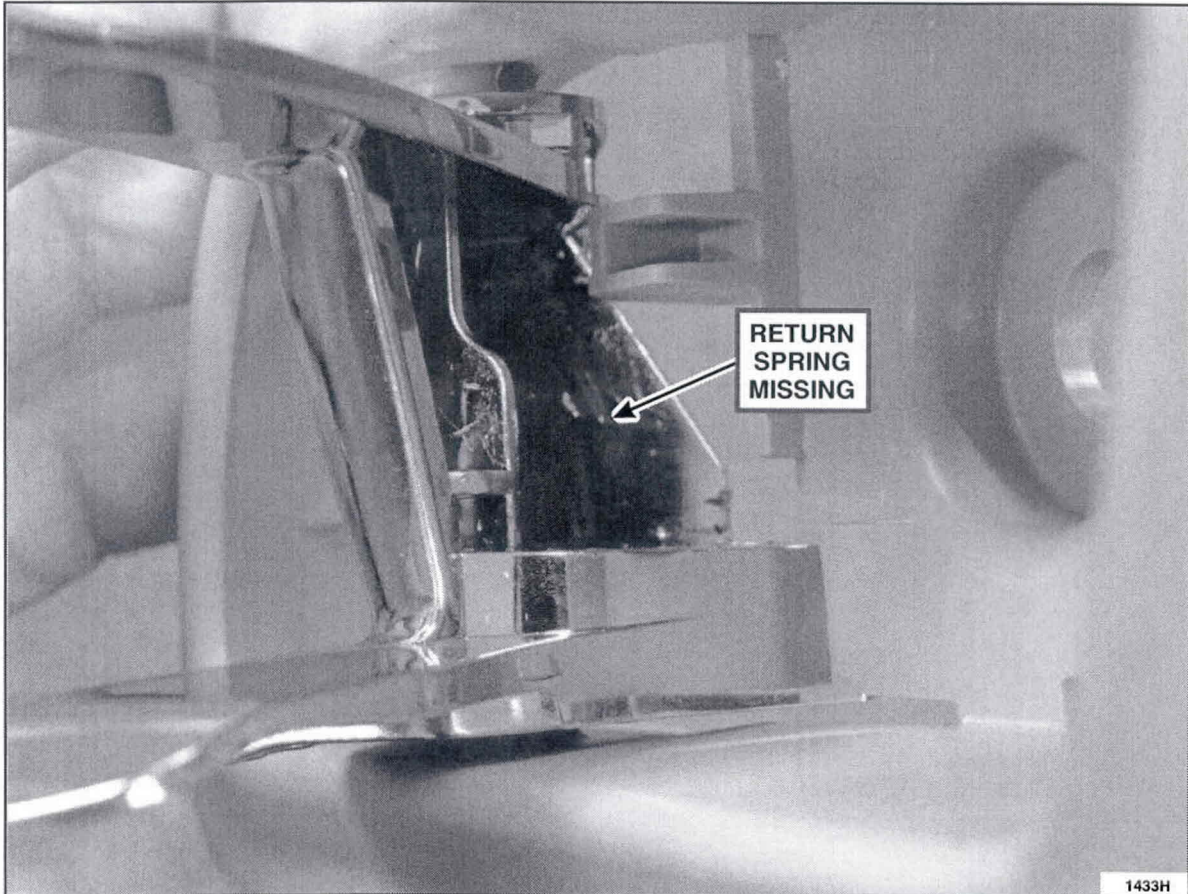
FIGURE 6

6. Return spring is loose, out of position, or missing. See Figure 6.

- Replace the interior door handle. Please follow the Workshop Manual (WSM) procedures in Section 501-14.

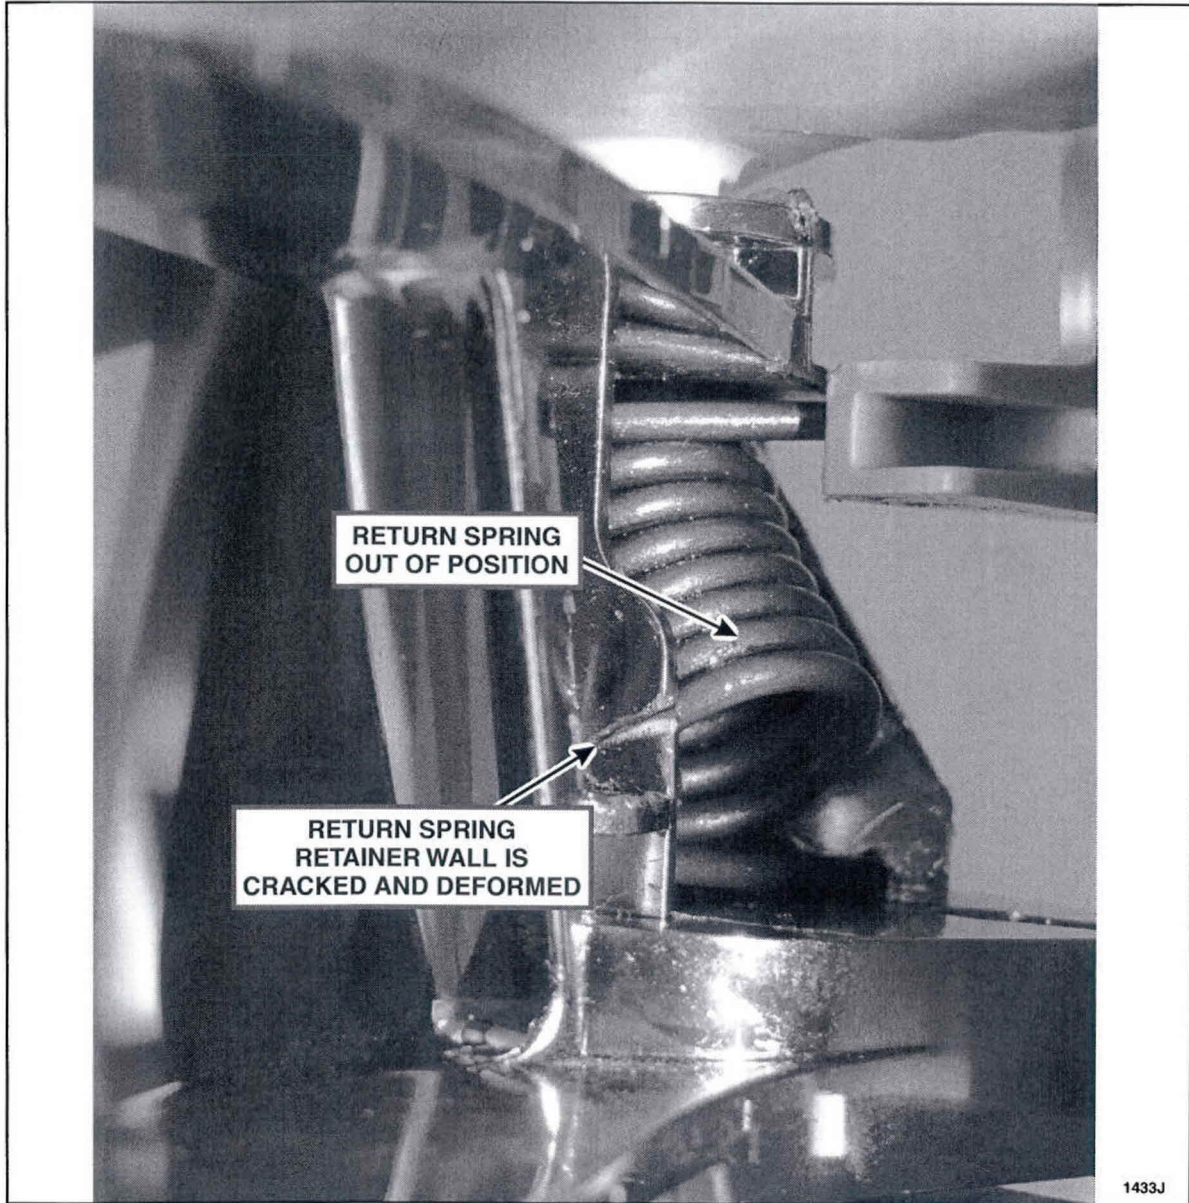
FIGURE 7

7. Spring retainer wall is missing, deformed, or broken. See Figure 7.

- Replace the interior door handle. Please follow the WSM procedures in Section 501-14.
